Evaluation of Public Safety at Run-of-River Dams

4.7 *Rock River Dams*

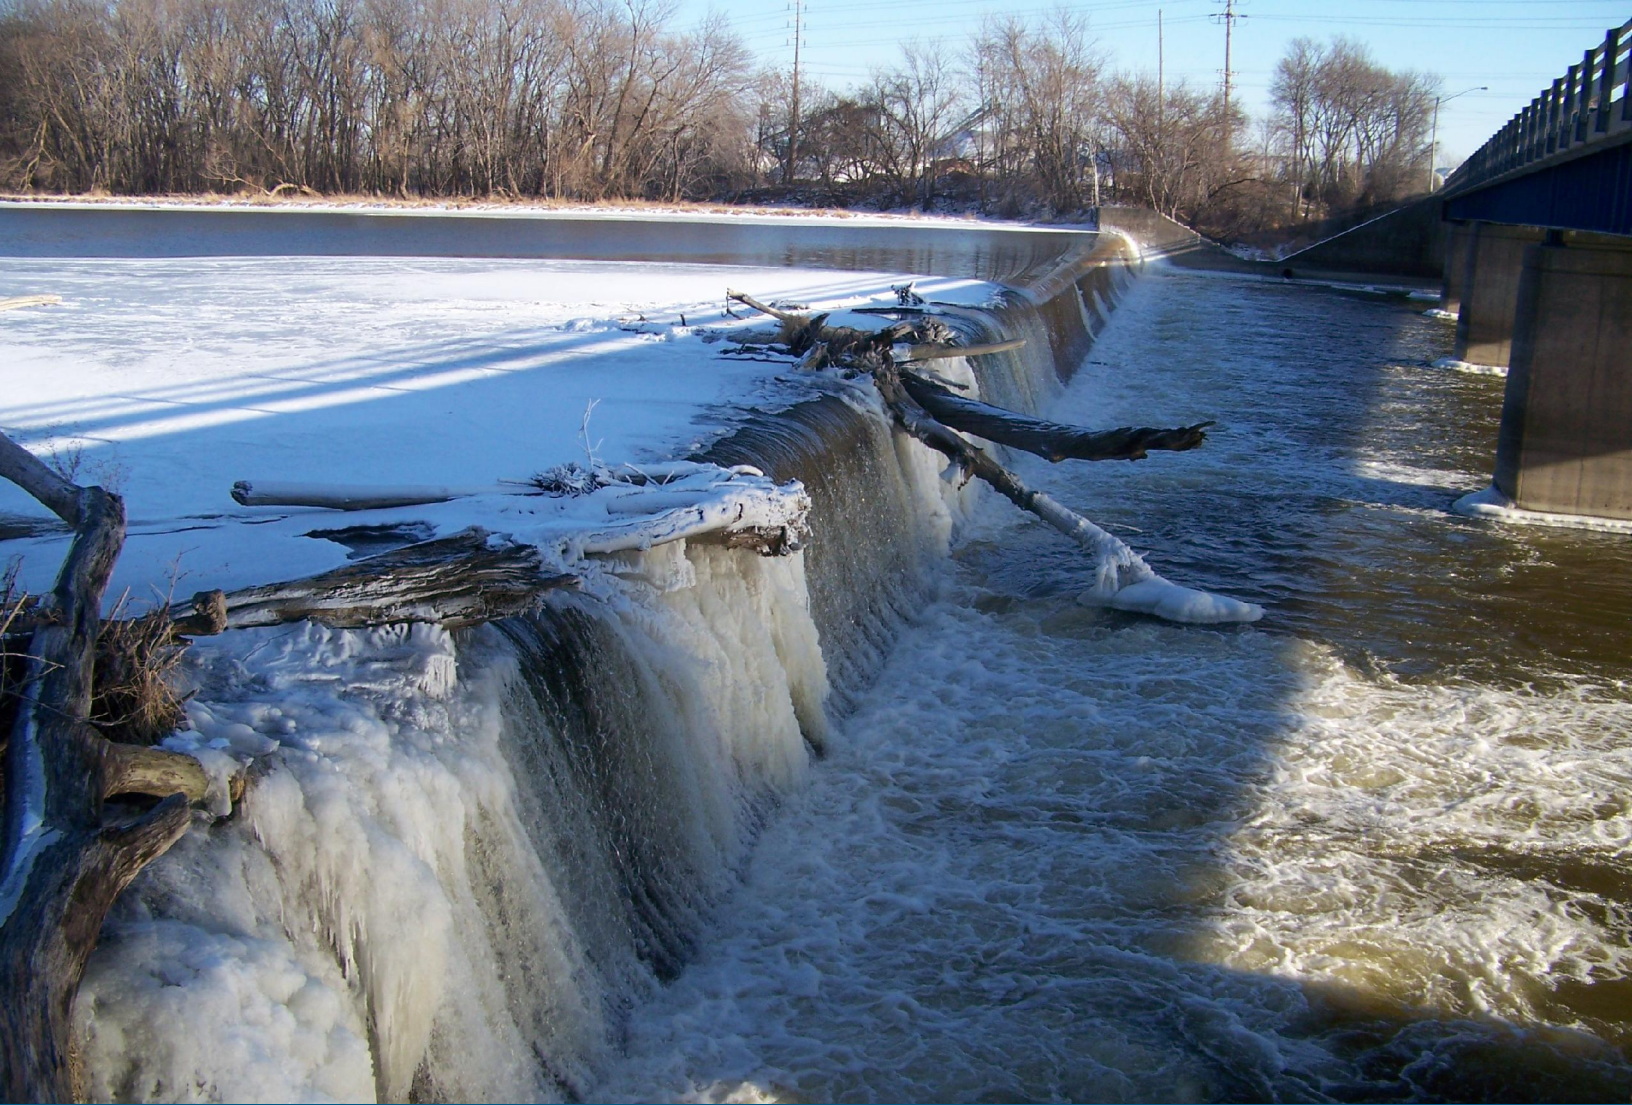
Sears Dam was visited on January 30, 2007. Observations made on these occasions and a review of IDNR summaries form the basis for the existing conditions summary.

Dam is in serviceable condition with some minor structural degradation in evidence. Abutments appear sound with some minor weathering. Upstream along the left bank is silt/sand deposit are evident. Upstream right bank is sloping private property with some access and boat docks. Downstream left bank is gravel/sand deposited downstream of the bridge pier/abutment. Downstream on the left bank there is 100 year old, operating hydroelectric plant in good condition.

10-15' reverse roller was noted downstream of toe - A floating automobile tire stayed within five ft of toe of dam for several hours.

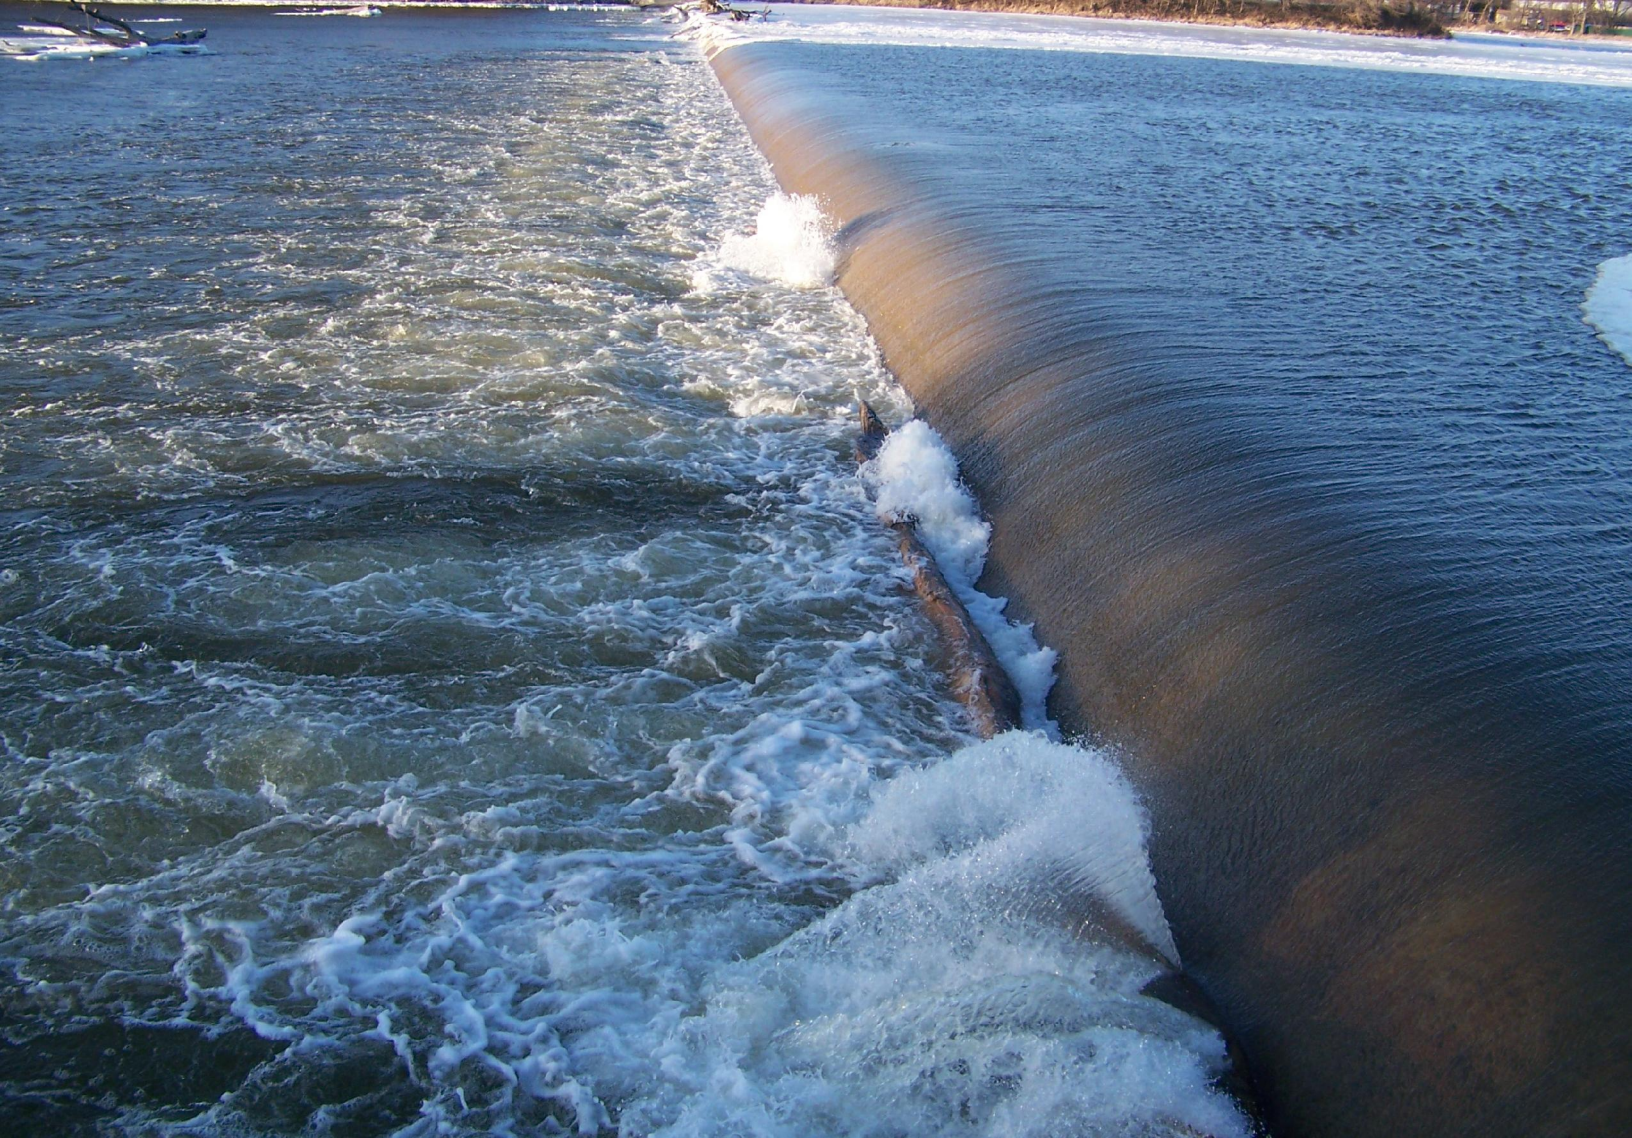
Steel Dam was visited on January 30, 2007. Observations made on these occasions and a review of IDNR summaries form the basis for the existing conditions summary.

The Steel Dam was recently rebuilt, appears to be in good condition with horizontal and vertical alignment of dam crest and abutments good. Abutments appear sound and in good condition. Upstream along the left bank there is a silt/sand deposit in state park. Downstream along the left bank there are gravel/sand deposits. This area is accessible through park. Right bank is on Van Druff Island. It can only be accessed from the river or over private property. The upstream right bank is gravel and bedrock.

5-15' reverse roller was observed downstream of toe. Three large tree trunks were trapped and rotating in the roller at the toe of the dam for several hours.

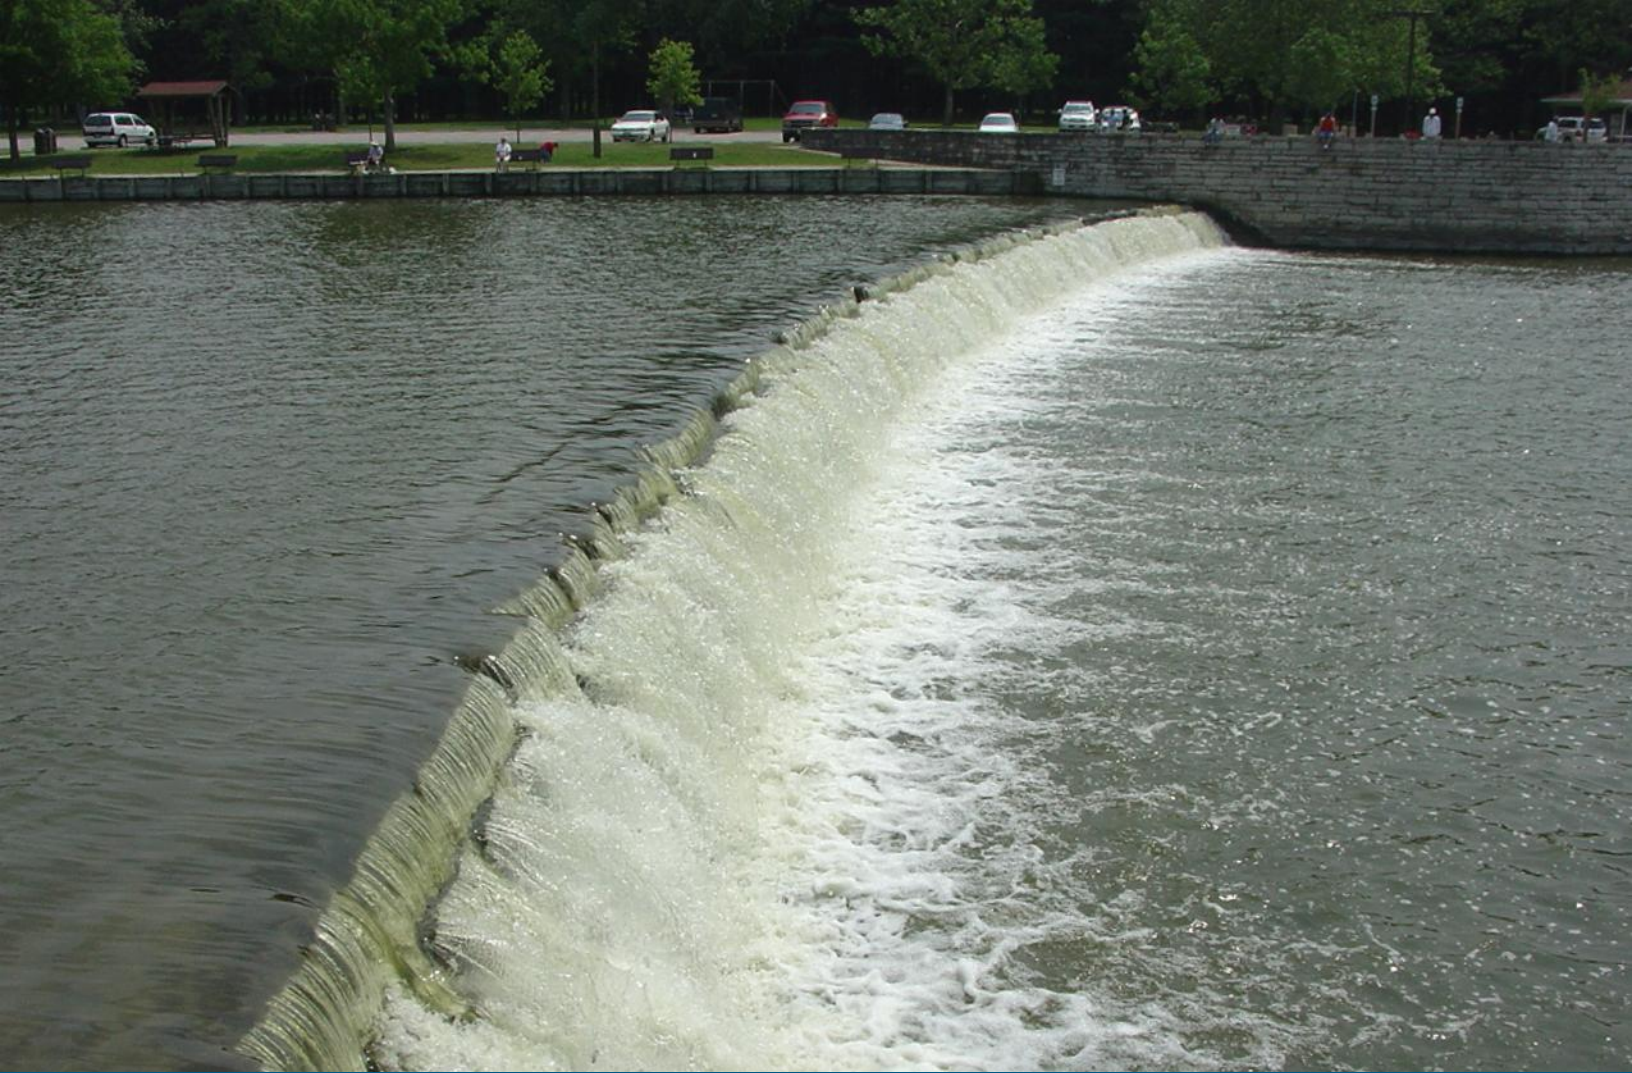
McHenry (Stratton L & D) Dam was visited on February 1, 2007. Observations made on these occasions and a review of IDNR summaries form the basis for the existing conditions summary.

The dam appears in good condition with no visible obvious deficiencies. A new gate was installed in left spillway within the last 10 years.

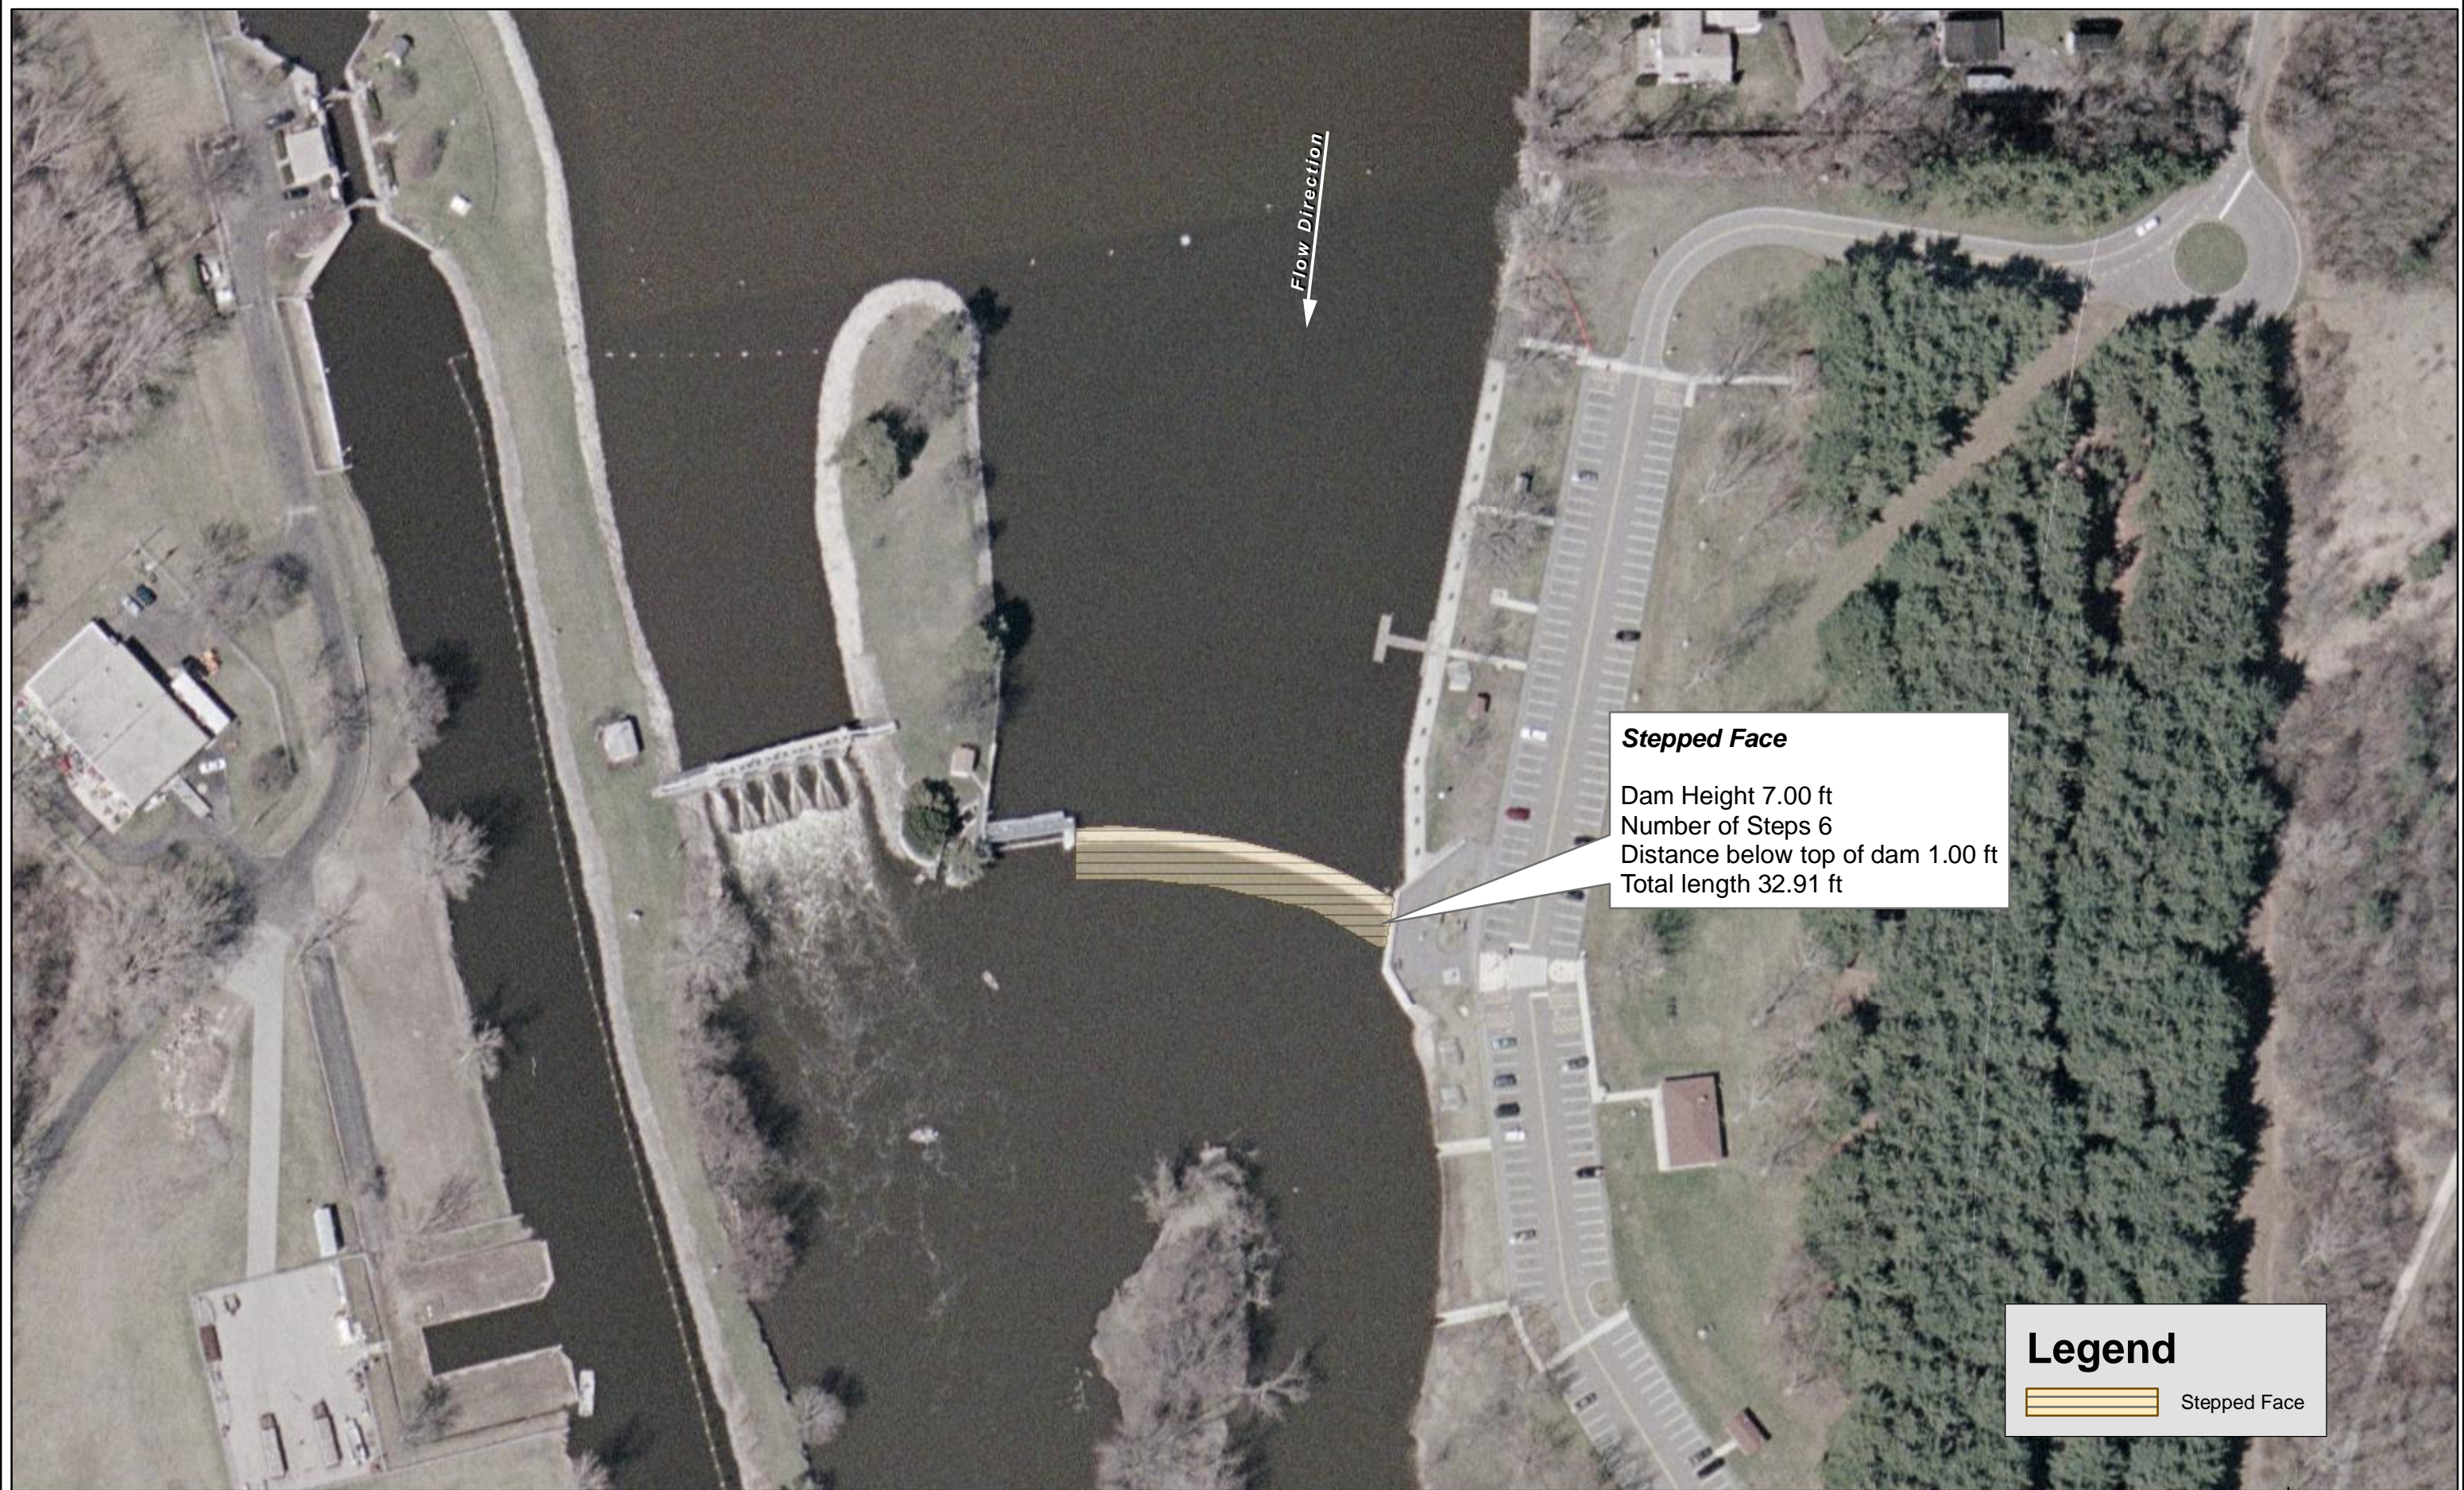
Stepped Face
 Dam Height 7.00 ft
 Number of Steps 6
 Distance below top of dam 1.00 ft
 Total length 32.91 ft

A dam face modification concept was developed for this reach (See Figure 4.8.4.1.6). A stepped face structure with 6 steps could replace the existing steps which appear to be quite steep (approximately a 1:1 (H:V) slope). Hydraulic studies and physical modeling of the proposed structure would be required to determine a final design and the effectiveness of the stepped face. The study should also examine the impacts of the conceptual stepped face on the adjacent gated structure.

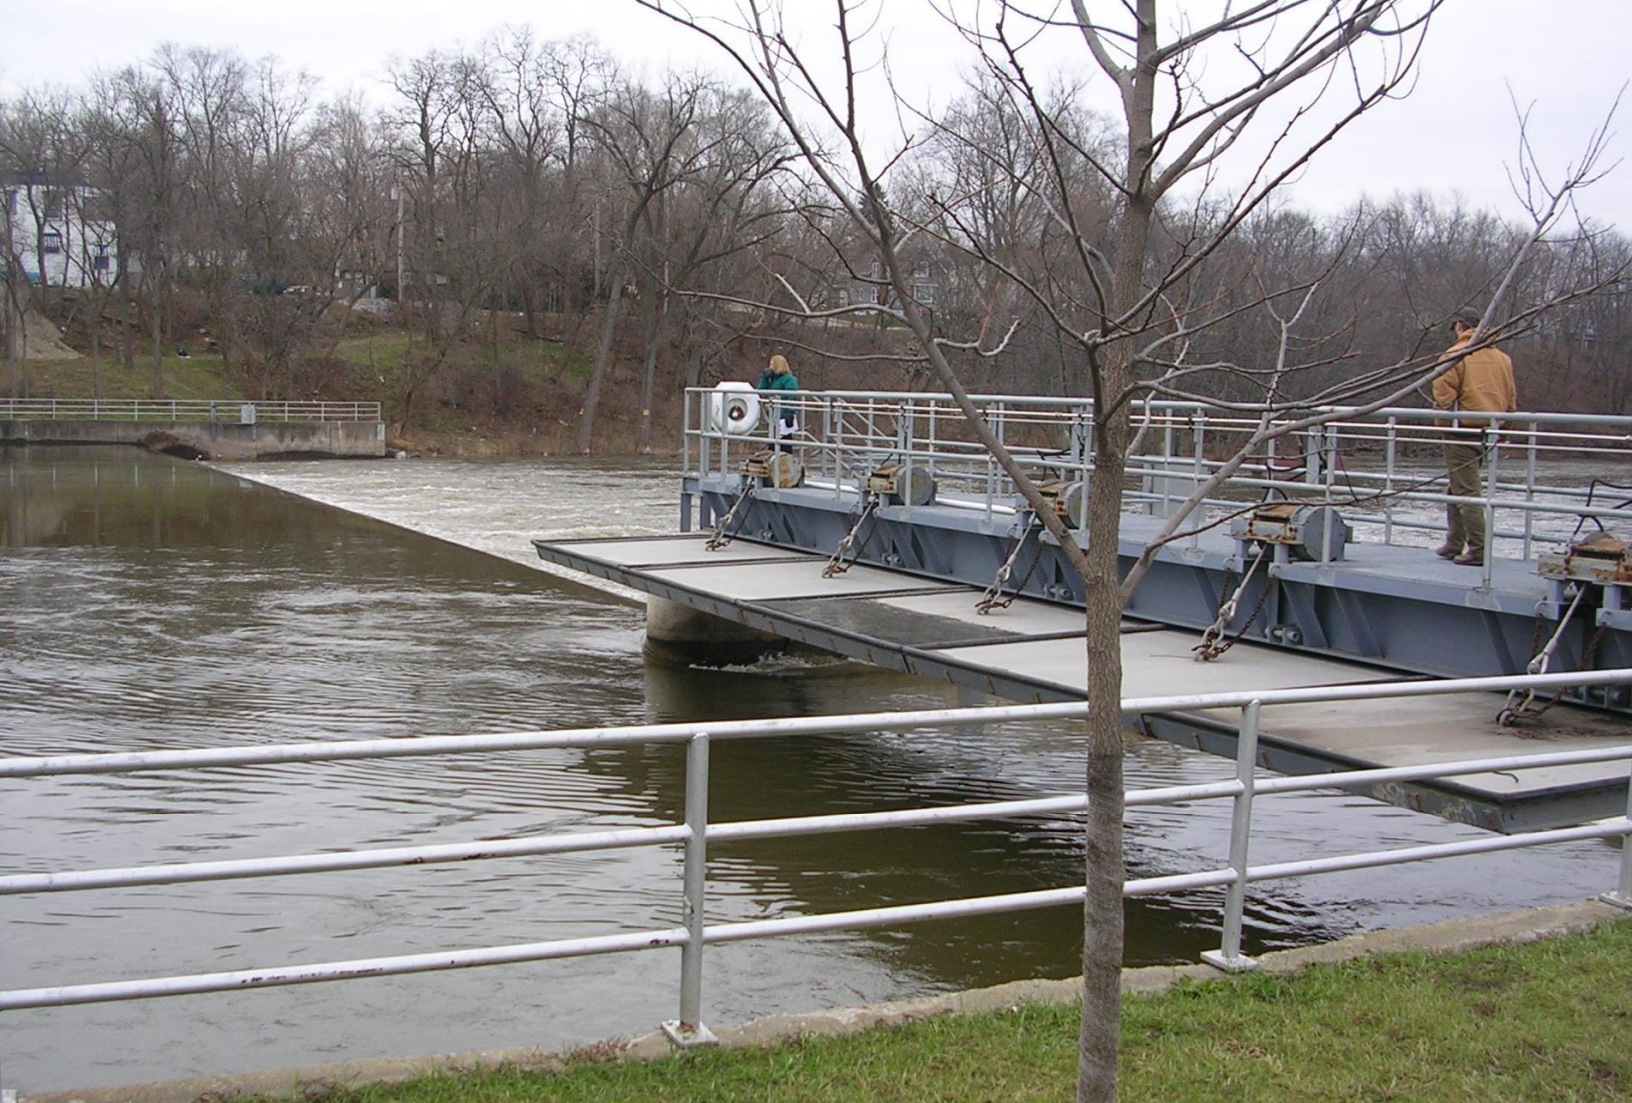
Algonquin Dam was visited on December 27, 2006. Observations made on these occasions and a review of IDNR summaries form the basis for the existing conditions summary.

No visible obvious deficiencies were noted. The horizontal and vertical alignment of the dam crest and abutments was good. Abutments are in good condition, with 4 ft. rails. The left downstream abutment is eroded with some large rocks and steep banks.

There are portages on the right bank. One is 1200 ft upstream and the other is 500 ft downstream. The portage is in good condition. No portage was signage observed. The downstream portage leads directly into strong current. This portage should be considered redesign.

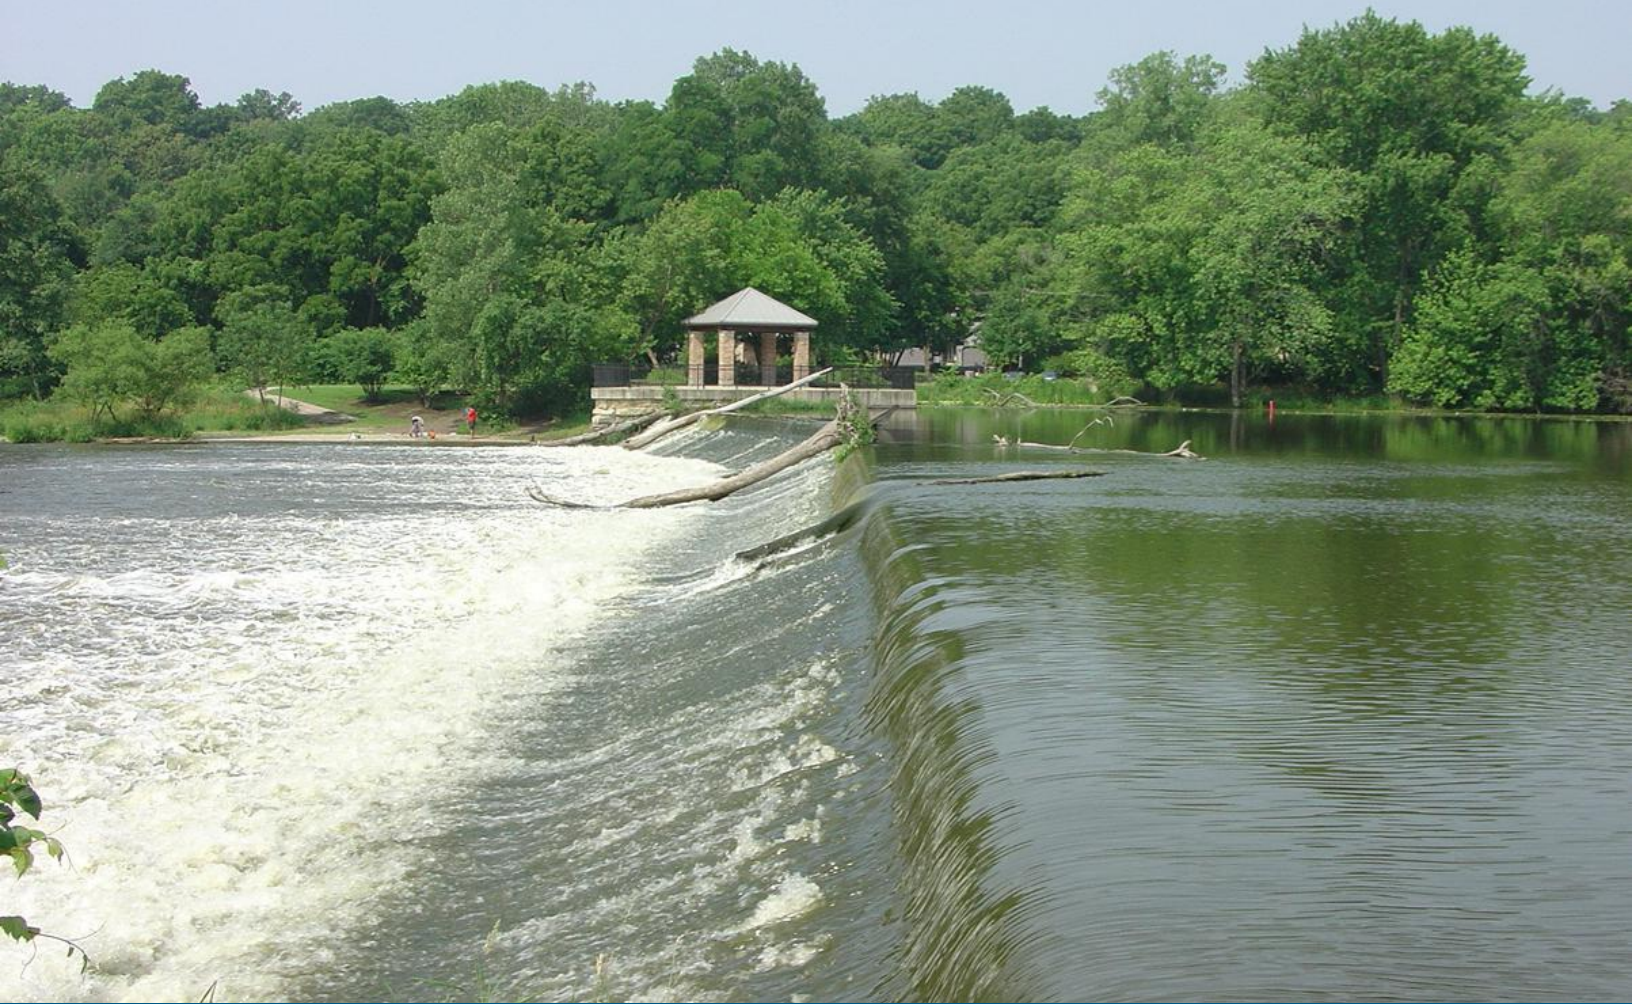
Carpentersville Dam was visited on January 5, 2007, and April 12, 2007. Observations made on these occasions and a review of IDNR summaries form the basis for the existing conditions summary.

The spillway's left training wall is constructed of stone masonry. The 75-ft long left embankment between the left training wall and east raceway is in poor condition and appears to have been overtopped in the past. Erosion is present behind the downstream training wall, with severe erosion of the left downstream bank due to an eddy. The fish ladder is blocked with debris. The embankment between the raceway and river is narrow and eroding, prone to failure. The right abutment appears to have some undercutting downstream of the abutment. Raceway head gates are three 12-ft high concrete bays, with a total width of 60 ft. Heavy duty timber stop logs plug the raceway, holding approximately seven ft of water. An earth berm (old cofferdam) crosses most of the east (left) raceway, just upstream of the head gates.

The right abutment has some undercutting at the downstream ft of the abutment. Log debris on the dam face near the right abutment was noted. The left abutment is in deteriorating condition with cracks and some vegetation growth in abutment. There is erosion around the left abutment. The fish ladder located at the left abutment showed some concrete deterioration and was partially clogged with log debris. Significant erosion was noted on the downstream left bank. There is a millrace left of the left dam abutment that has been bulkheaded to prevent flow. Some overflow could occur at exceptionally high river levels. There is a pedestrian walkway over the millrace that is in poor condition. This walkway is the access to the left abutment.

No warning signage was observed.

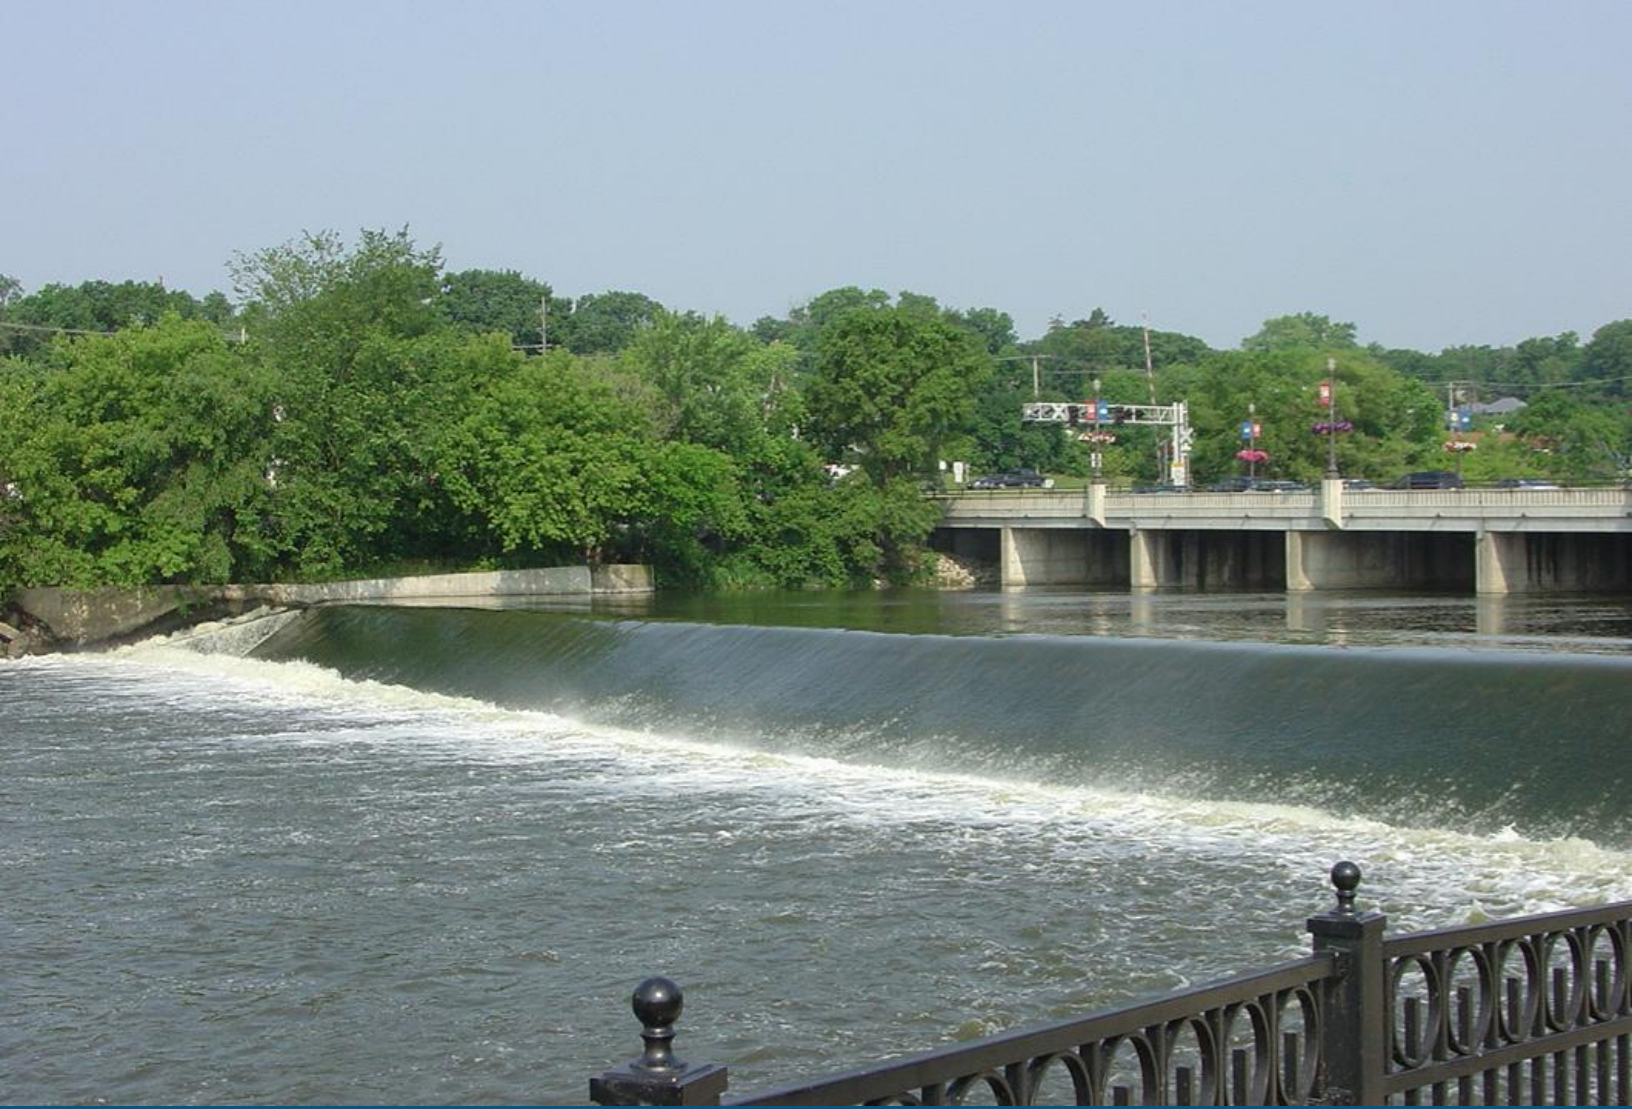
Elgin Kimball Street Dam was visited on February 1, 2007, and April 11, 2007. Observations made on these occasions and a review of IDNR summaries form the basis for the existing conditions summary.

This dam is located 150 ft downstream (south) of Kimball Street and is owned by the City of Elgin. It consists of a right training wall, spillway, left training wall, and two scenic overlooks at the left abutment. The dam appears to be in good overall condition.
