Kickapoo Creek Stream Restoration Project - Phase 3

FY 2010 State Wildlife Grant

Final Report

October 2012

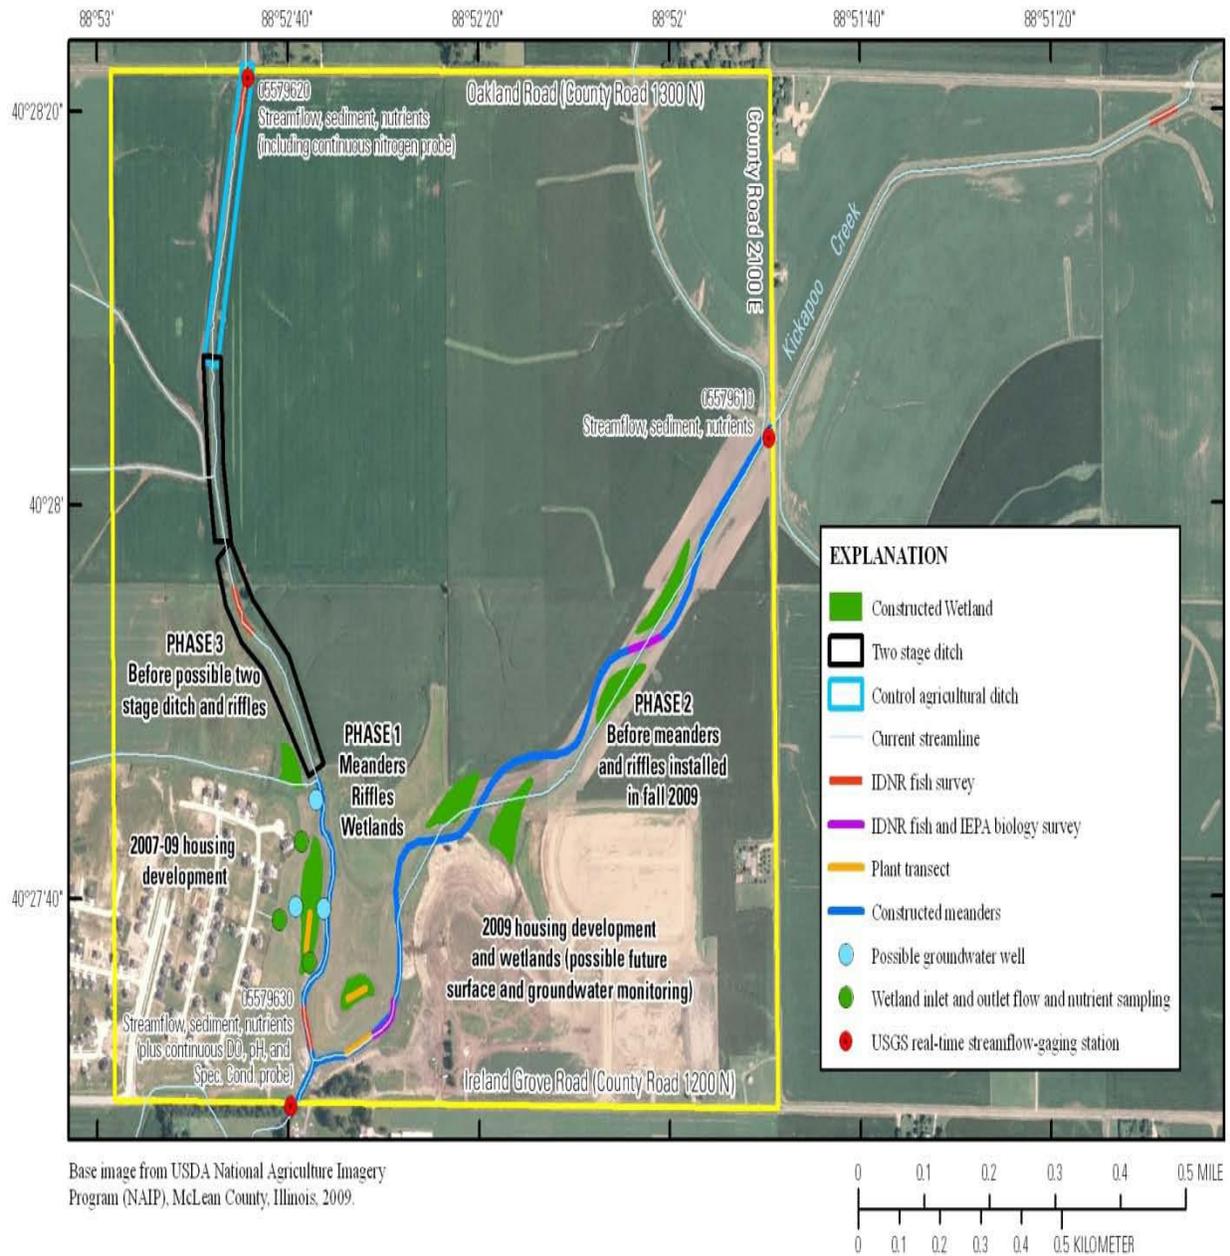
Figure 2. Aerial photograph of the Kickapoo Creek Stream Restoration site, showing the location of the 2-stage ditch on the unnamed west branch tributary outlined in black. Other features of the restoration work completed in the previous two phases and the monitoring infrastructure is also labeled on the photograph.

1. Implement in-stream habitat restoration practices within 3000 feet of a 2-stage ditch demonstration project on the unnamed west branch of the Kickapoo Creek headwaters (Figure 2).
 - A. 12 rock riffles will be constructed within the Phase 3 reach (Figure 3).
 - B. 600 feet of bank will be protected with rip rap within the Phase 3 reach (Figure 3).
2. Monitor the fish population for post-restoration evaluation and documentation of the project.

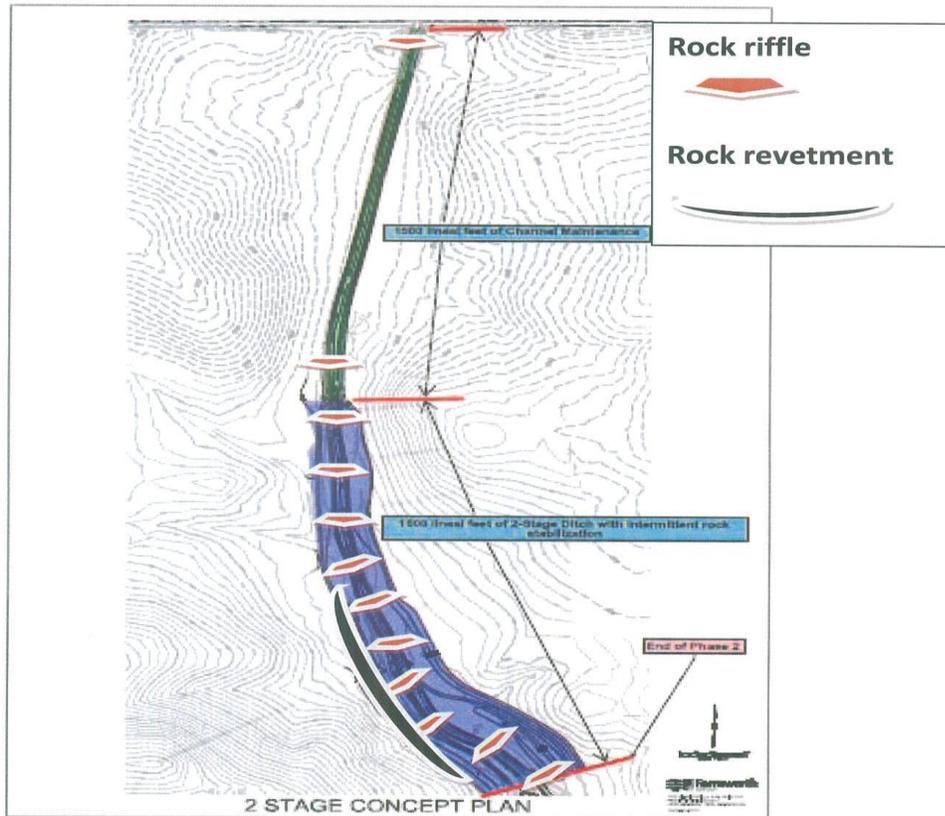
b/ the intended location of the 12 rock riffles and the 600 feet of rip-rapping.

Figure 3. Schematic drawing showing the location of the rock riffles and bank stabilization within the 2-stage ditch Phase 3 reach.

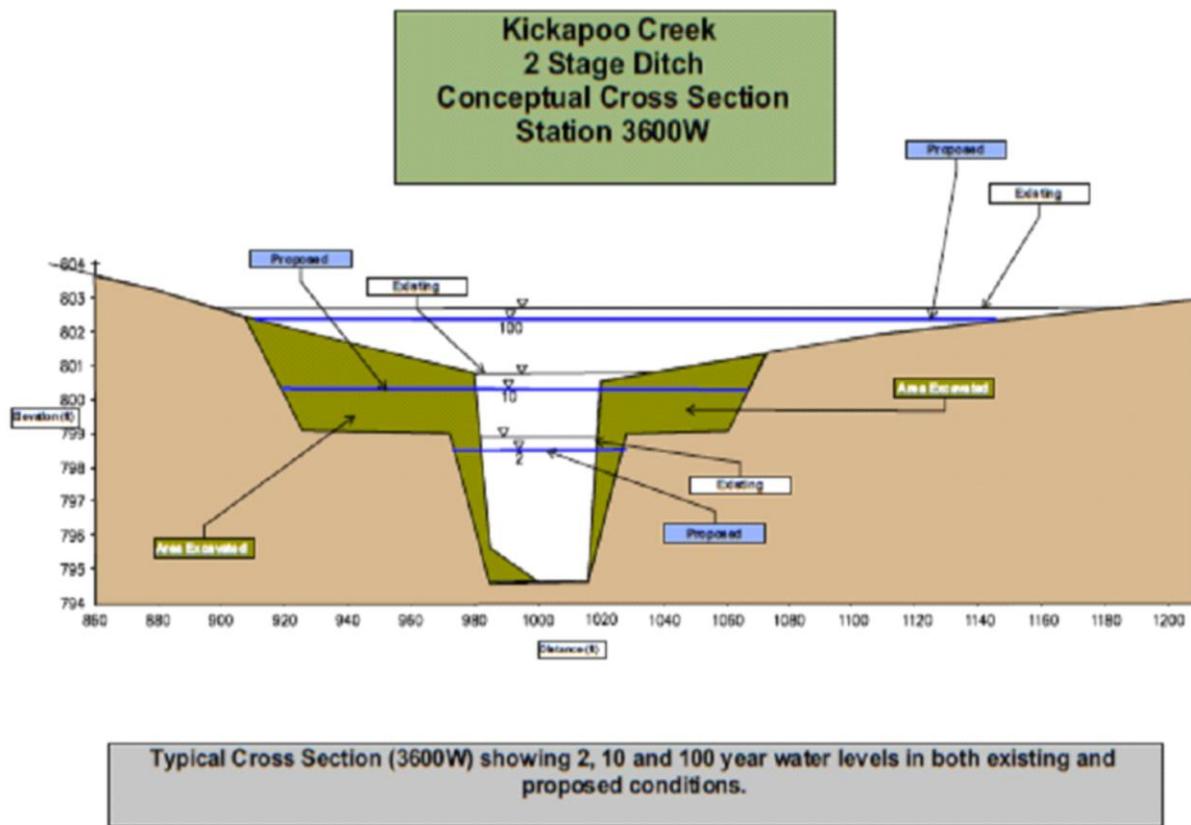
Figure 4. Schematic drawing of a 2-stage ditch design, as referenced in Rebecca M. Gorney, Dawn R. Ferris, Andy D. Ward, Lance R. Williams. 2011. Assessing Channel-Forming and Equilibrium Characteristics of an Impacted Headwater Stream in Ohio, USA. *Ecological Engineering*. No. 37: 418-430.

Job 1. In-stream restoration practices, rock riffles (Figures 5 and 6) and bank stabilization (Figure 7), were implemented within 3000 feet of a 2-stage ditch demonstration project (Figure 4) on the unnamed west branch of the Kickapoo Creek headwaters. All work was completed under the direction of well-known stream restoration specialist, Don Roseboom of the USGS. This Phase 3 work builds upon and complements the first two phases of the Kickapoo Creek Stream Restoration Project completed in 2008 and 2009 (see Kickapoo Creek Restoration Project – Phase 1 T-46-D-1 SWG Final Report). Construction work for the project was awarded through a confidential bid process conducted by the City of Bloomington.

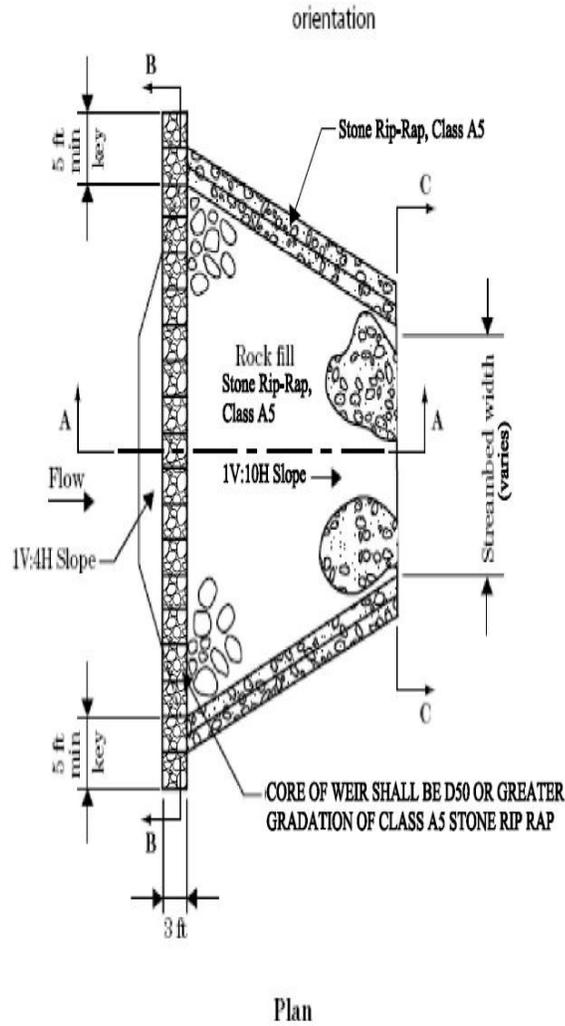
Figure 5. Schematic drawing of rock riffle.

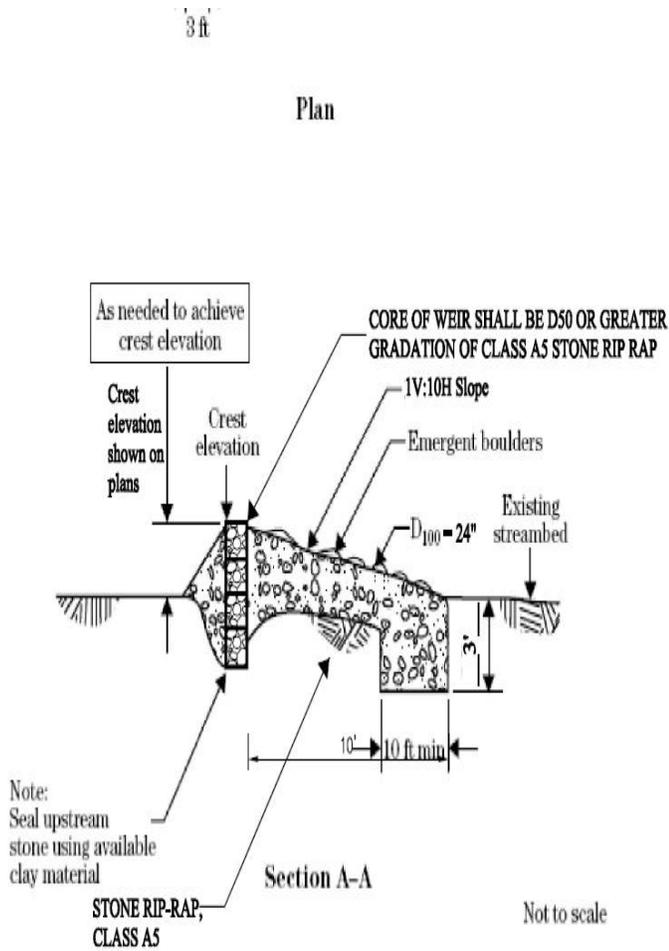
Figure 6. Schematic drawing of rock riffle.

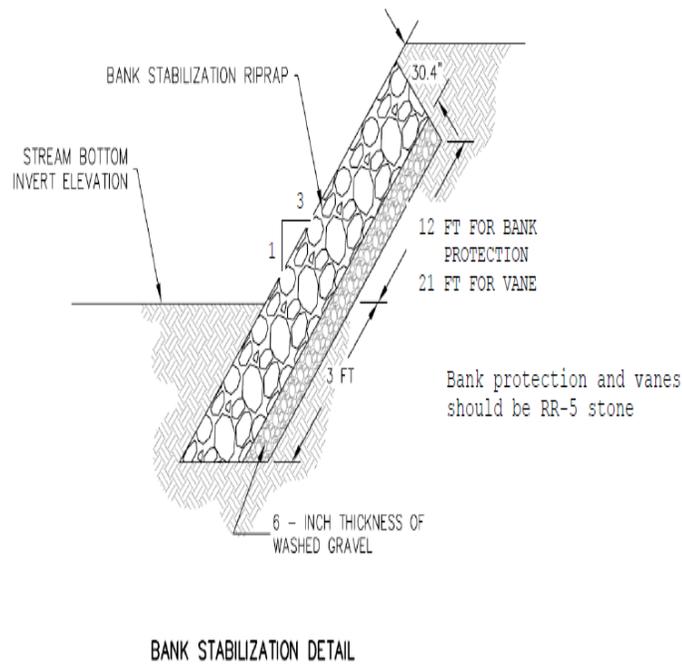
Figure 7. Schematic drawing of bank stabilization.

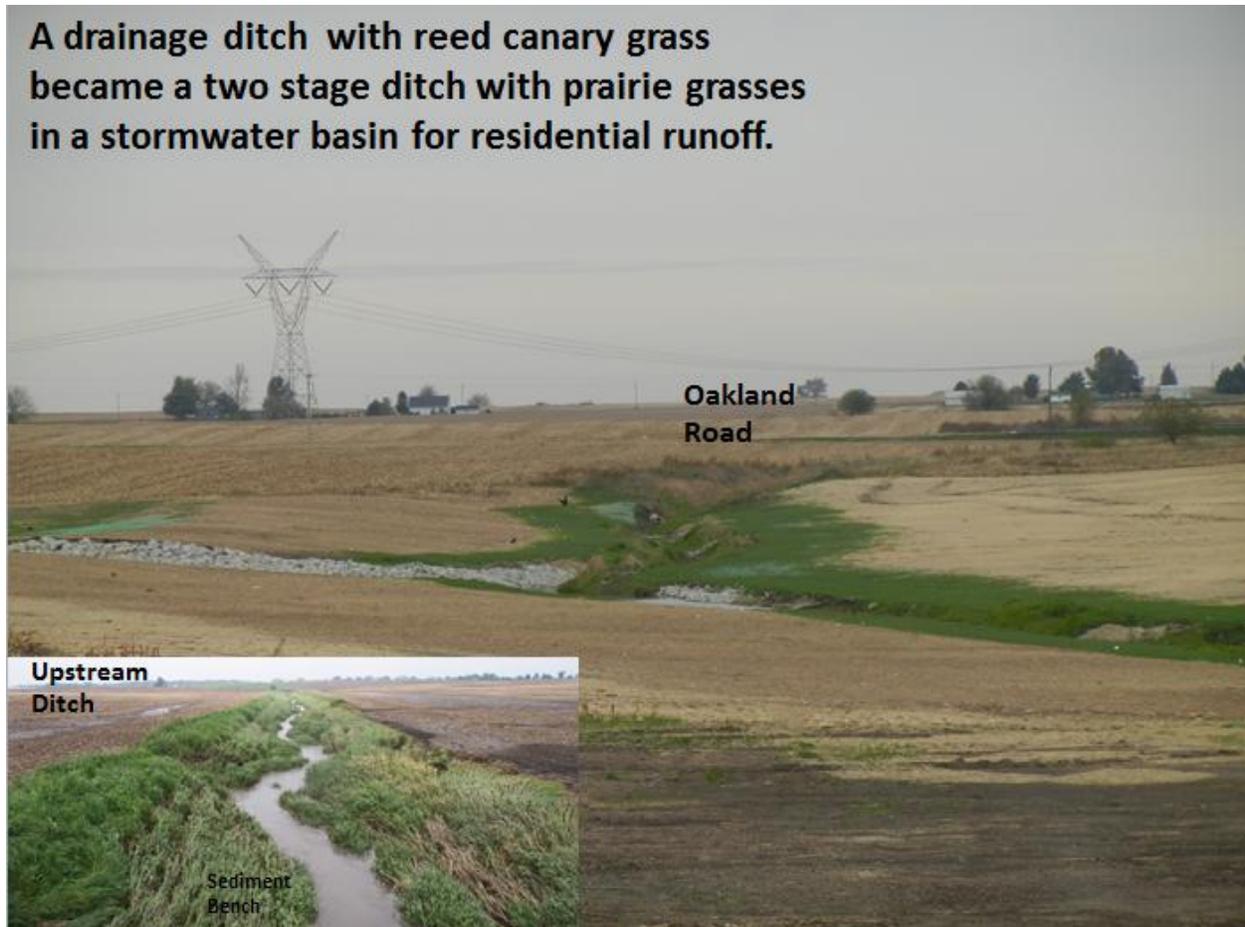
Figure 8. Sediment benches in the drainage ditch and in the two stage drainage ditch with a larger excavated sediment bench.

Bloomington selected the two stage ditch as the practice to be applied in Phase 3 of the Grove Restoration on the West Branch of Kickapoo Creek. The typical agricultural two stage ditch is widened at the elevations of sediment benches deposited in the bed of normal agricultural ditch (Figure 8).

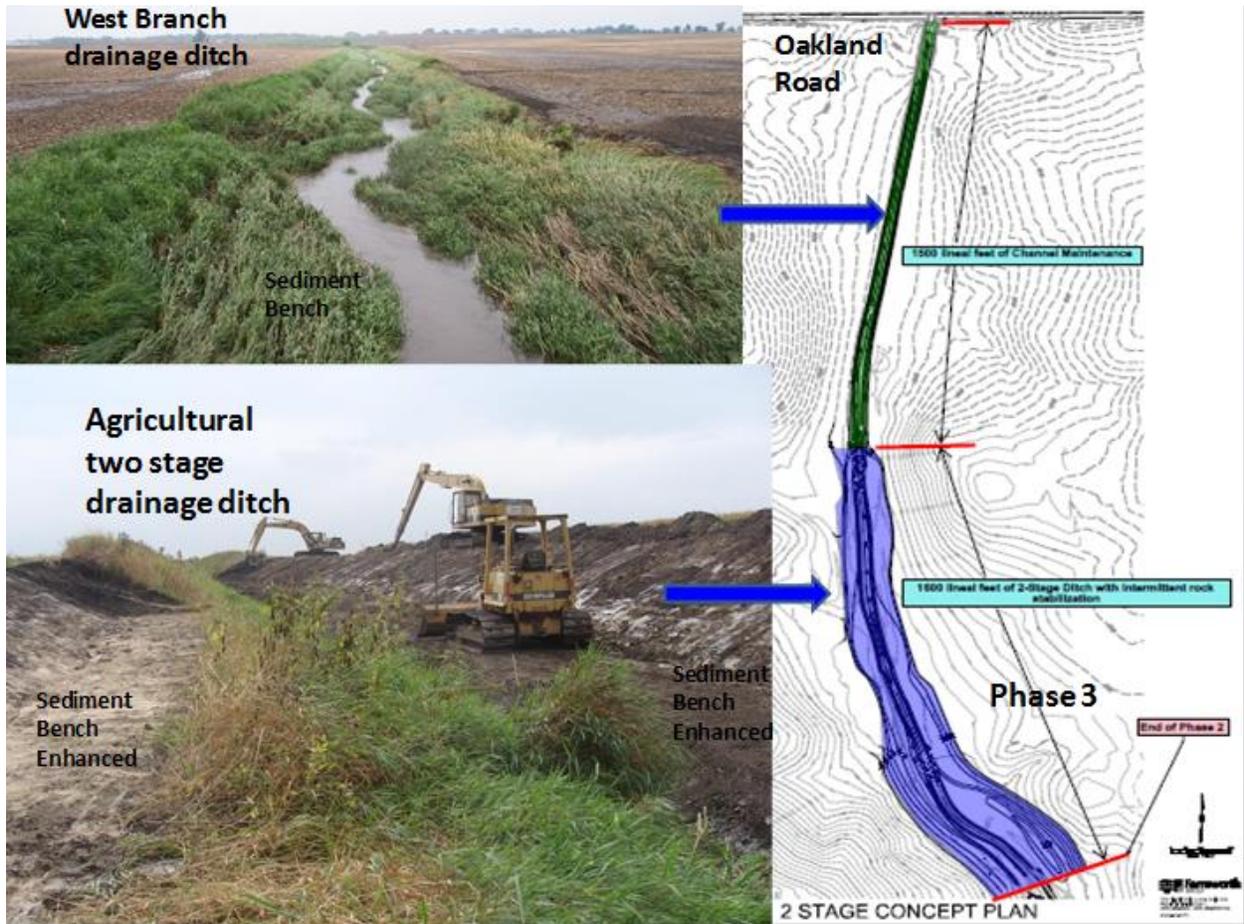
Figure 9. The drainage ditch was excavated to a wider ditch with a larger and lower floodplain area, which was seeded with prairie grasses.

The two stage ditch practice was modified to include significant stormwater storage (36 acre ft.) in the prairie wetland complex adjacent to the ditch (Figure 9).

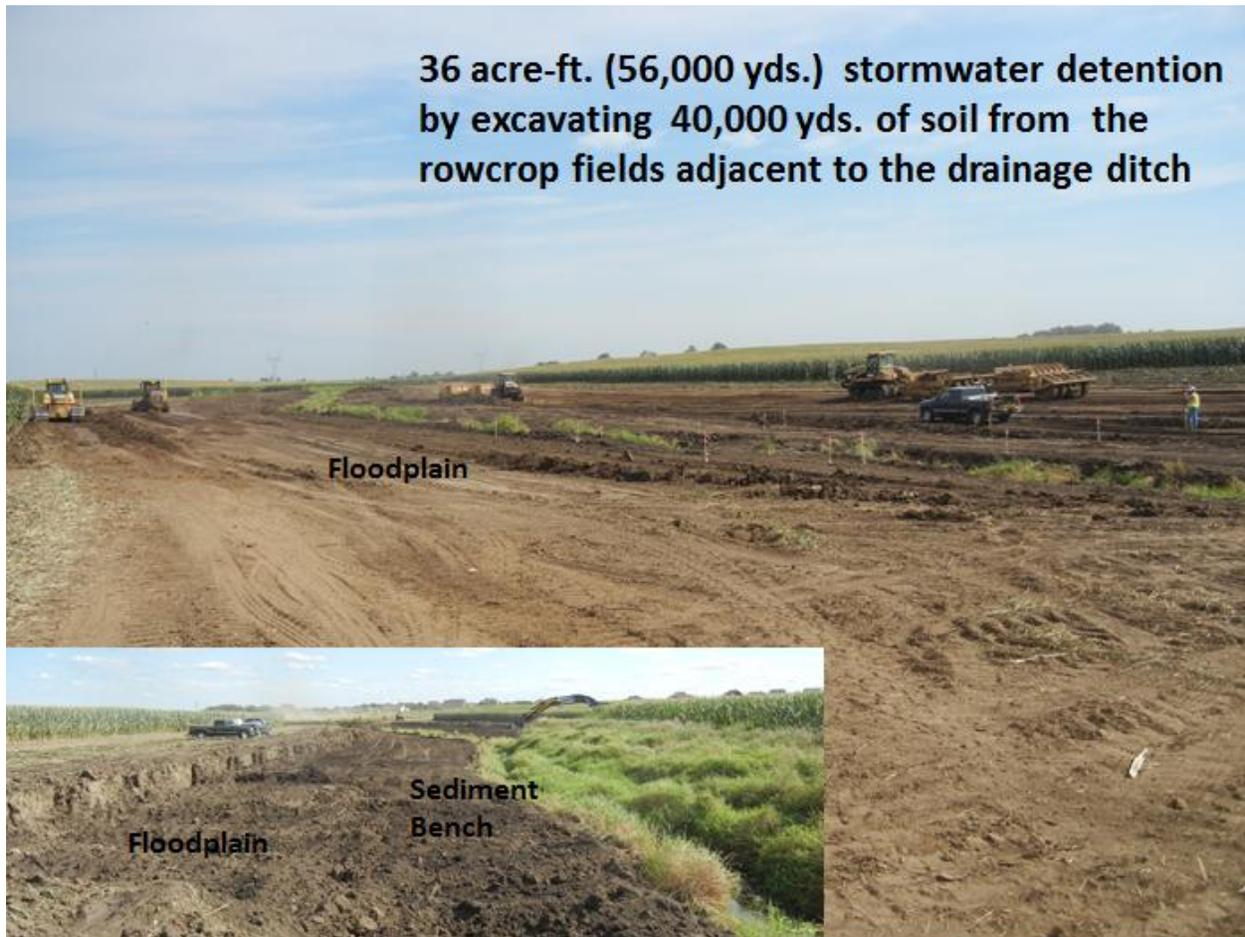
Figure 10. Excavation lowered the rowcrop fields to form the sediment benches and floodplain required for stormwater detention in Phase 3.

In Phase 3 of the restoration, the banks of the two stage ditch were lowered and widened at the floodplain elevations to meet the city's required 36 acre-ft. storage for residential runoff of 1000 new homes for the Phase 3 area of the park (Figure 10).

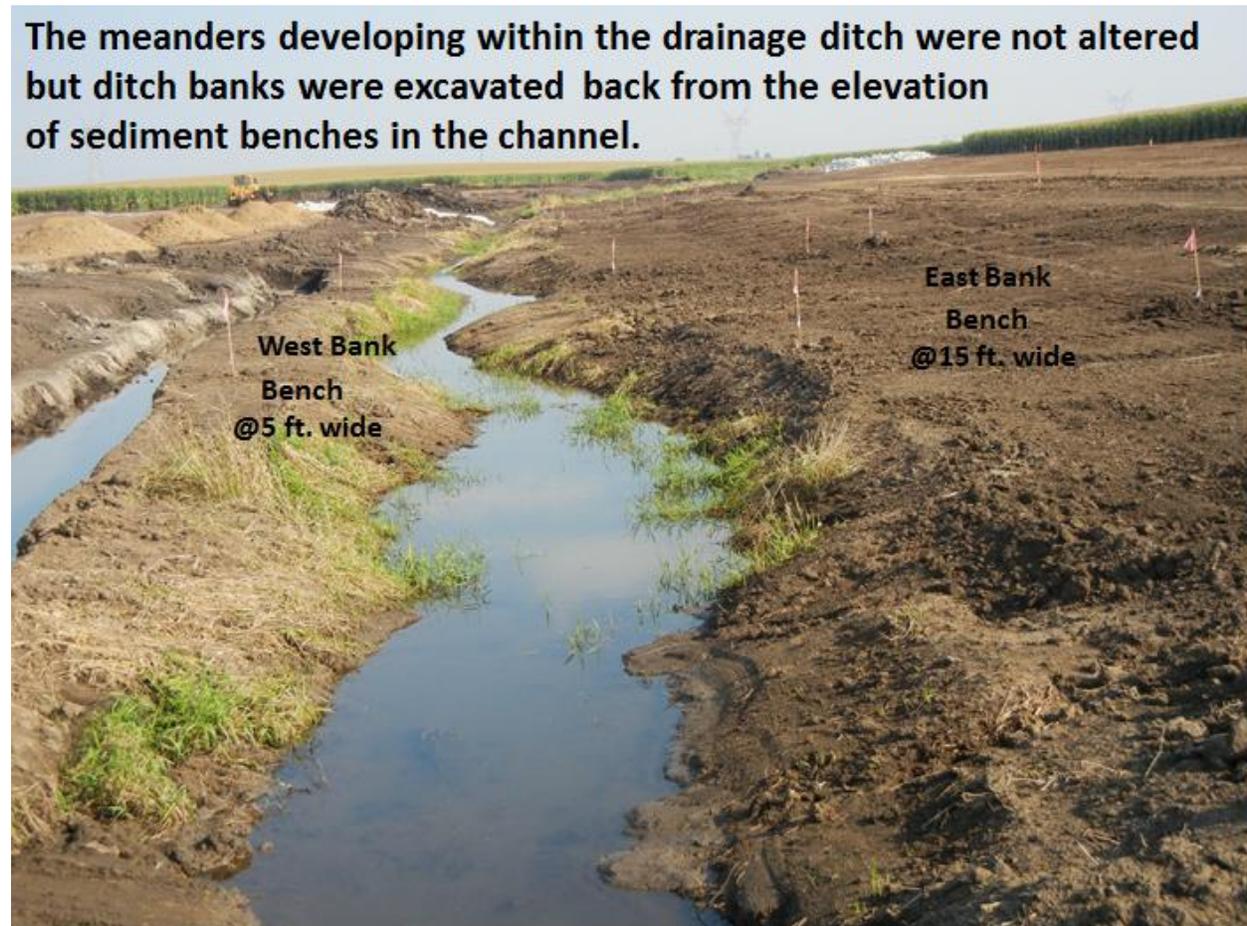
Figure 11. Survey stakes set elevations for the excavation of rowcrop fields to form the sediment benches of the two stage ditch and the prairie floodplain required for stormwater storage in Phase 3.

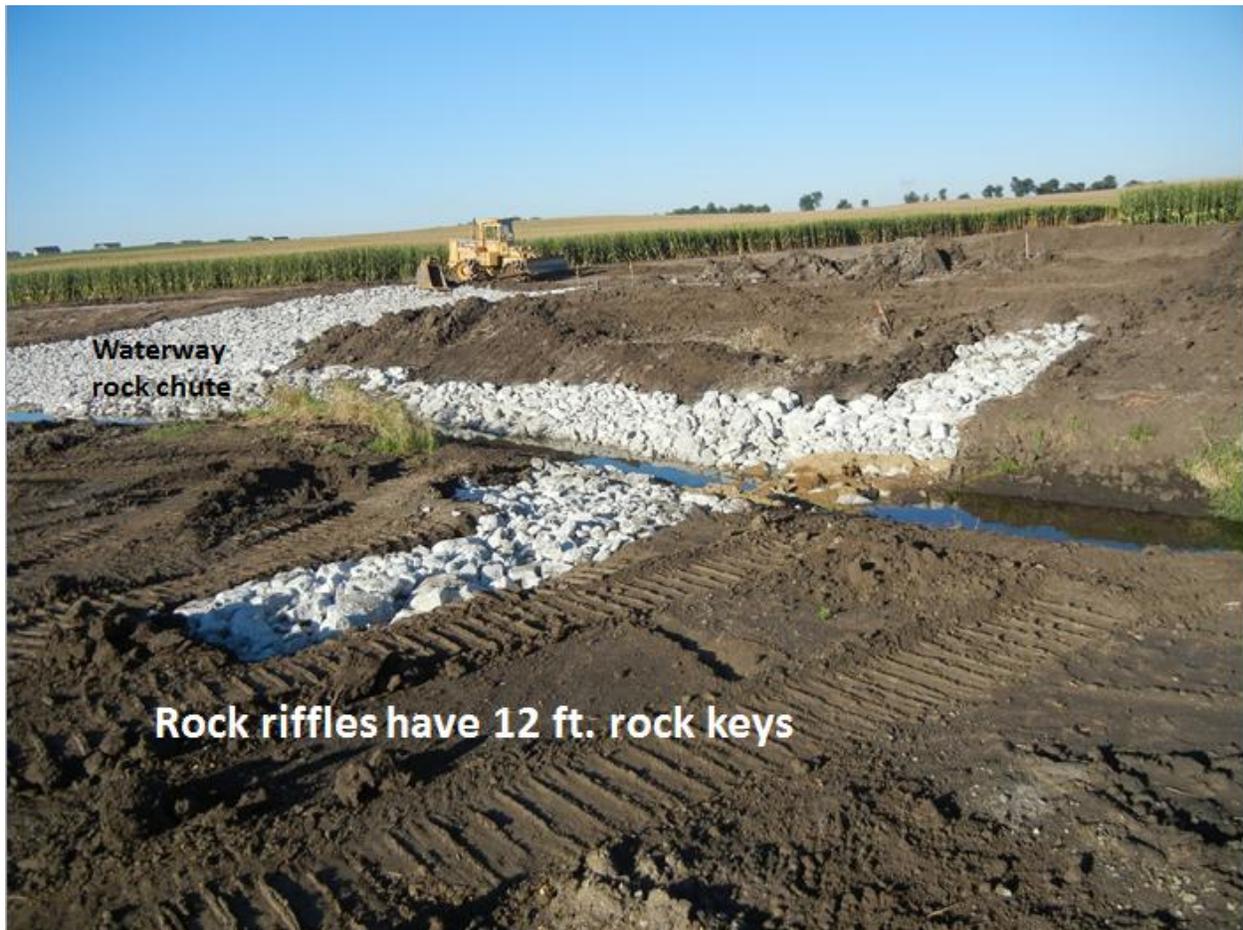
Figure 12. Rock keys extend 12 ft. into the east sediment bench (15 ft. wide) to limit meander migration.

12 rock riffles were constructed as instream habitat enhancements within the two stage ditch. Rock keys were extended across the sediment bench for 12 ft. (Figure 12).

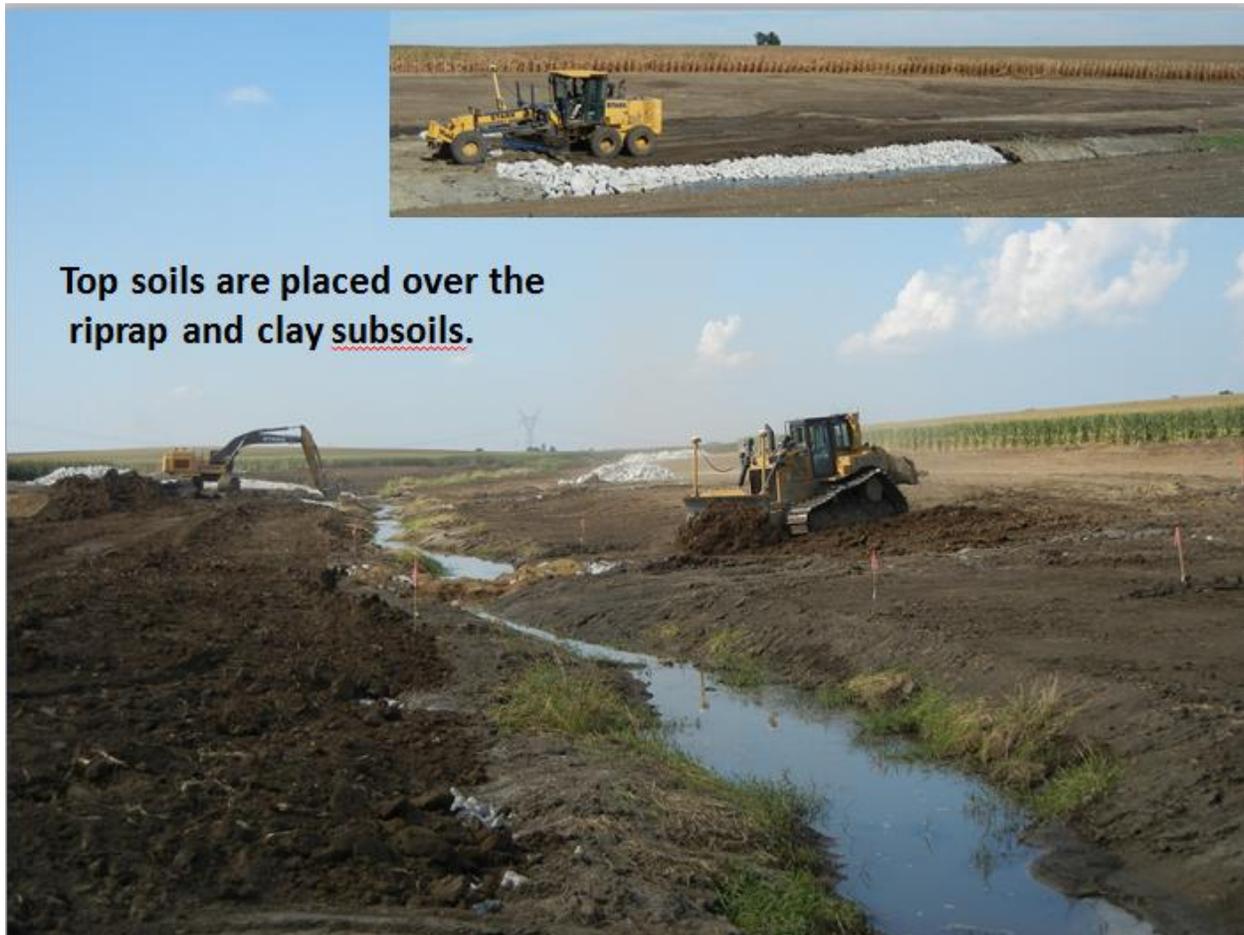
Figure 13. Soil was compacted over the riprap in preparation for prairie seeding and mulching blankets for plant growth.

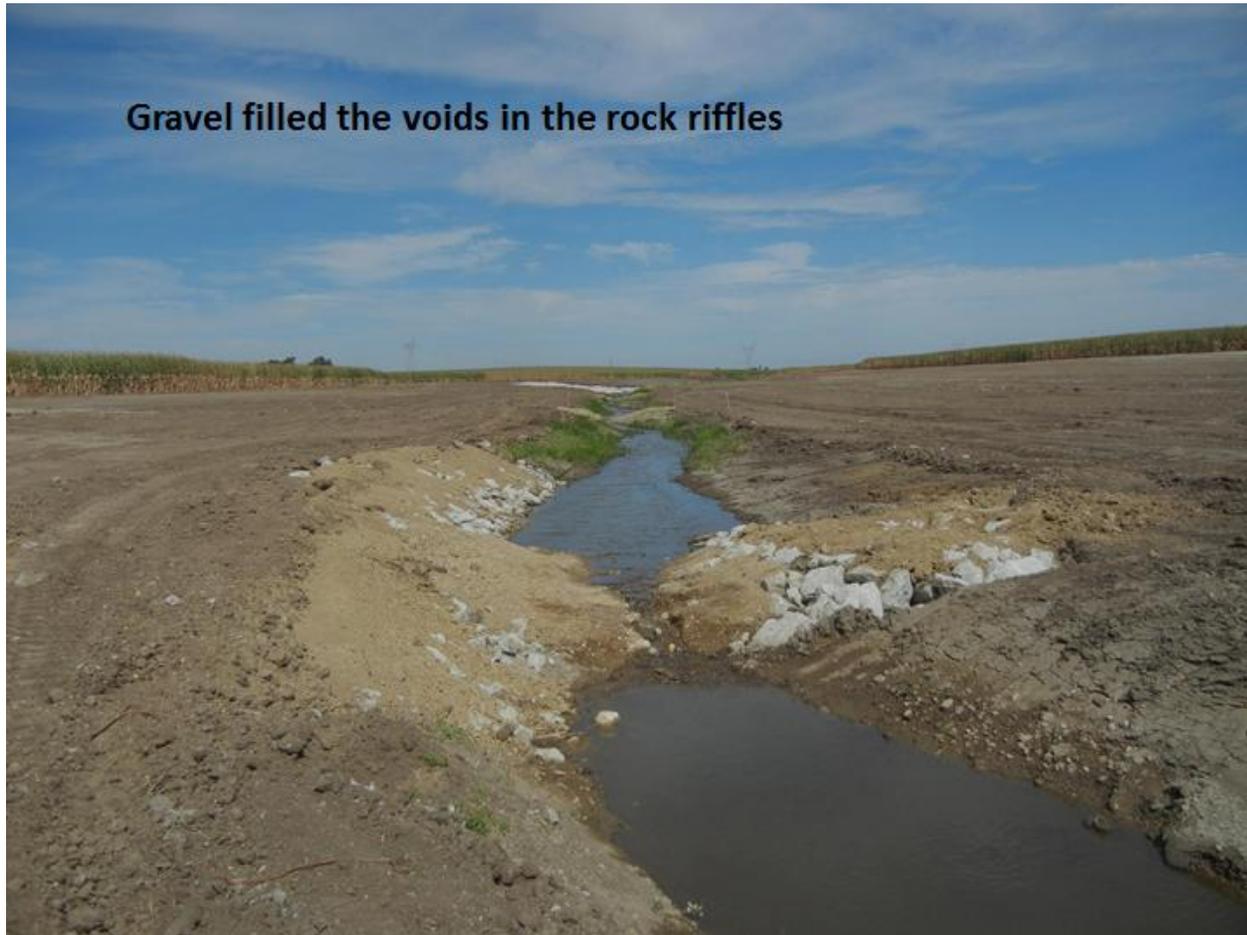
Figure 14. Gravel and sands are placed into the voids in the rock riffles to decrease subflow through the riprap.

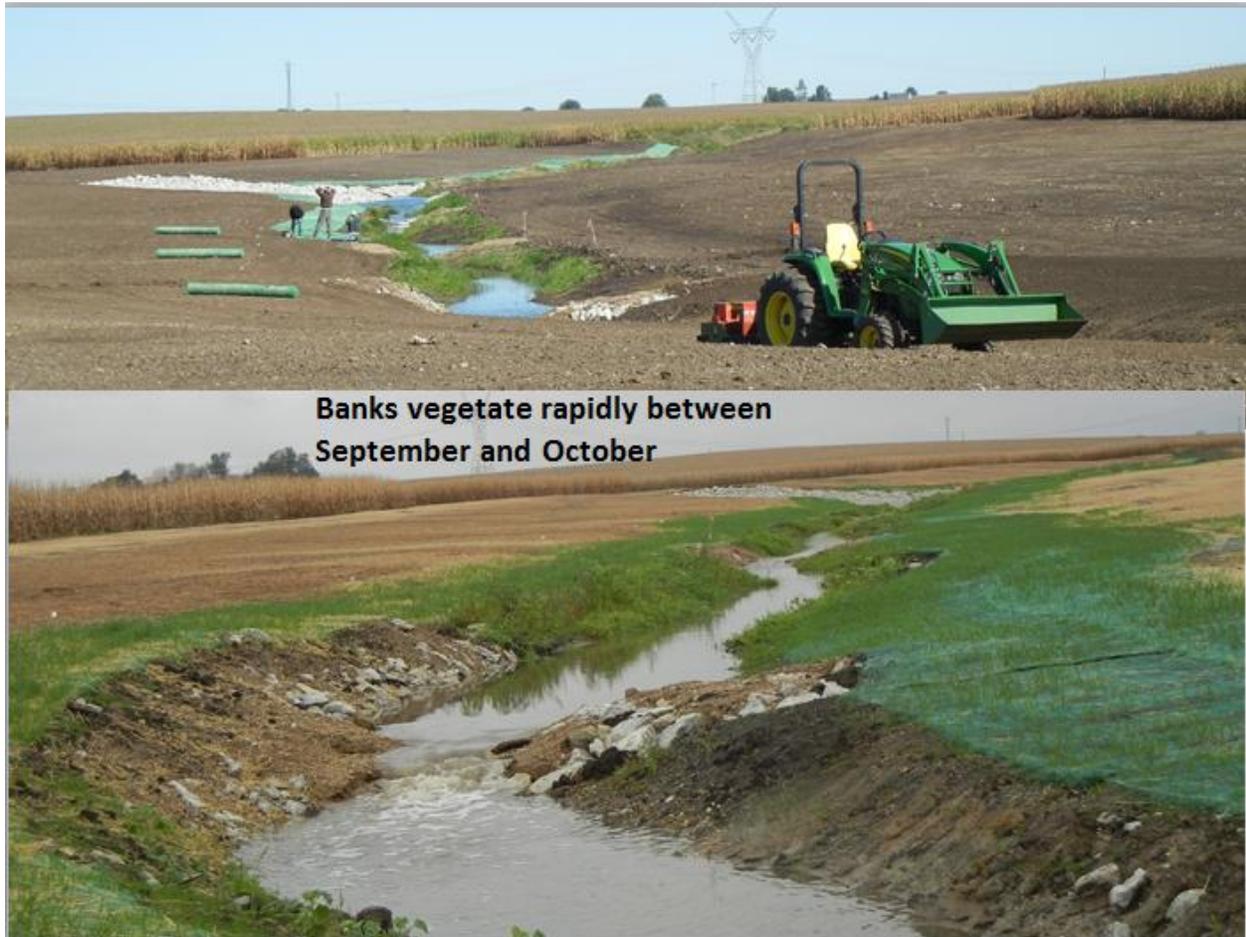
Figure 15. Cover crops of oats and winter wheat quickly grow through the mulch blankets to protect prairie seed until spring growth.

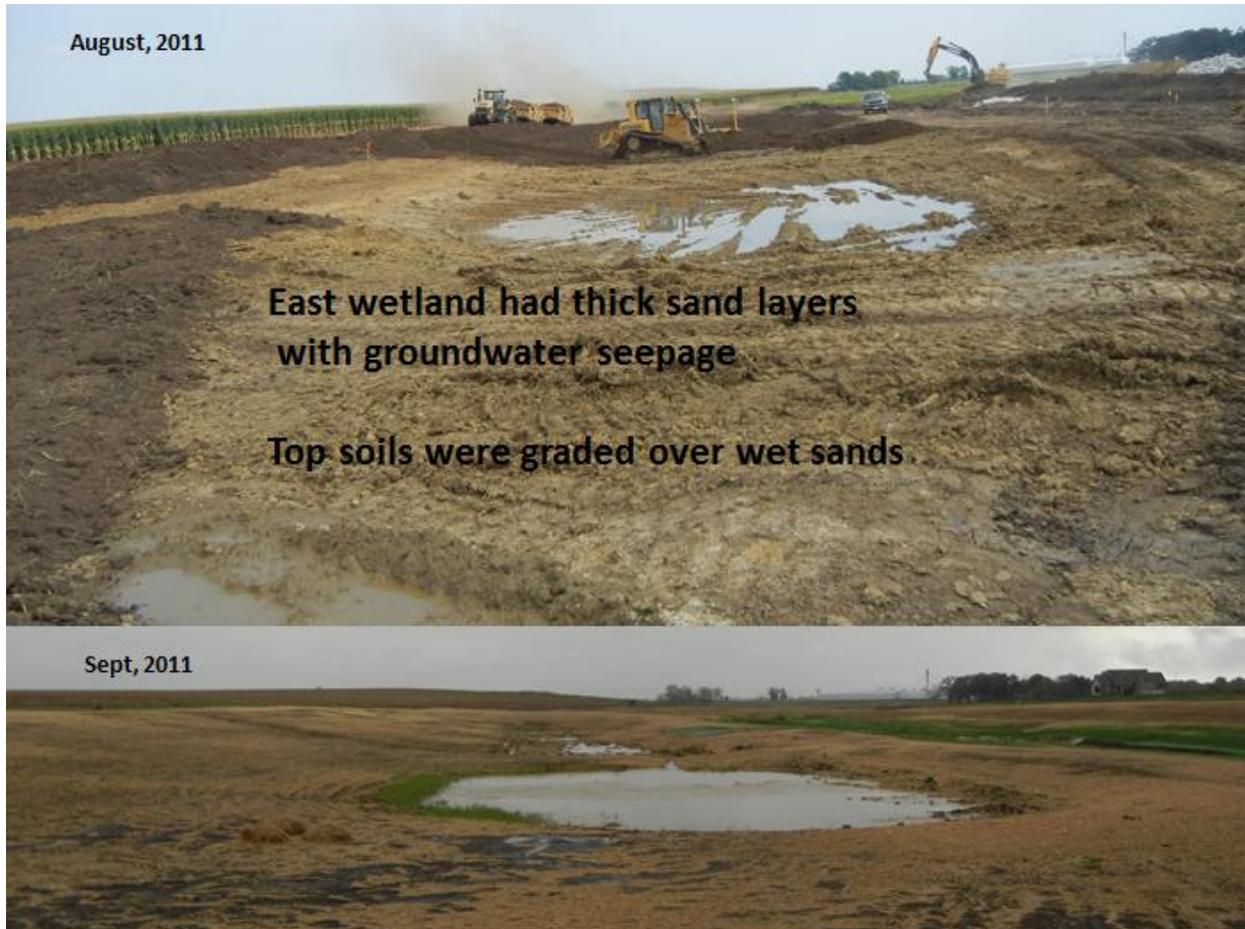
Figure 16. The east wetland was excavated in late August and a thick sand layer allowed groundwater to seep to surface.

A wetland was excavated to capture runoff from future housing and increase water quality by wetland plant uptake of nutrients. The wetland was excavated in late August and planted in September (Figure 16).

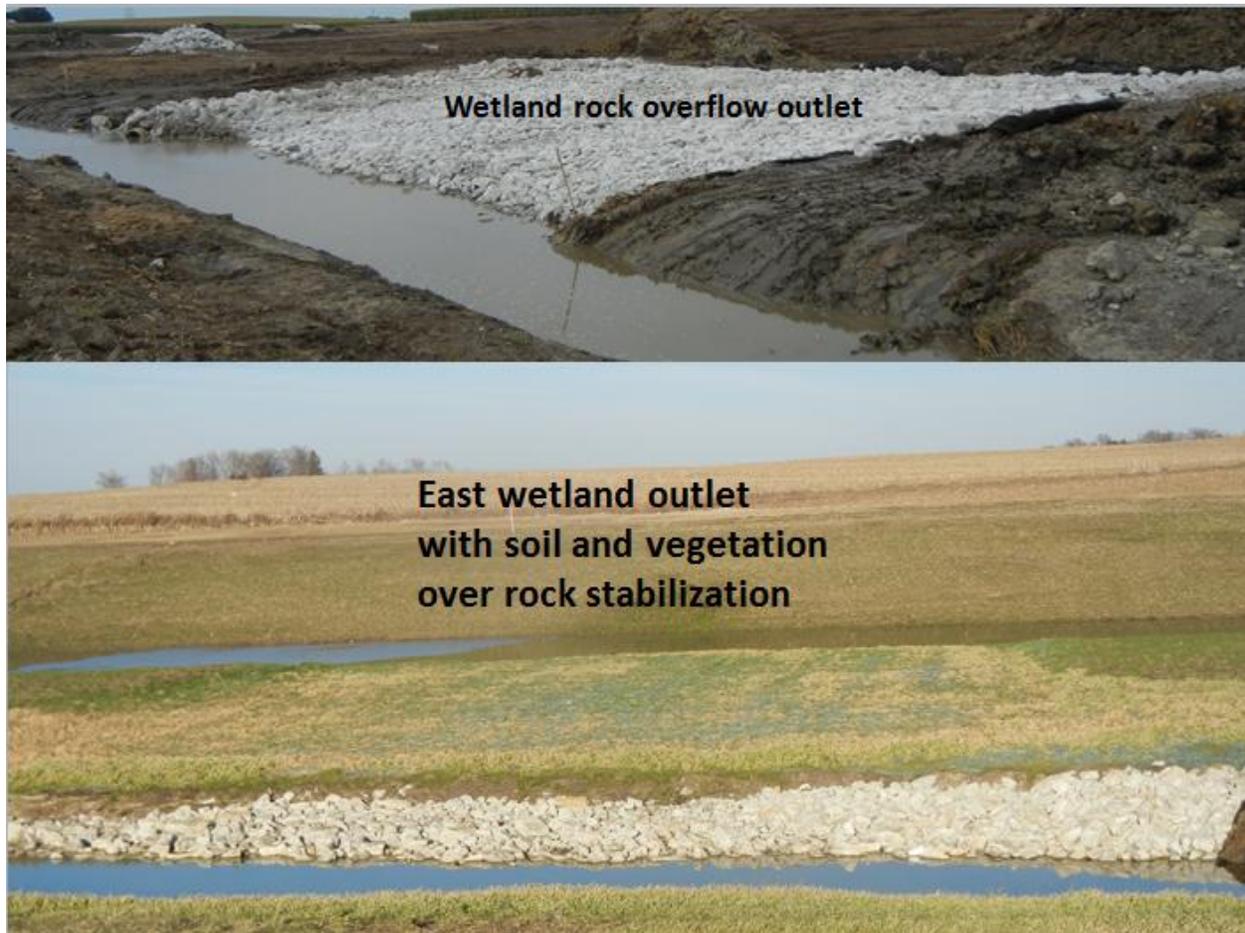
Figure 17. With surface runoff from a large area of rowcrops or future housing entering the wetland, the wetland overflow required both rock and vegetative stabilization.

The outlet overflow of the east wetland was stabilized with riprap and vegetation (Figure 17).

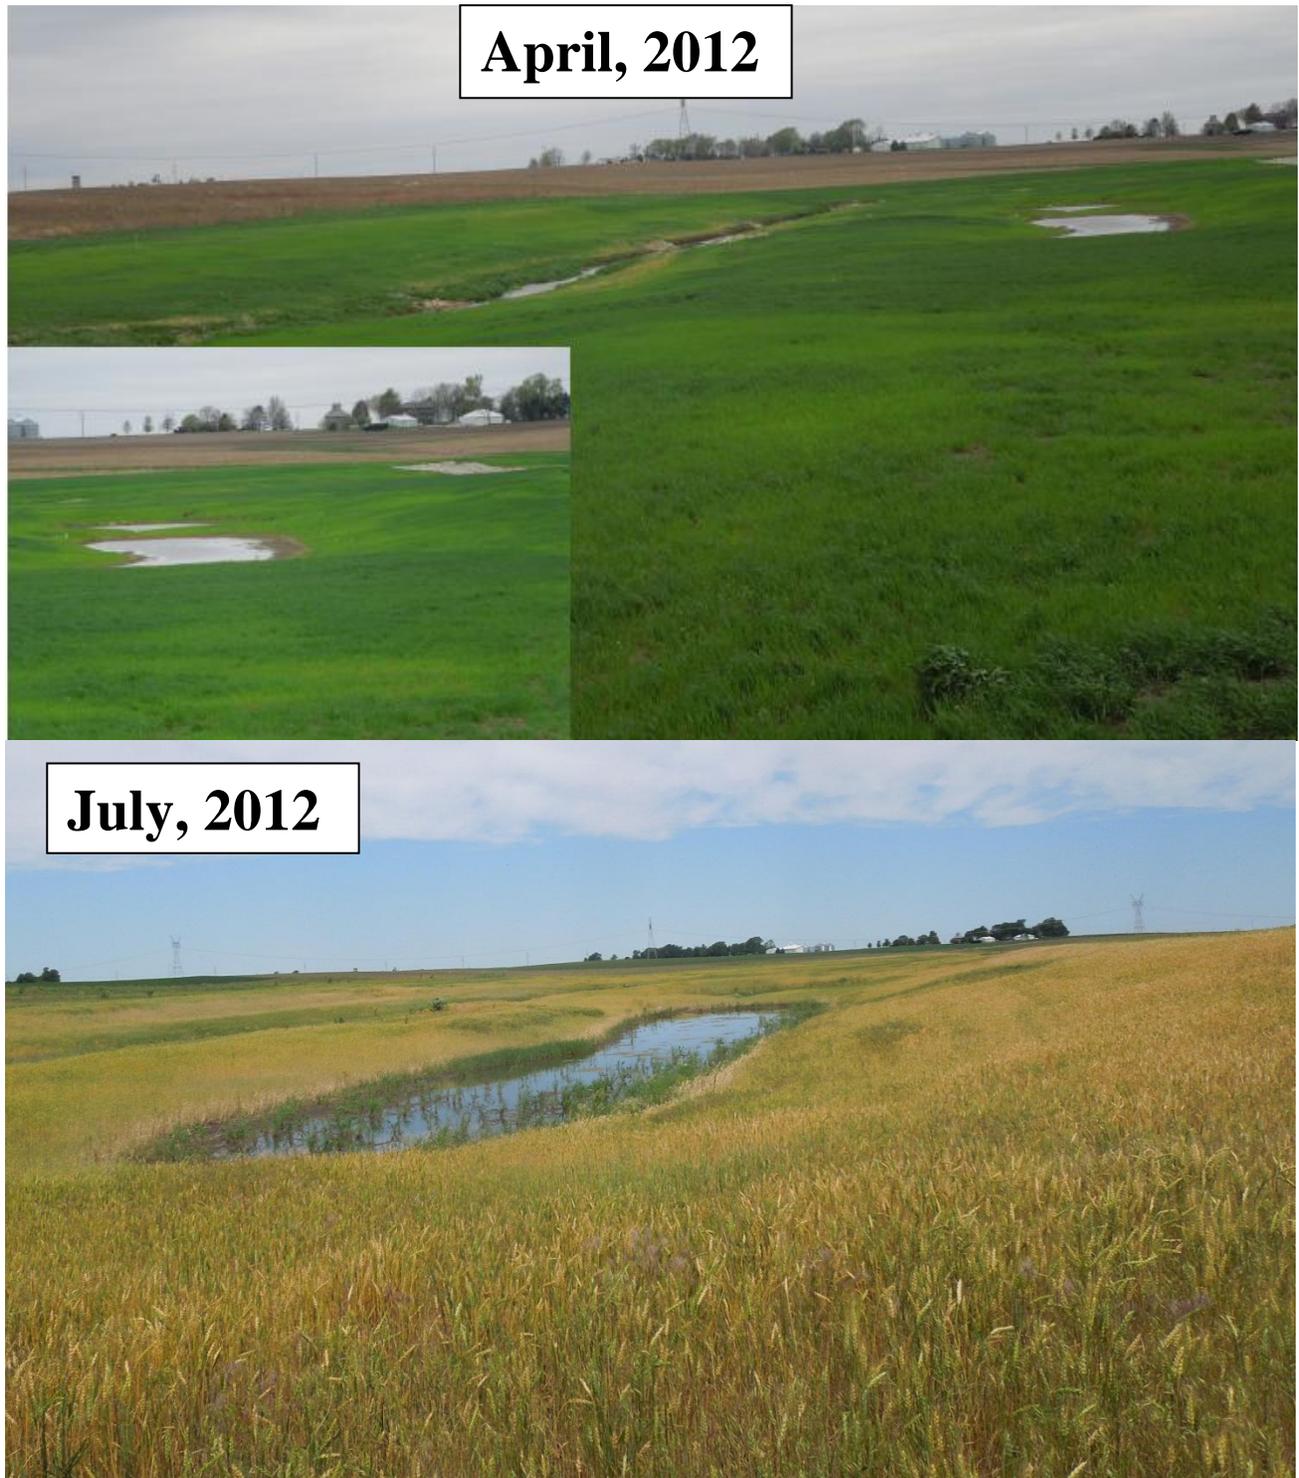
Figure 18. With the warm and early spring, cover crops grew rapidly and wetland plants began to emerge even in the drought.

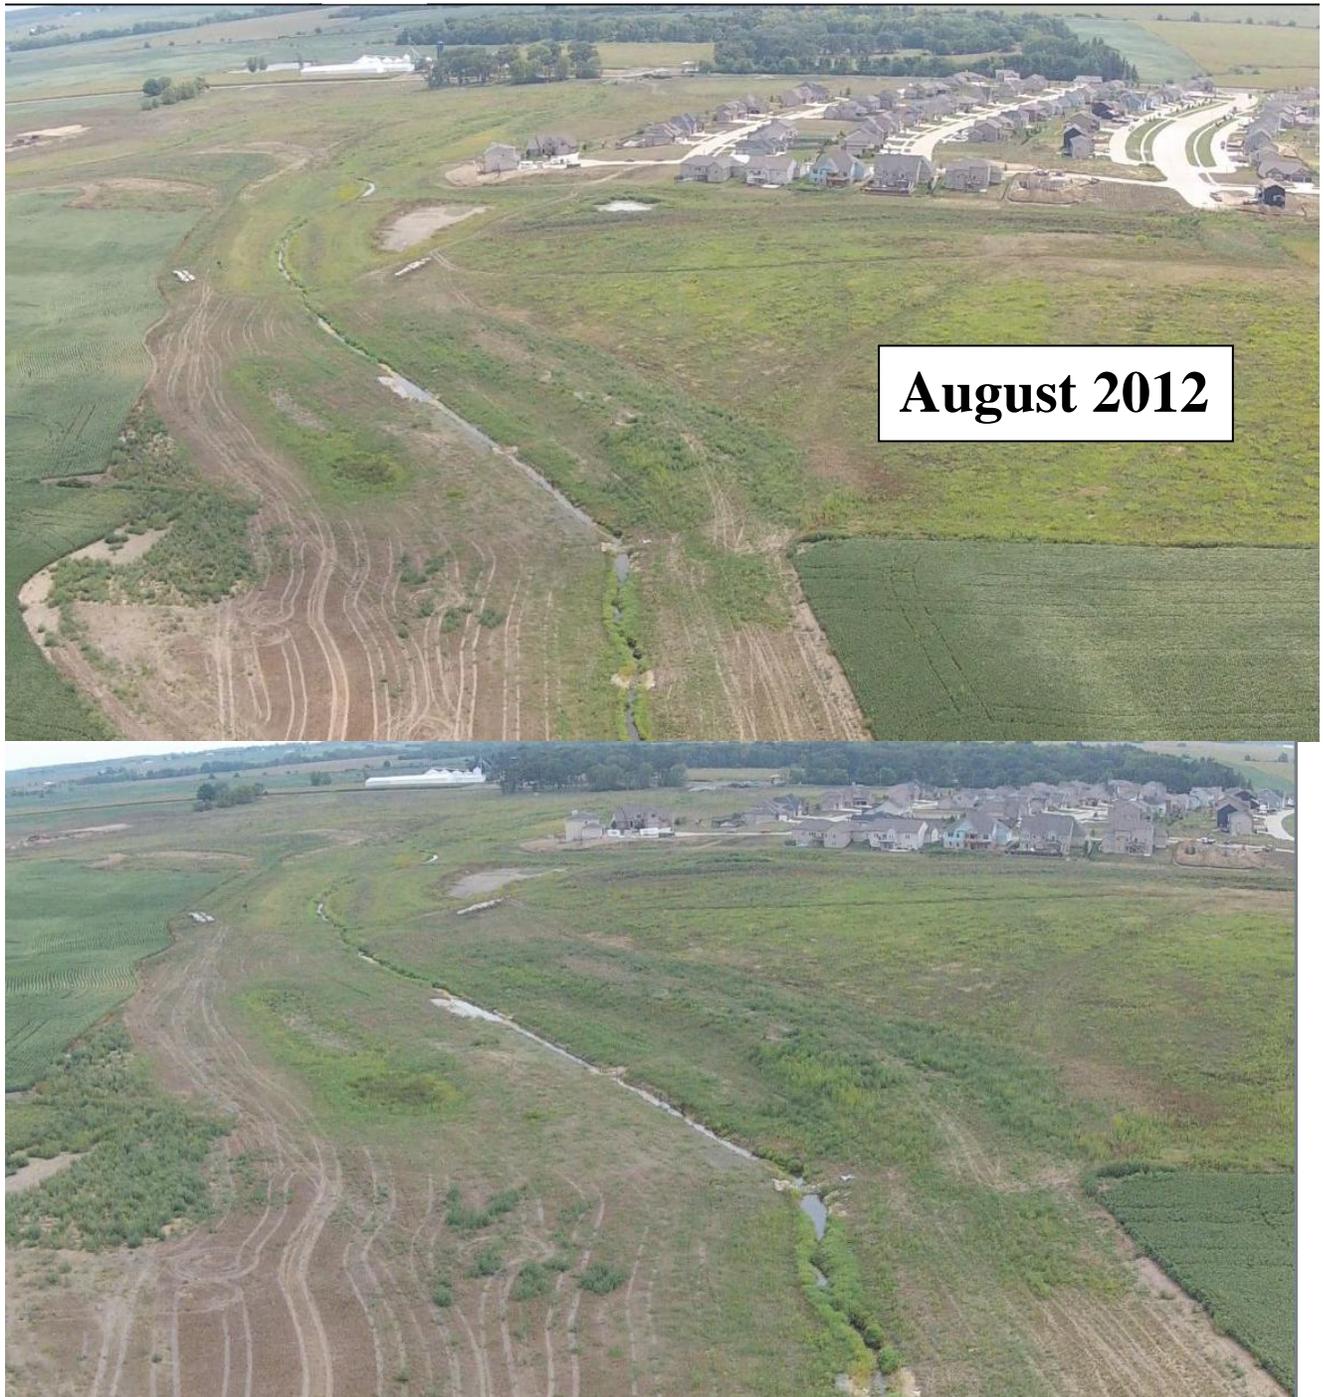
Figure 19. Aerial photographs show only stream banks and wetland had good growth of prairie and wetland plants by late summer of 2012.

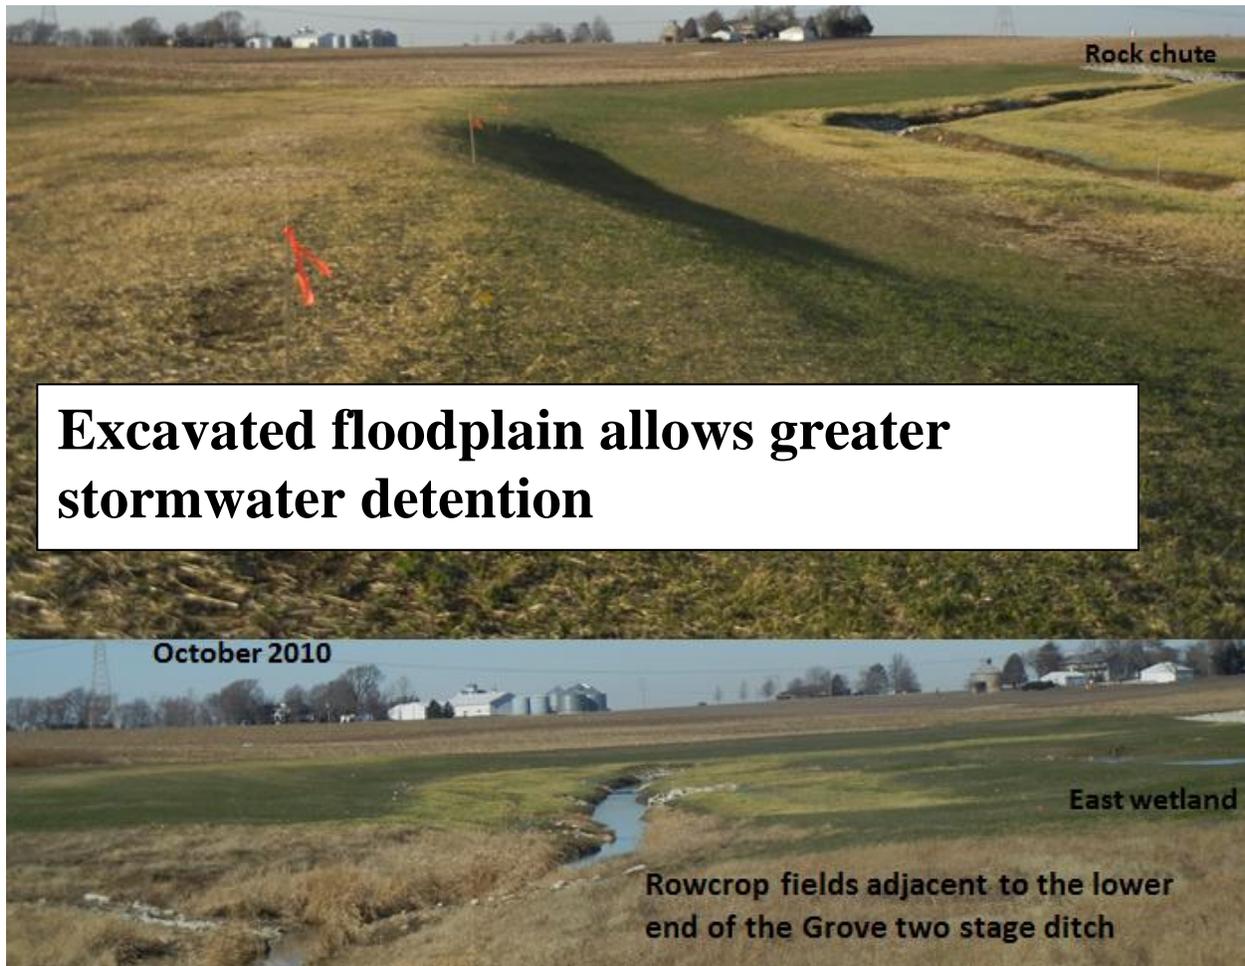
Figure 20. Until the housing market returns, corn and soybean fields will supply the majority of surface water runoff into Phase 3.

The city utilizes green infra-structure practices to increase nutrient reduction and have modified the agricultural practice to increase stormwater storage and increase water quality of agricultural and residential runoff. The West Branch of Kickapoo Creek receives runoff from 2500 acres of rowcrop in the park.
