Kickapoo Creek Stream Restoration Project - Phase 3

FY 2010 State Wildlife Grant

Final Report

October 2012

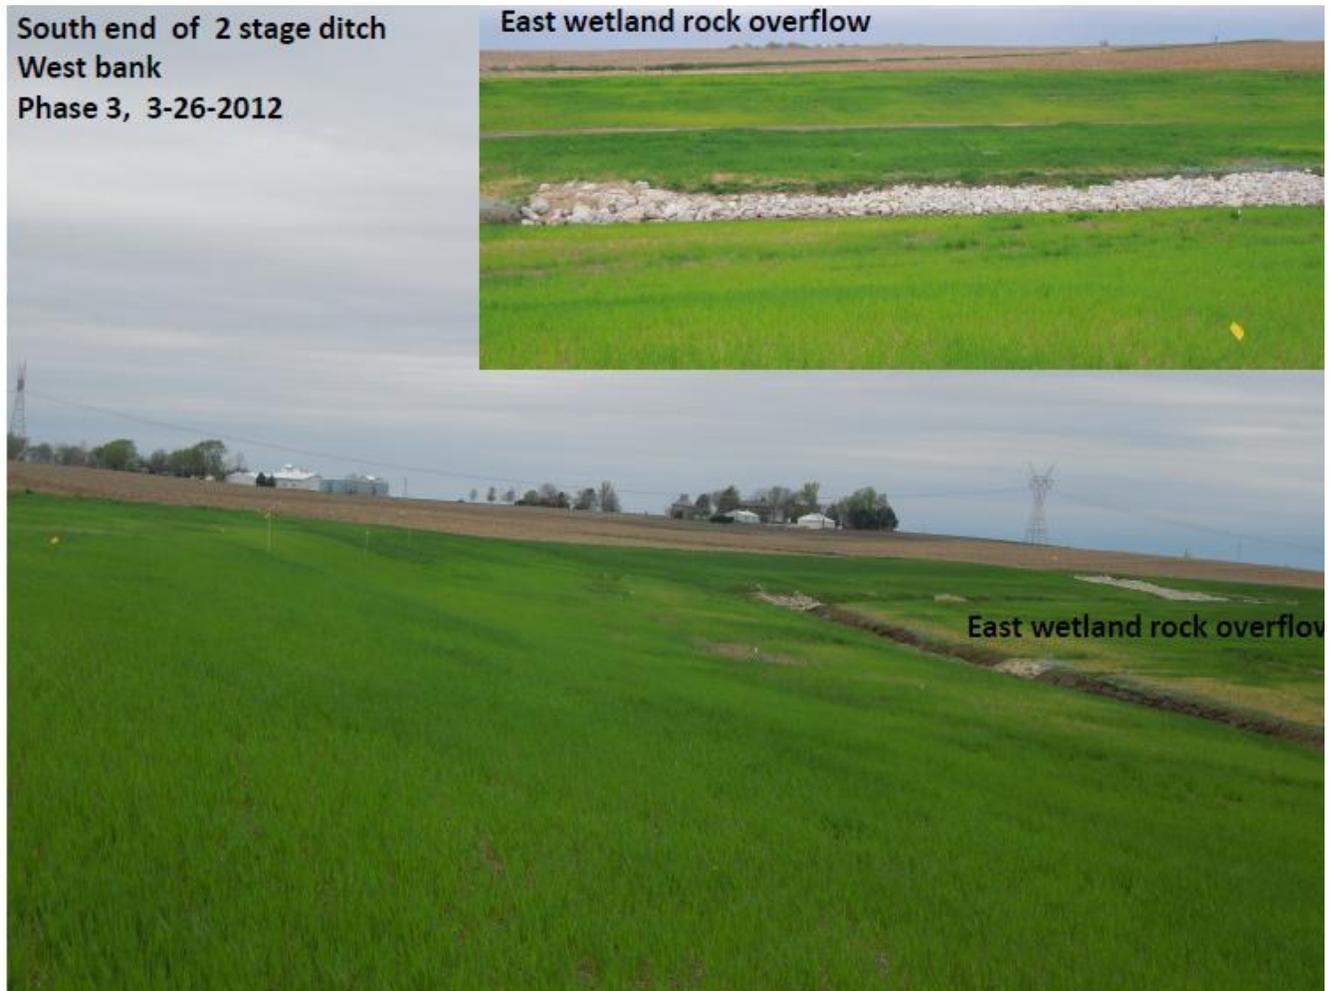
Figure 21. Cover crop growth was rapid in spring of 2012.

Prairie and wetland vegetation is planted in Phase 3 to increase nutrient uptake in the modified two stage ditch practice. The prairie vegetation will require 3 growing seasons to achieve a mature effective plant community.

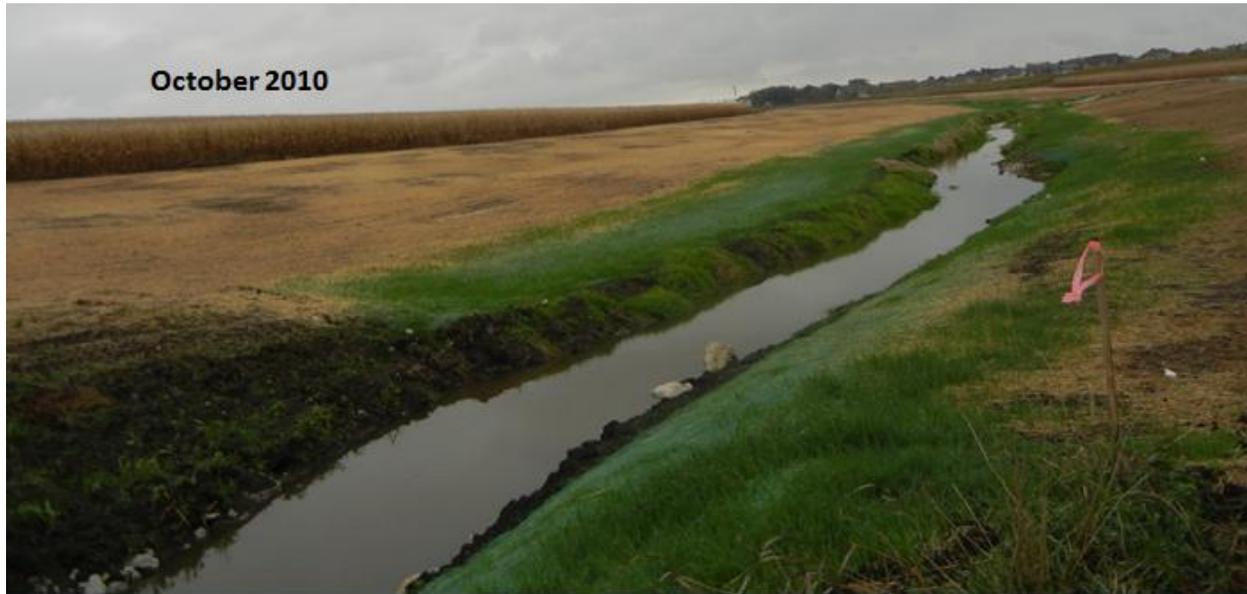
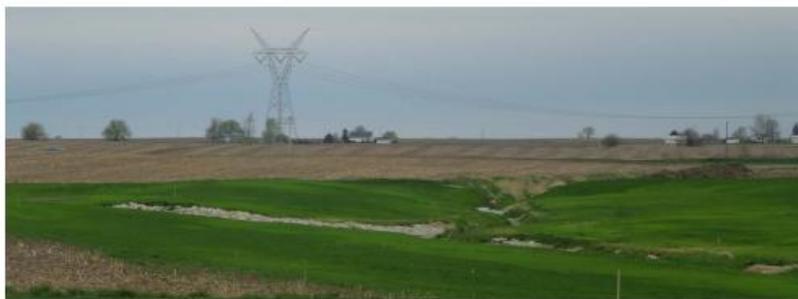
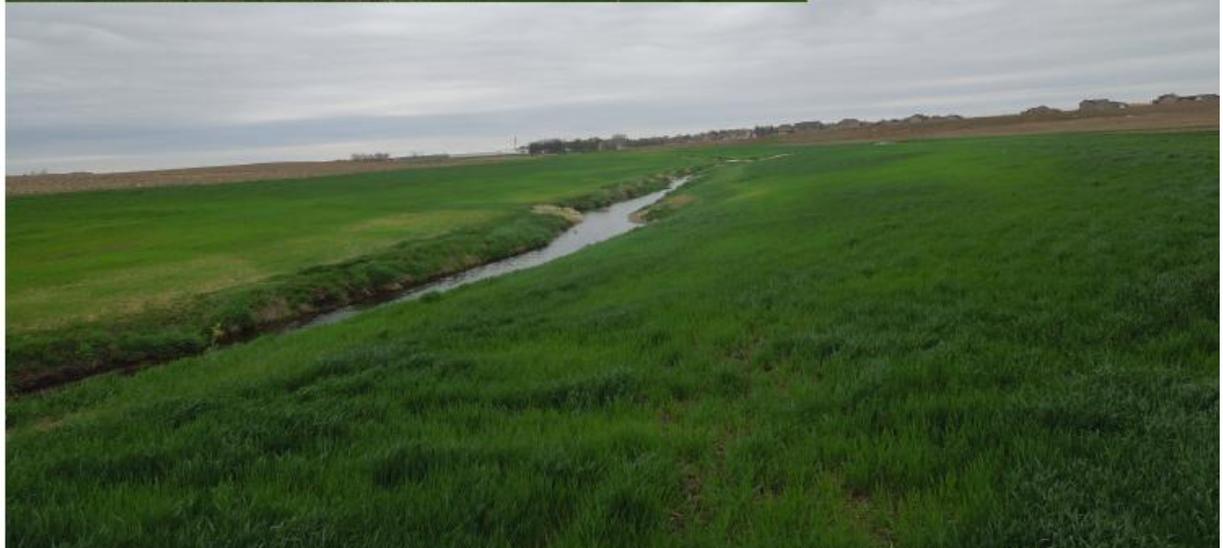
North end of 2 stage ditch
Phase 3, 3-26-2012

Figure 22. The Phase 3 area provides a suitable site for monitoring nutrient reduction and fishery increases in this two stage ditch application.

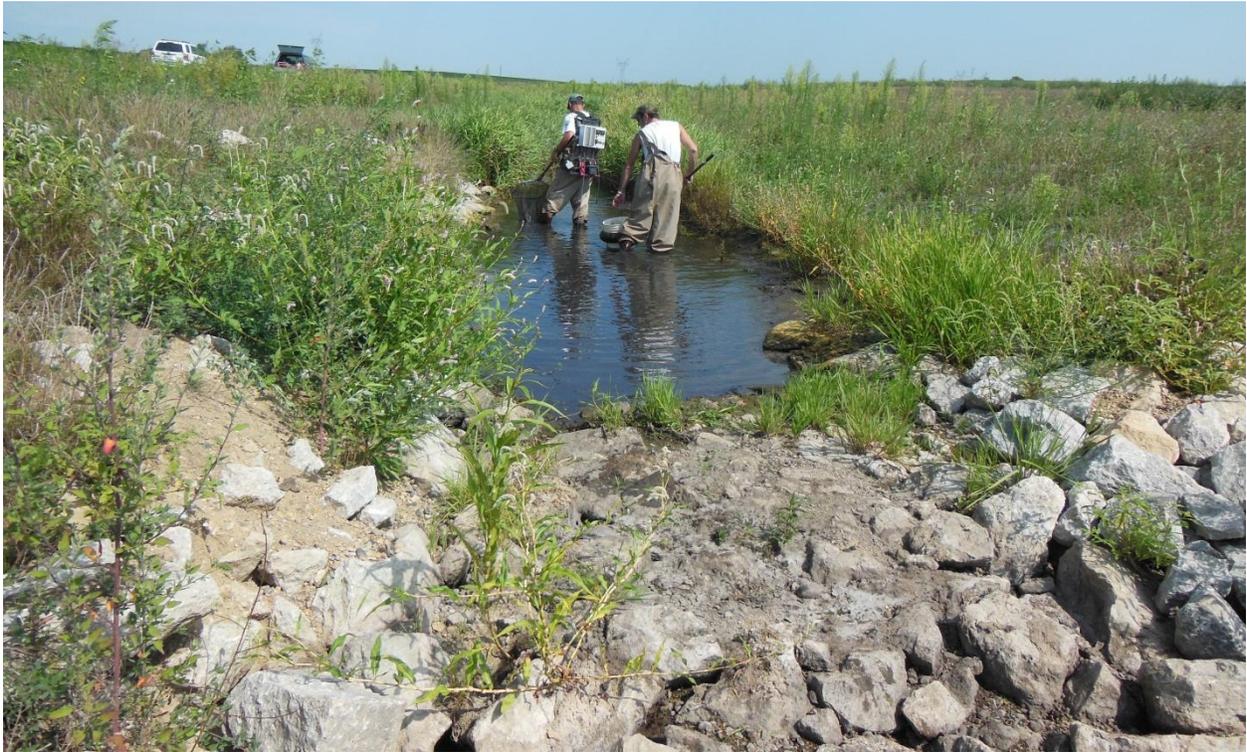
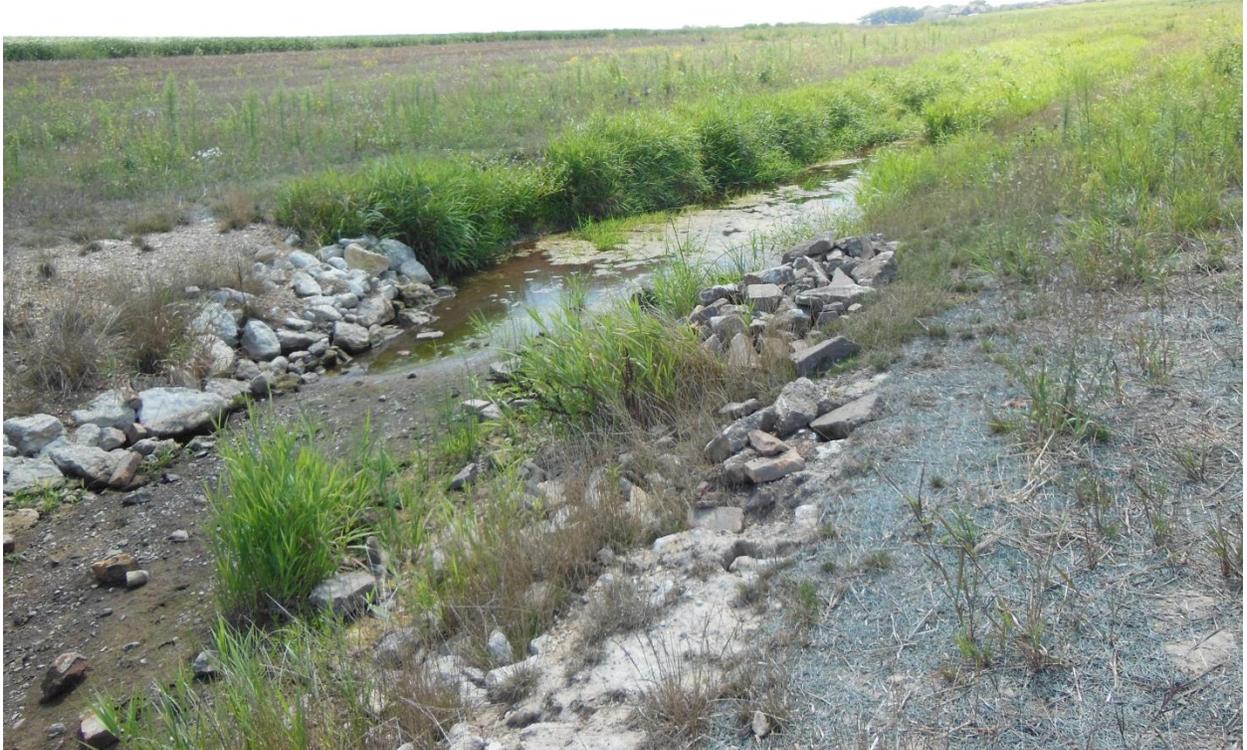
Figure 23. The 2012 drought pooled water and exposed dry bed in July and August.

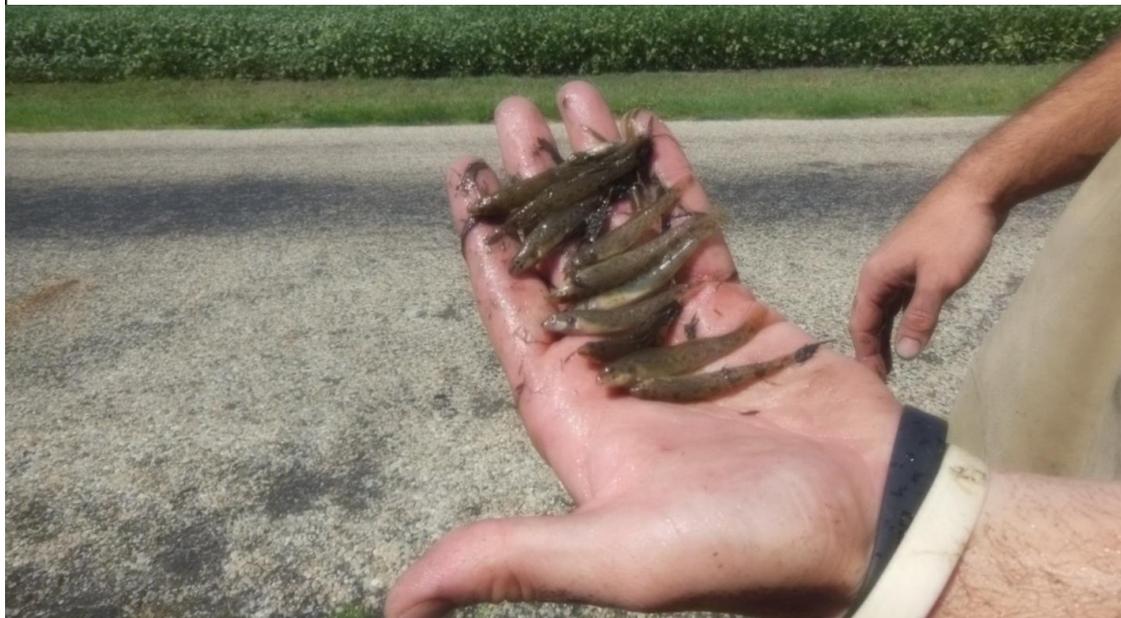
Figures 24- 25. During low flow conditions, sensitive species found refuge in the pools that developed downstream of the constructed riffles.

In Phase 2, the restored channel is well-defined. The concentrated flows over the constructed riffles have developed and maintained deep scour holes downstream of the riffles. These deep pools have attracted additional resident and visiting fish species to this restored reach, resulting in a six-species increase in the two most recent fall surveys over the maximum recorded number of species in the pre-restoration samples. The Phase 2 restoration work has also resulted in significantly higher fish abundance numbers, orders of magnitude higher than pre-restoration numbers.

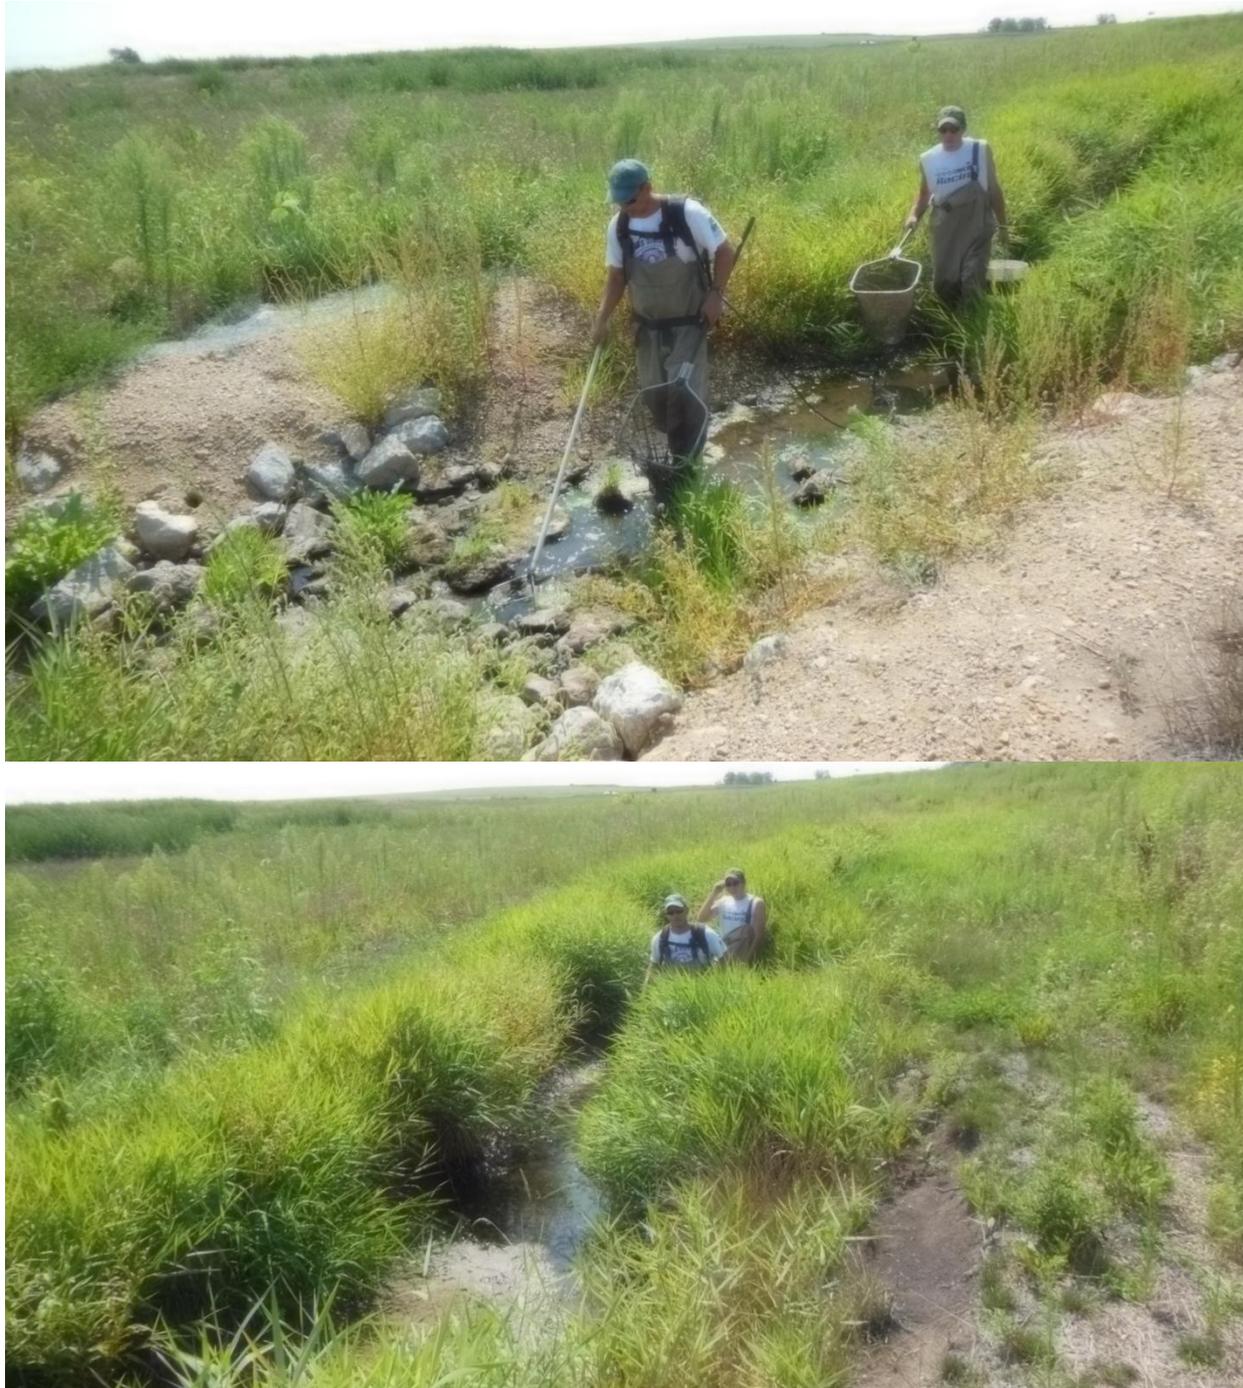
Figure 26. Severe drought and two months of 90 degree plus temperatures allowed vegetation growth in the channel.

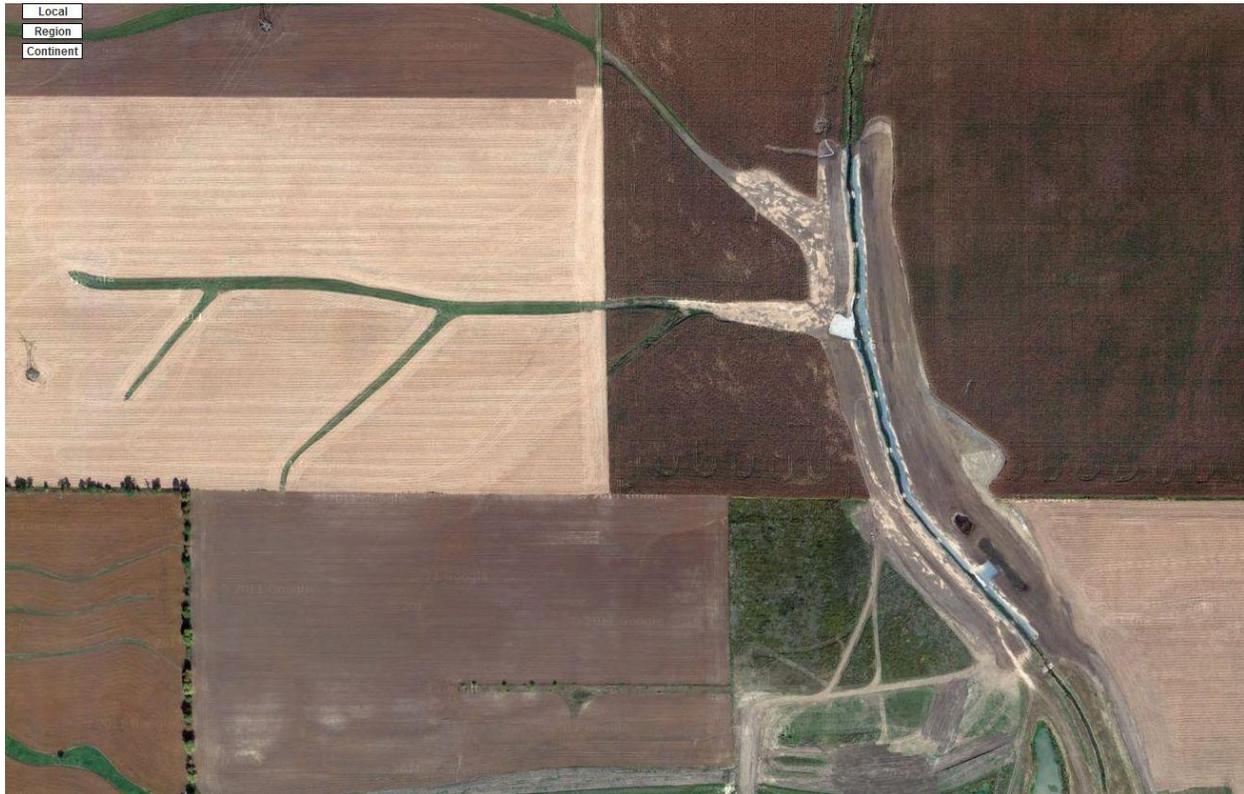
Figure 27. Phase 3 with 12 rock riffles, wetland overflow, and large waterway rock chute.

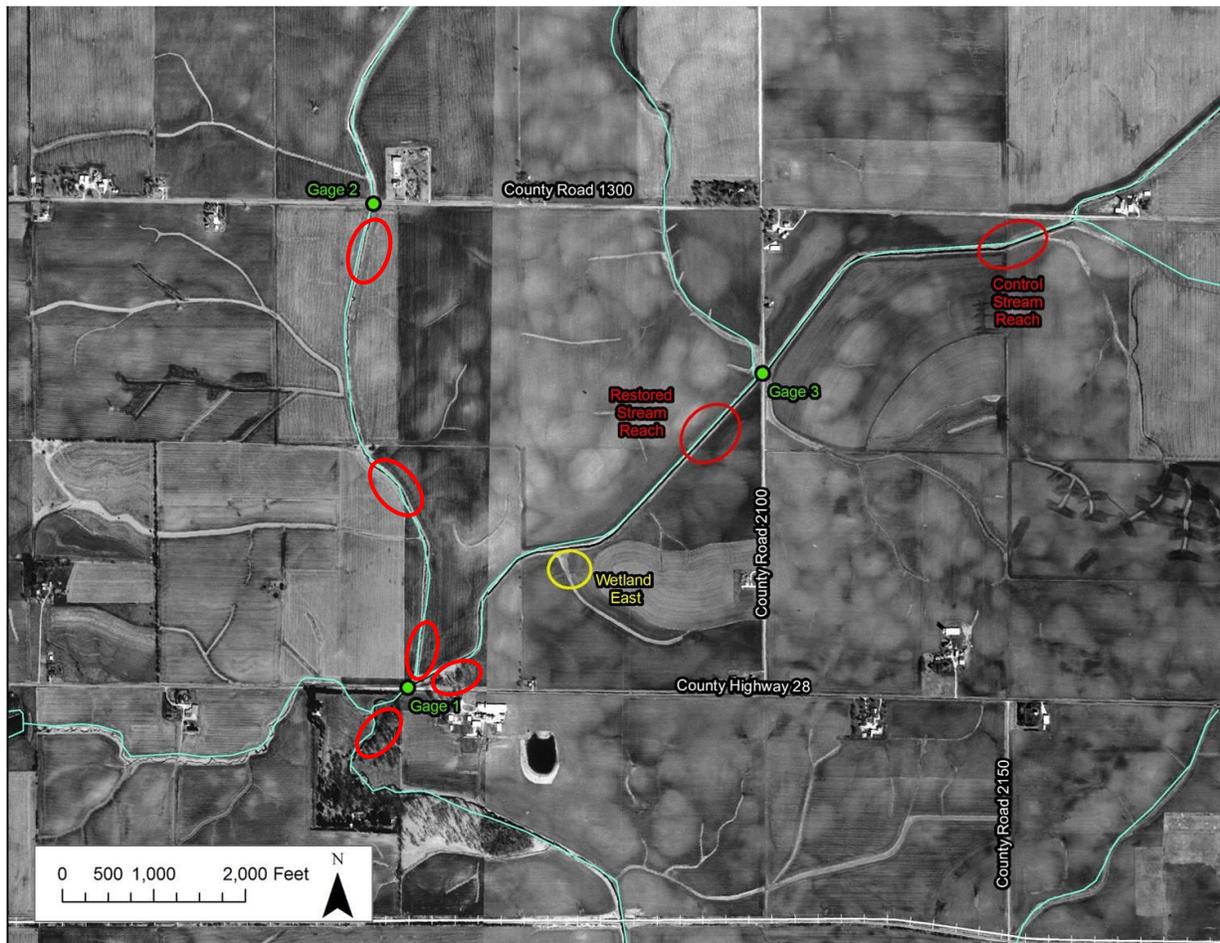
Figure 28. An aerial view of the pre-restoration project area showing the location of the fish population monitoring stations, indicated by red ovals.

The fish population monitoring program was designed to capture the responses to these various practices. The East Branch Downstream Treatment (EIE-18) and West Branch Downstream Treatment (EIE-01) sites are located within Phase 1. The East Branch Upstream Treatment site

(EIE-19) is within Phase 2. The West Branch Upstream Treatment site (EIEM-02) is within Phase 3. The East Branch Upstream Control (EIE-20) and West Branch Upstream Control (EIEM-03) were established as reference sites that have received no channel enhancement work. An additional Downstream Reference site (EIE-22) has been surveyed prior to restoration work and following Phase 3 work in 2011 to monitor downstream off-site changes to the fish population over time.

All monitoring stations consisted of 300-foot stream reaches isolated with block nets. However, the Downstream Reference site was a 500-foot reach. Stations were sampled by electrofishing with a single pass in an upstream direction. The Phase 1 sites (EIE-18 and EIEM-01) and Downstream Reference site were sampled by electric seine. All other sites were sampled by backpack electrofisher. The East Branch Upstream Treatment site (EIE-19) was switched to pushboat electrofishing post-restoration due to the deep scour pool that developed.

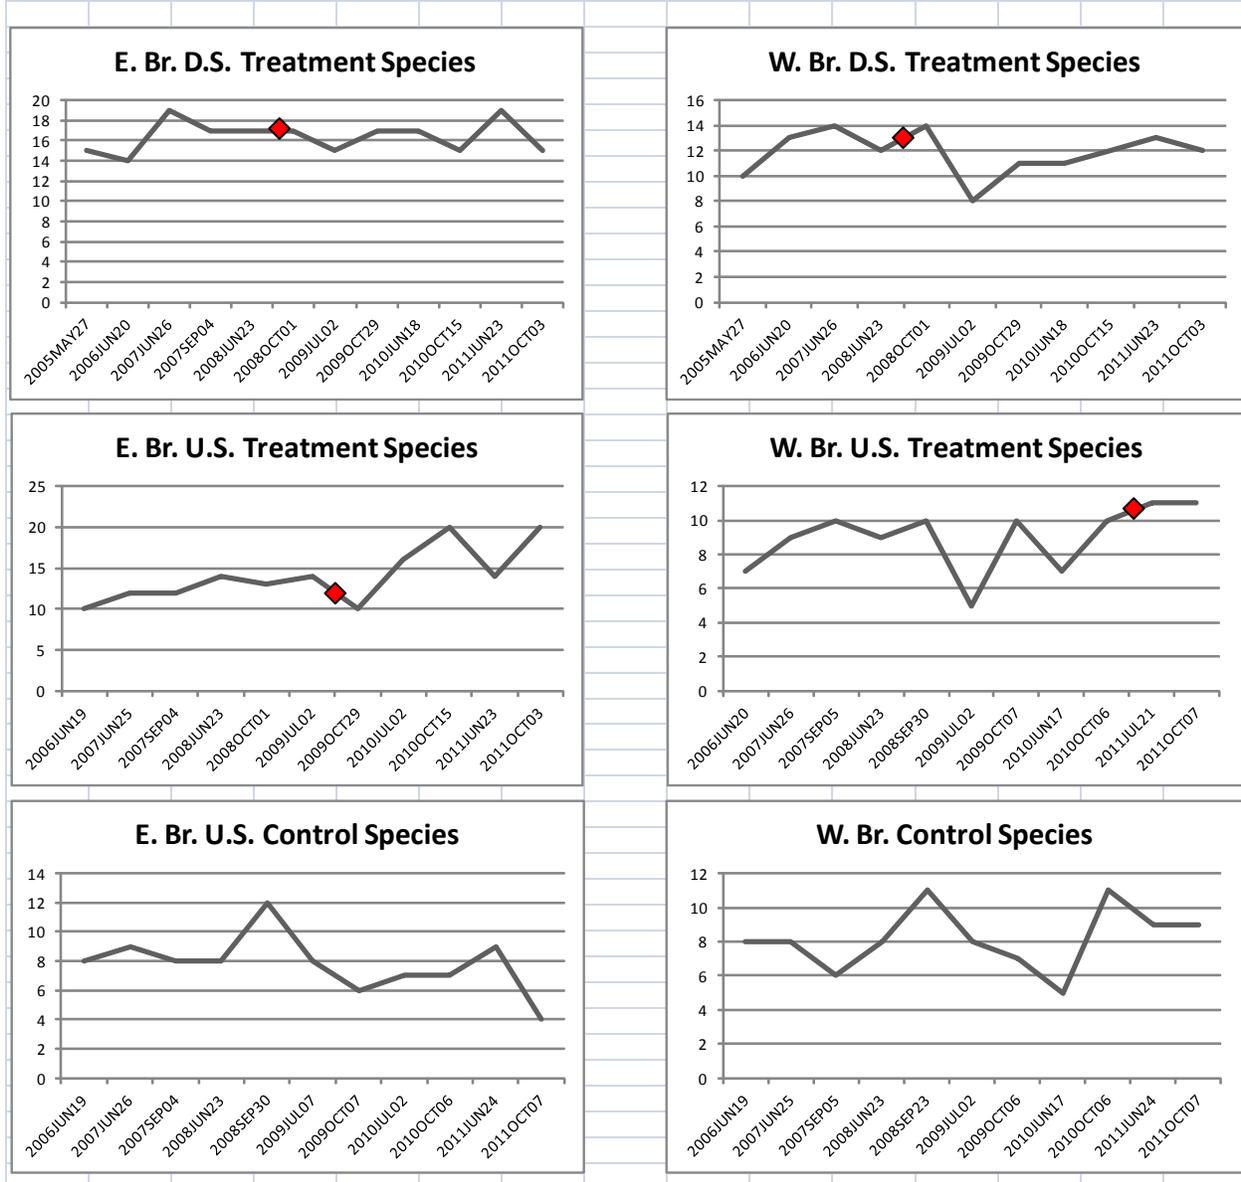
Figures 29-34. Species Abundance graphs for the six monitoring stations. Red diamonds indicate the point of restoration work that directly impacted each of the stations.

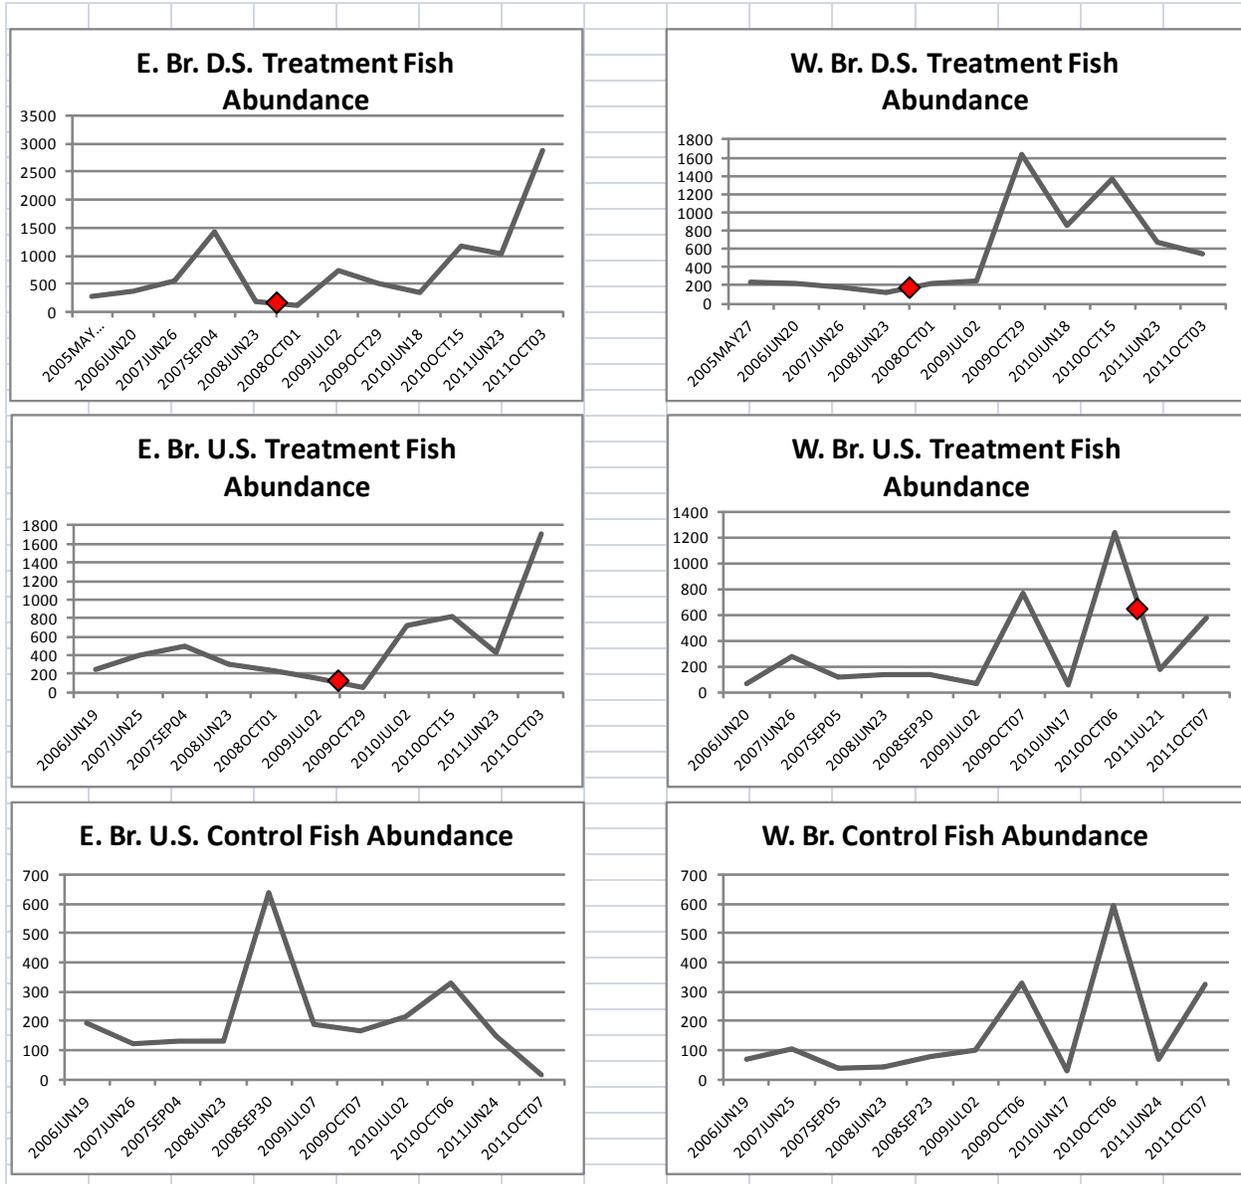
Figures 35-40. Fish Abundance graphs for the six monitoring stations. Red diamonds indicate the point of restoration work that directly impacted each of the stations.
