Evaluation of Public Safety at Run-of-River Dams

4.7 *Rock River Dams*

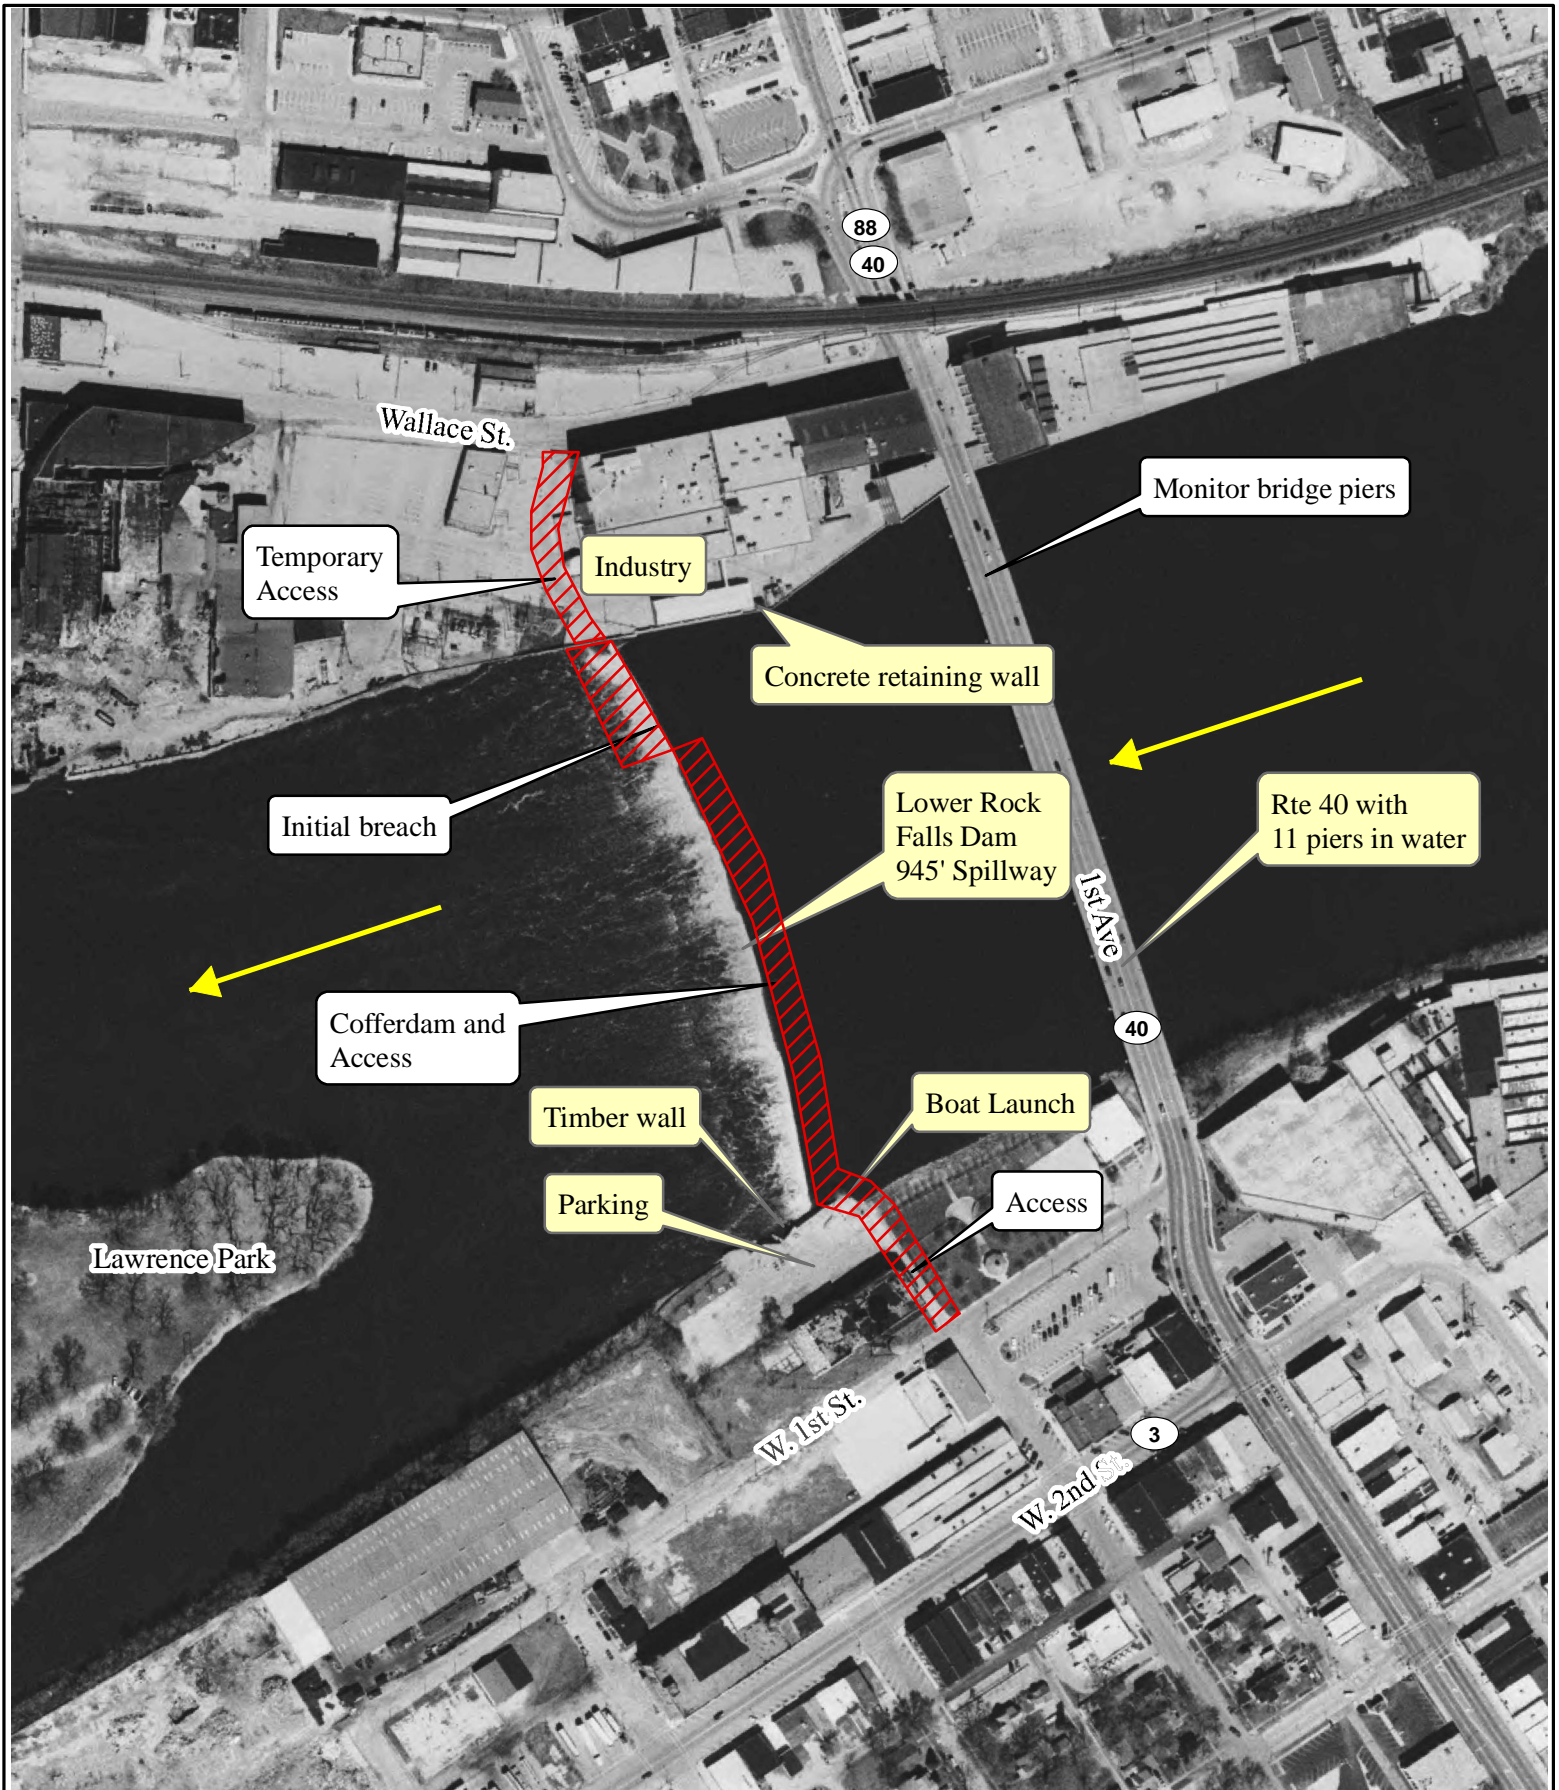
Dam condition, no obvious visual deficiencies were noted. Abutments: left bank old mill race incorporated into concrete vertical structure, access for fishing platform, Onshore left bank is dilapidated factory possibly being demolished or failing.

A 5' to 15' roller was observed at the downstream toe of the dam.

removal, bridge foundations plans need to be evaluate. Hopefully this major bridge is founded on bedrock.

- b) The upstream riverbank riprap should be checked for its below water coverage and post dam stability.
- c) The right bank, upstream walls need to be checked.
- d) Numerous active industries are present in close proximity to the dam. It is not known if they use the impoundment water for industrial or fire fighting purposes.

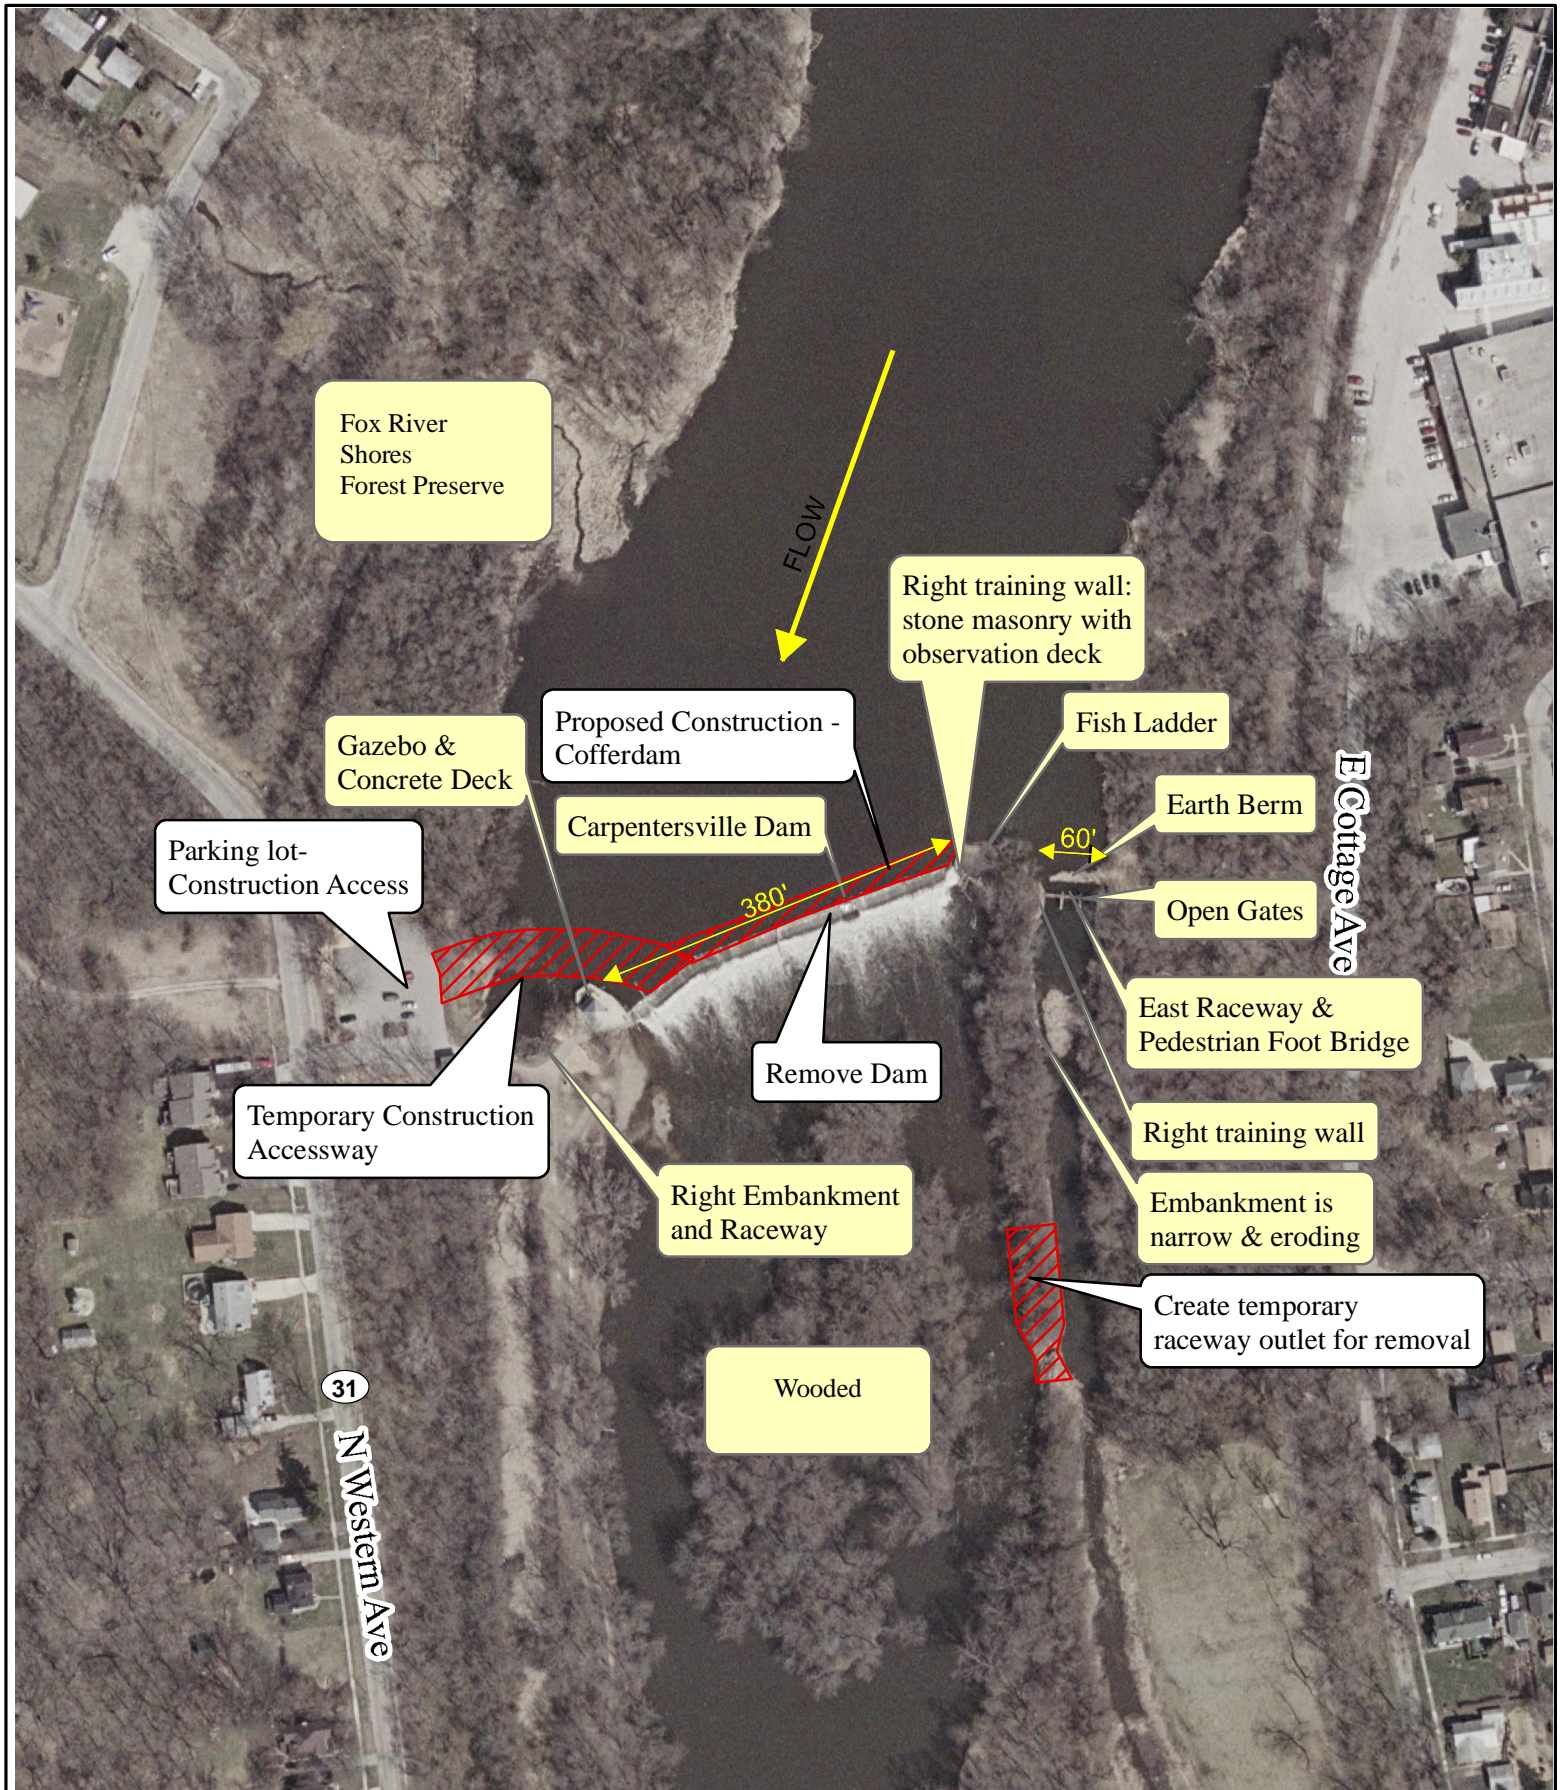
The right abutment has some undercutting at the downstream ft of the abutment. Log debris on the dam face near the right abutment was noted. The left abutment is in deteriorating condition with cracks and some vegetation growth in abutment. There is erosion around the left abutment. The fish ladder located at the left abutment showed some concrete deterioration and was partially clogged with log debris. Significant erosion was noted on the downstream left bank. There is a millrace left of the left dam abutment that has been bulkheaded to prevent flow. Some overflow could occur at exceptionally high river levels. There is a pedestrian walkway over the millrace that is in poor condition. This walkway is the access to the left abutment.

Upstream sediment could be significant due to the pool's broad width and low velocity.

The pool's perimeter supports wetlands that could be impacted.

The right raceway could, with minor improvements, be used to divert water from the spillway. It could be temporarily reconnected to the river just below the dam. The left raceway appears to have significant flow capacity and could be the prime water control system. Removing the flashboards and bulkheads gradually would provide a controlled drawdown to minimize the extent of needed cofferdams and sediment control costs during construction. Favorable access to both ends of the dam and easy drawdown conditions would enable a relatively easy removal.

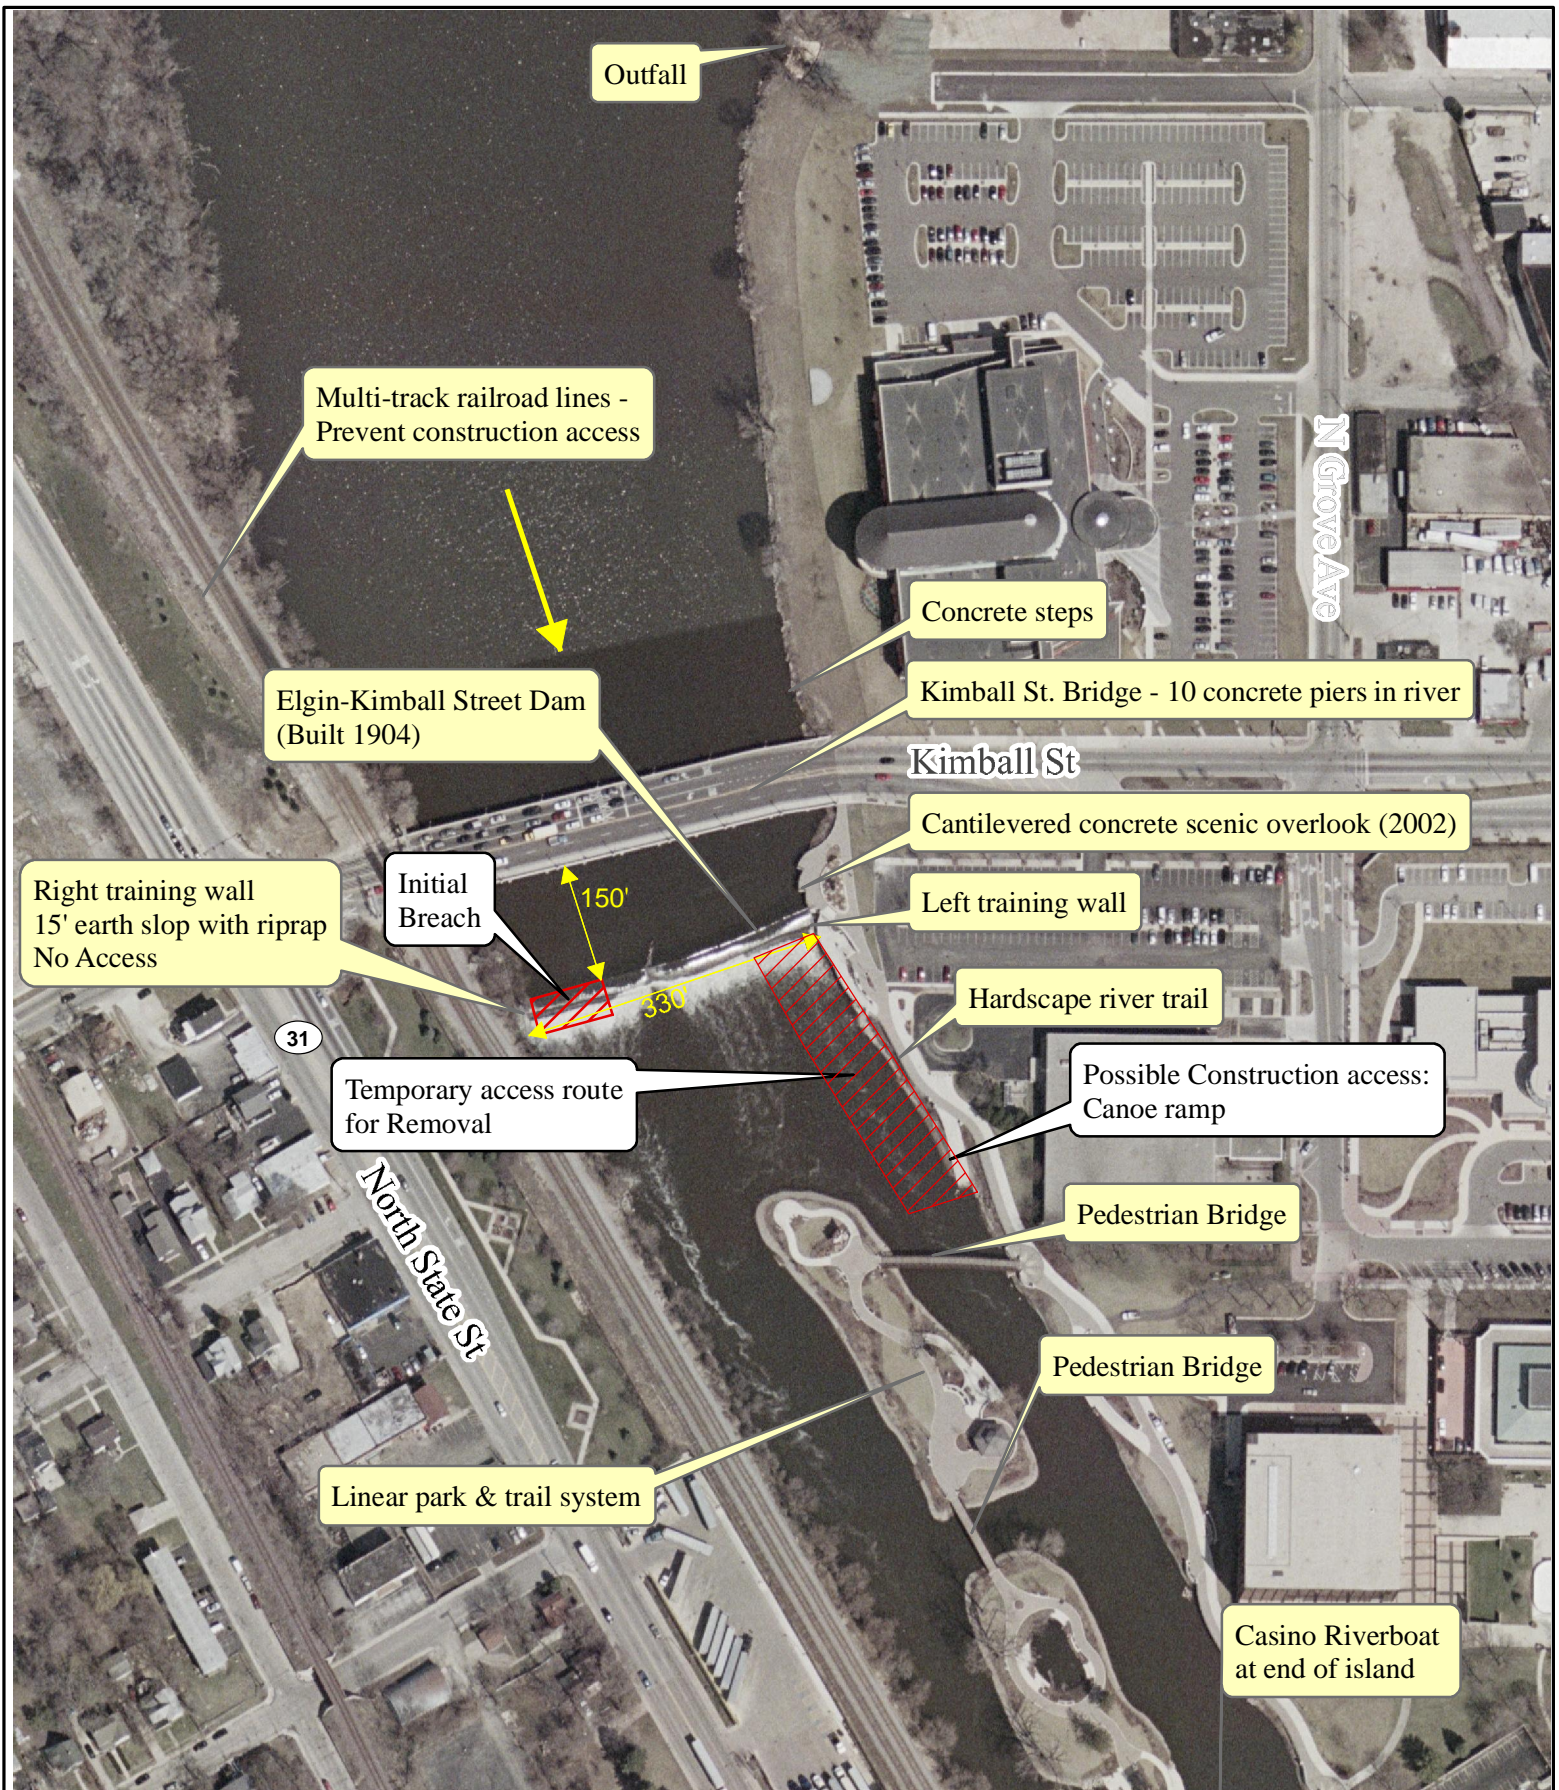
**Existing Conditions and
Proposed Removal**

velocities, and increased potential for pier scour. This would need to be carefully assessed during dam removal feasibility studies.

- g) This structure is massive and will require an extensive amount of demolition. Removal is likely to be expensive.

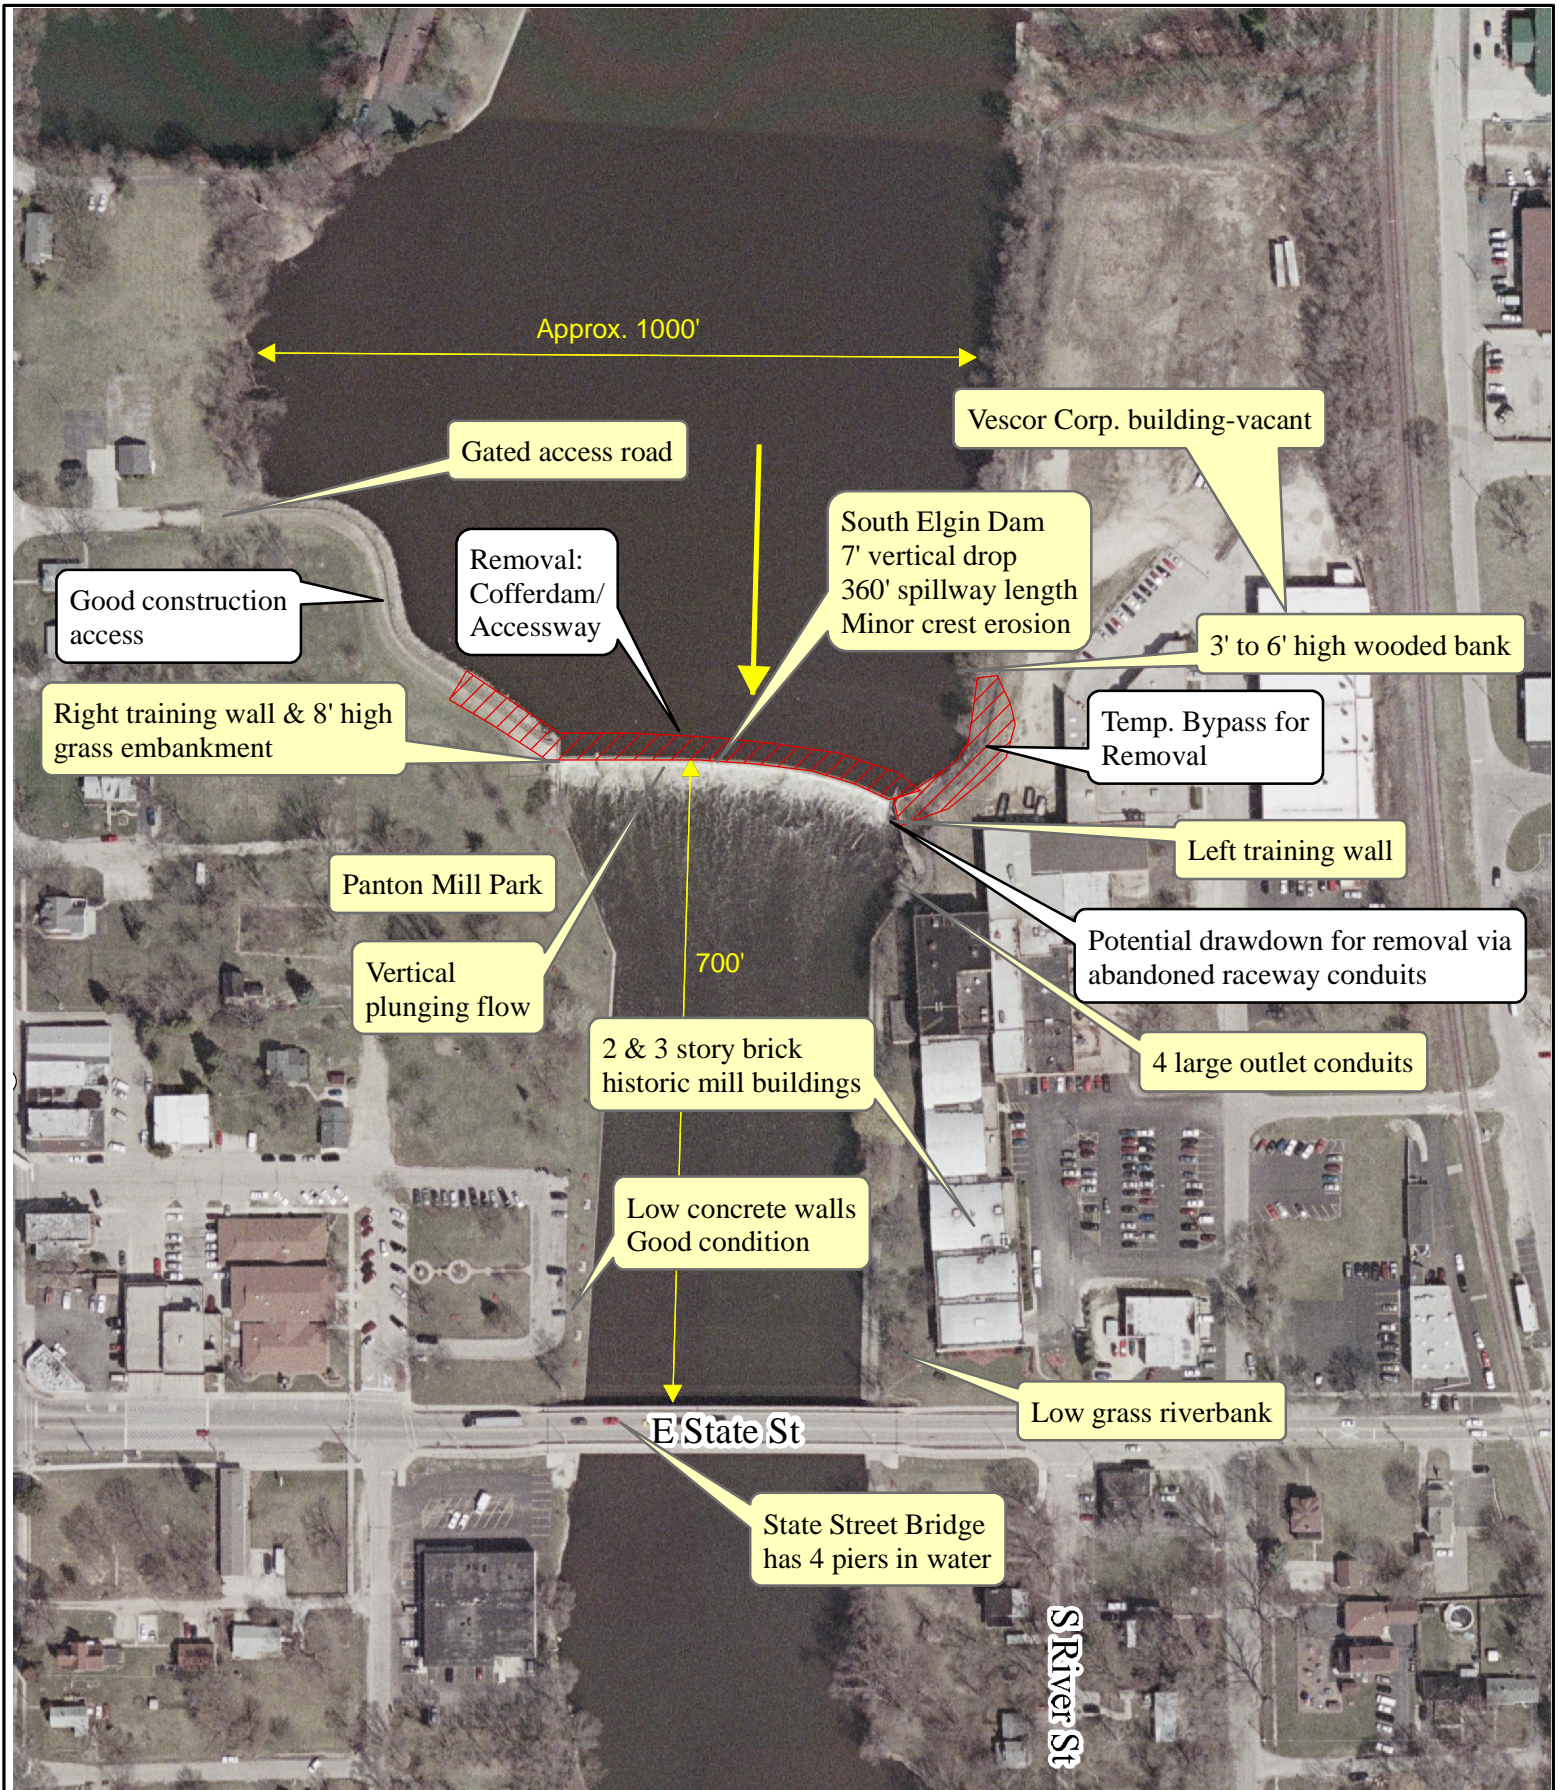
- The left abutment gates and conduits need to be inspected to confirm their operation and flow capacity.
- Construction access through the park would require moderate restoration.
- The USGS gauging station will need to be relocated.
- The river boat casino floating in the Fox River at Elgin appears to be in the upper end of the South Elgin dam impoundment.
- There are many private properties along the pool perimeter.
- The State Street is unlikely to be impacted by dam removal, given the run-of-river operating regime of the existing dam (i.e. post-construction flows and water surface elevations will remain unchanged).
- Upstream use of the impounded water appears to be significant and would likely be impacted by dam removal.

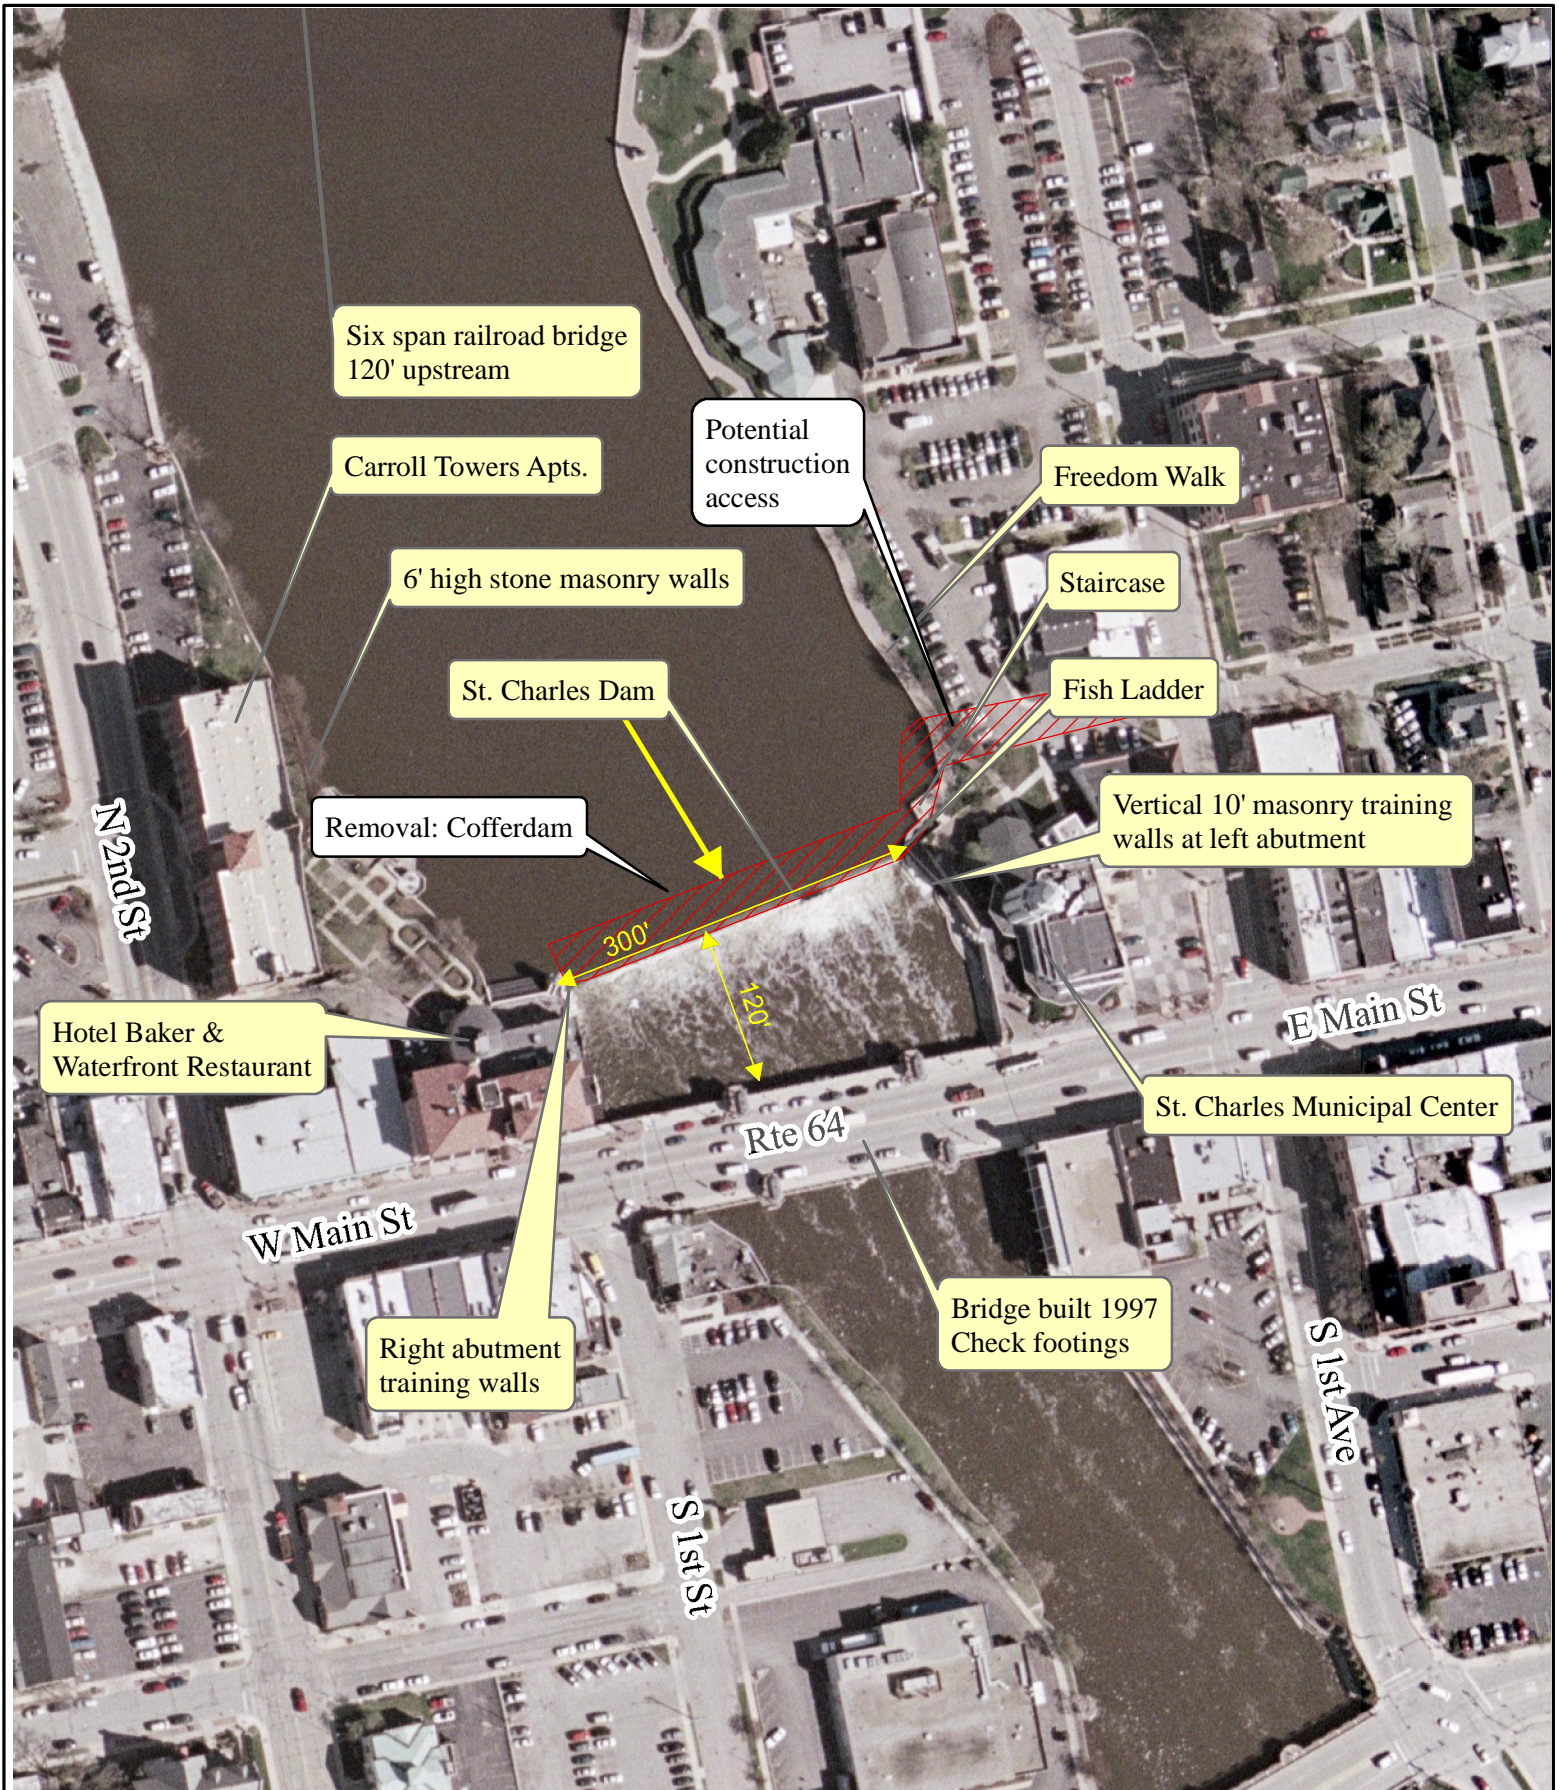
The downstream channel and Main Street Bridge have high flow velocities.

The large pond may contain sediments.

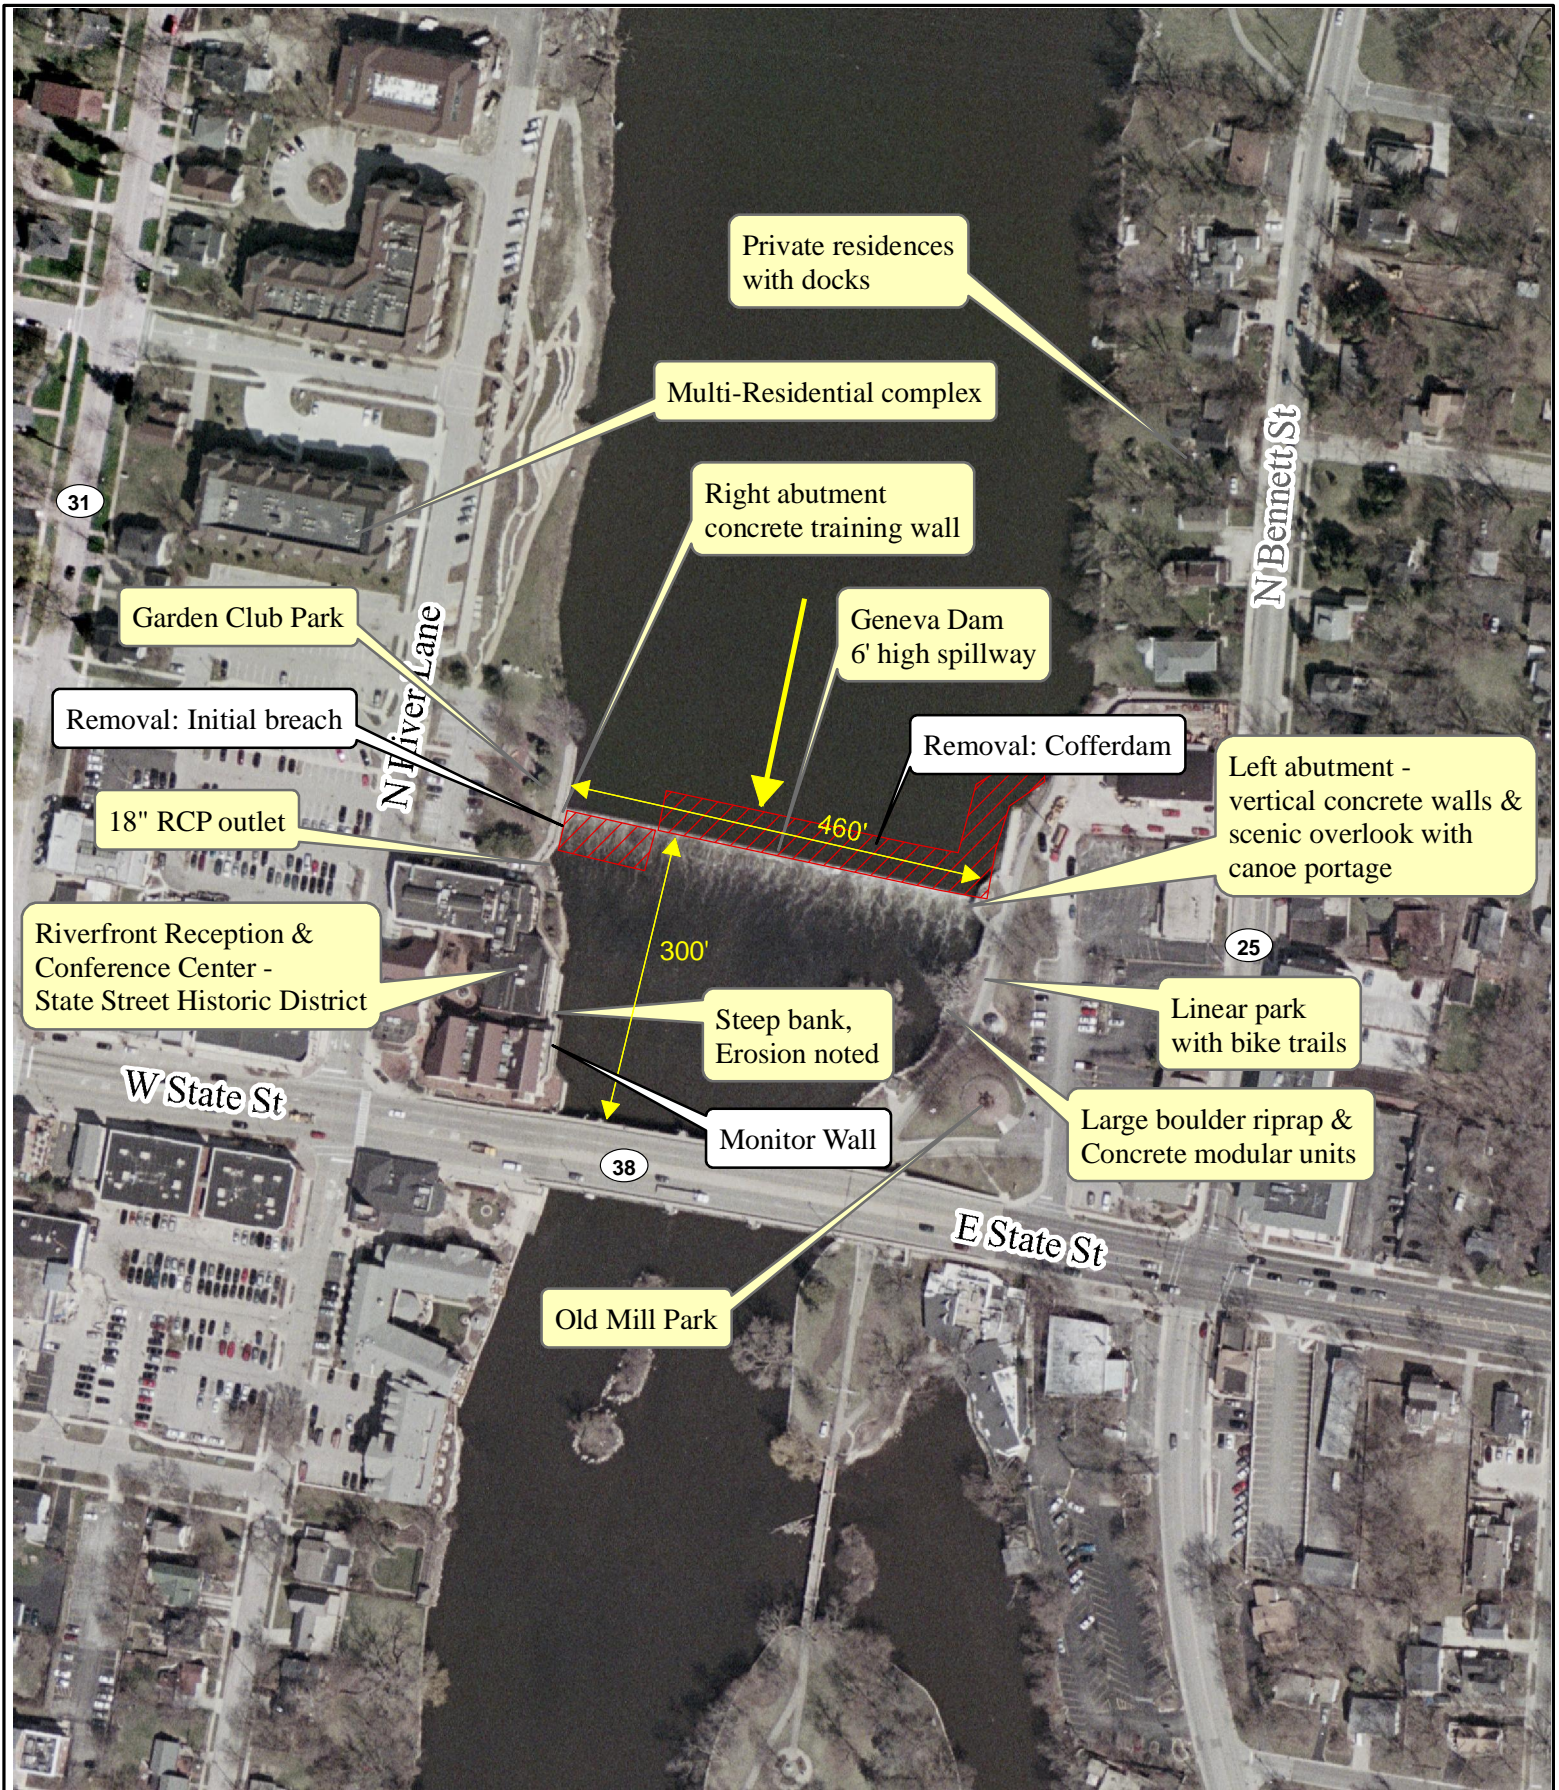
- There are heavily used public parks on the east bank, and upscale private properties on the west bank.
- The impoundment has many riverfront houses, some with docks.
- Signs indicate a State Street historic district.
- A pool this large could have significant fine grain sediment that could be released.
- The length of this spillway and the associated volume of concrete that would need to be demolished are high.

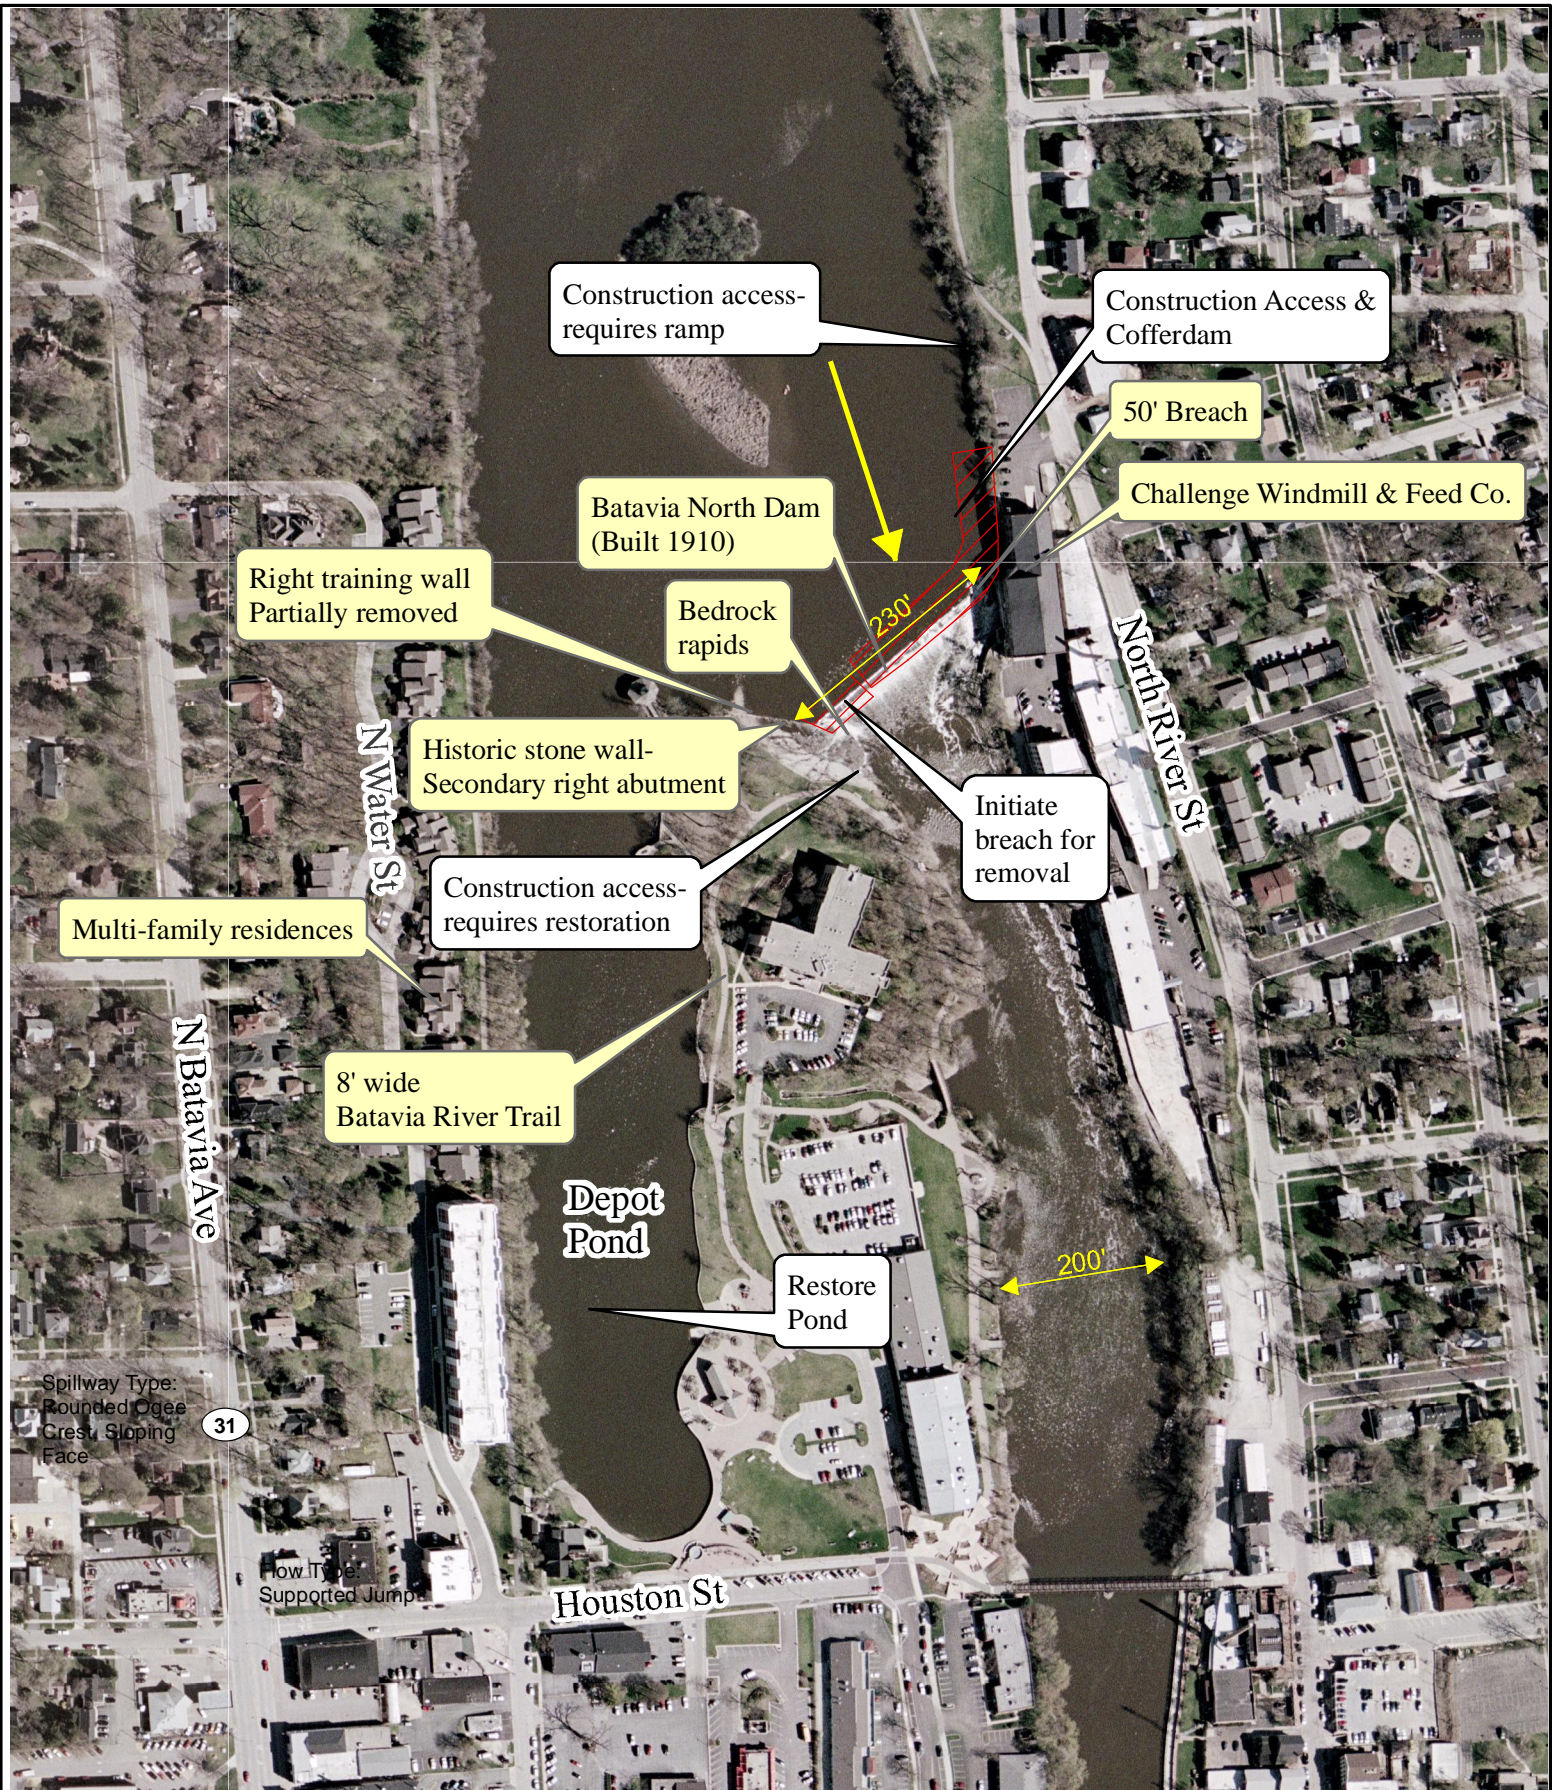
- The dam site has been landscaped as an integral part of the Batavia River trail system.
- Many riverfront apartments/condominiums overlook the dam and pool.
- The lateral headrace pond, called the Depot Pond, as part of the port system.
- A timber boardwalk with a large gazebo, dated 1994, overlooks the duck pond area impounded by the dam.
- The Batavia Riverwalk is supplemented by nature plants by the Batavia Plain Dirt Gardeners and the Wildflower Sanctuary won a USEPA award.
- The left breach has a short headcut extending upstream.
- The face of the dam is generally in good condition, but several large spalls are visible even from a distance.
