Evaluation of Public Safety at Run-of-River Dams

4.7 *Rock River Dams*

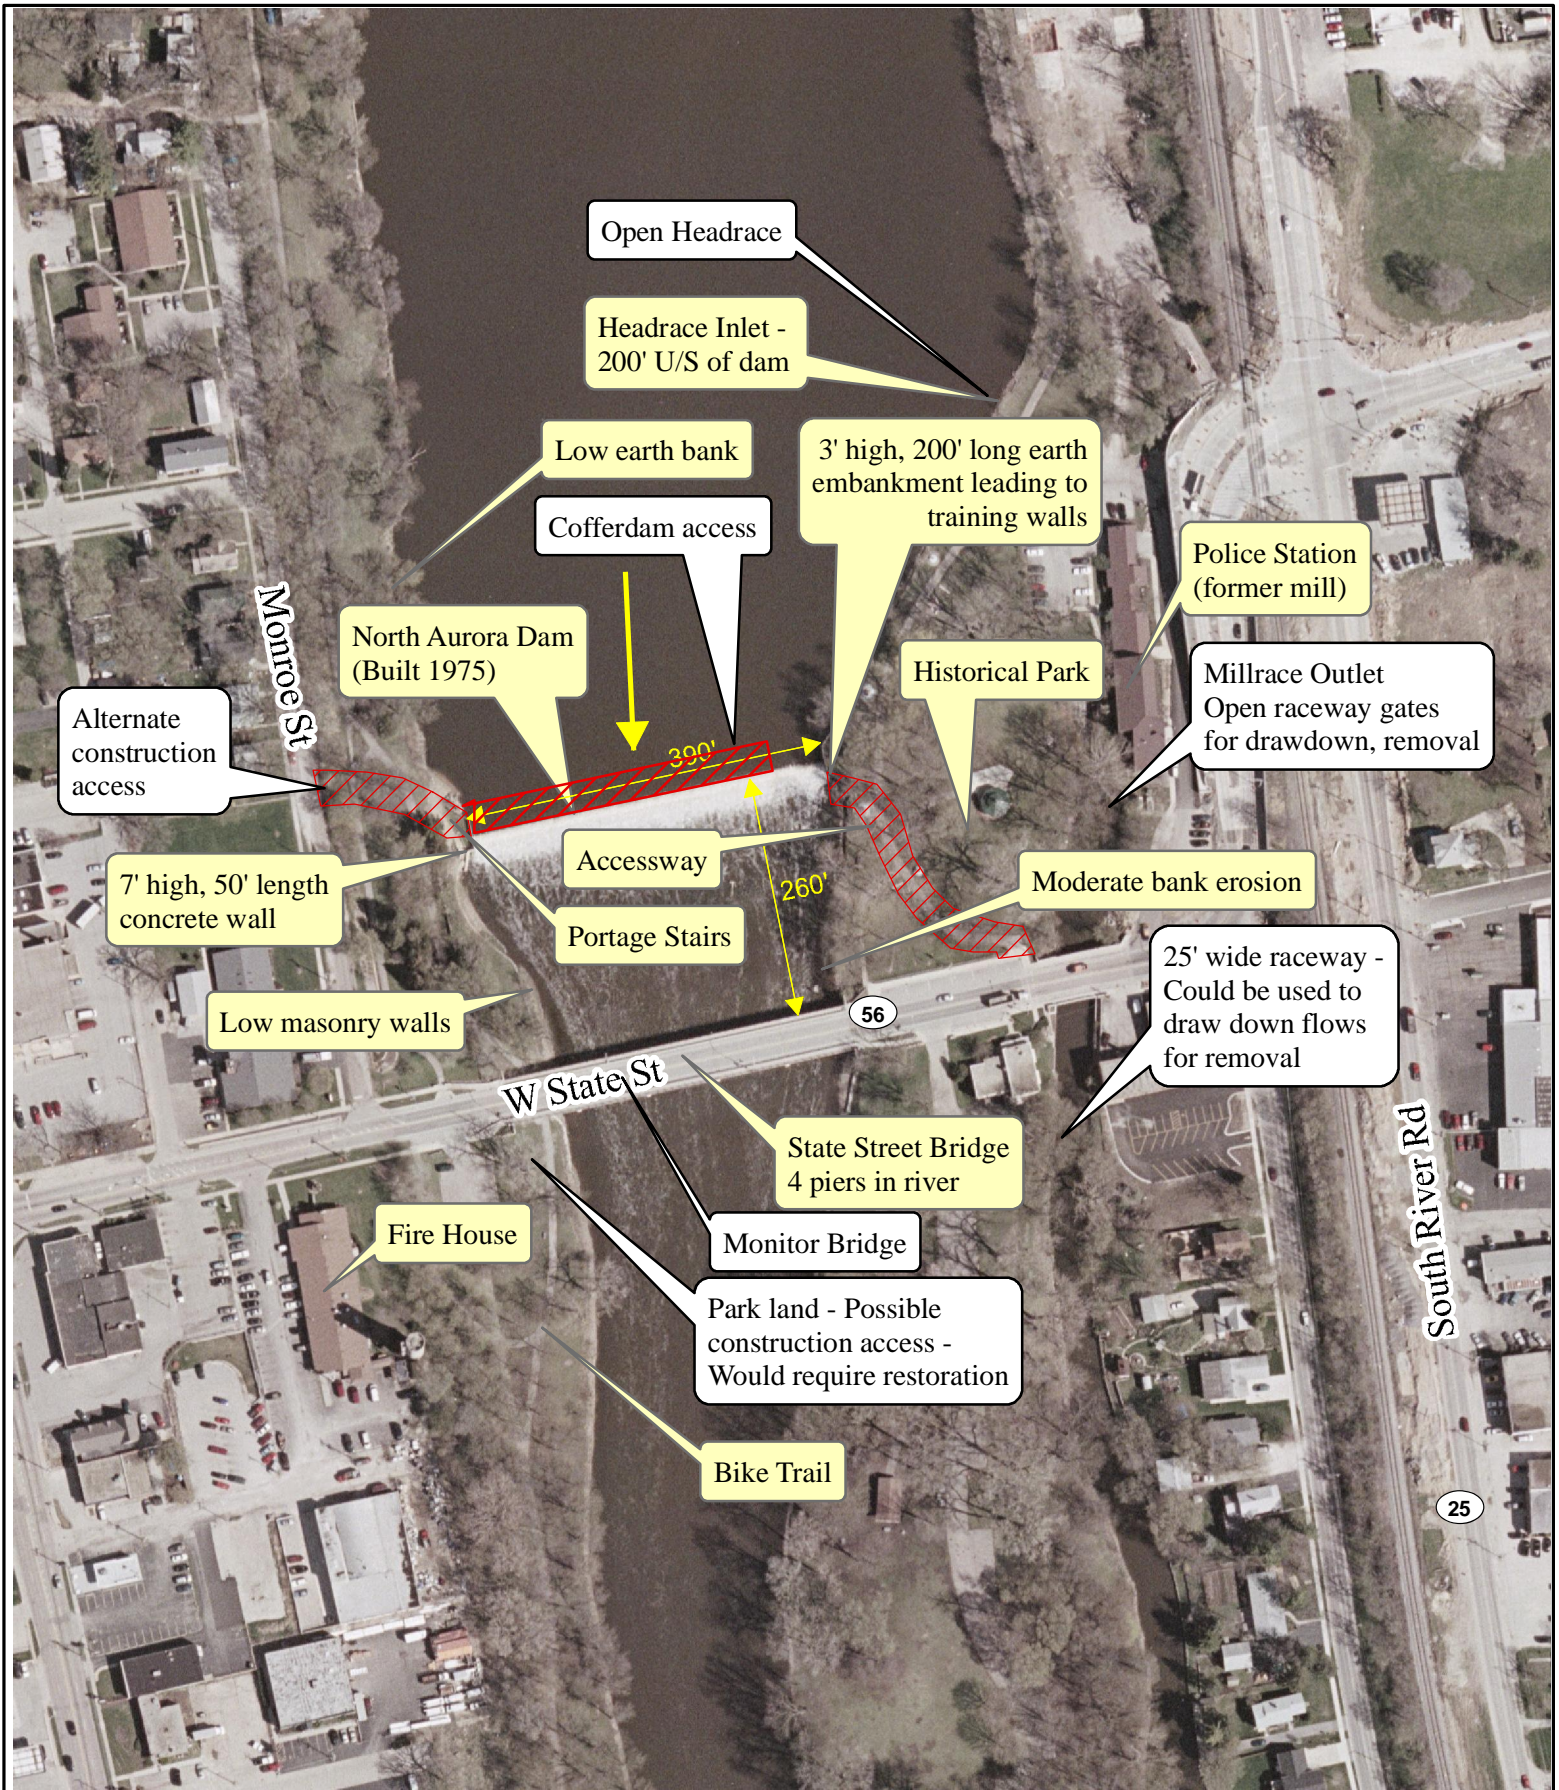
- Downstream currents from the dam to the bridge are quite fast, on the order of four to five ft per second. This would be a difficult site for an access road, despite its firm gravel bed.
- Both ends of the dam have popular well maintained public parks and bikeways. The dam is an integral part of the riverbank experience.
- Previous probes of the pool (taken approximately five years ago) found several ft of soft fine grain sediments near the banks. It would be difficult to contain this material.
- An eight-ft diameter, above-grade chamber at the left training wall could support utilities. It would need to be evaluated during design.

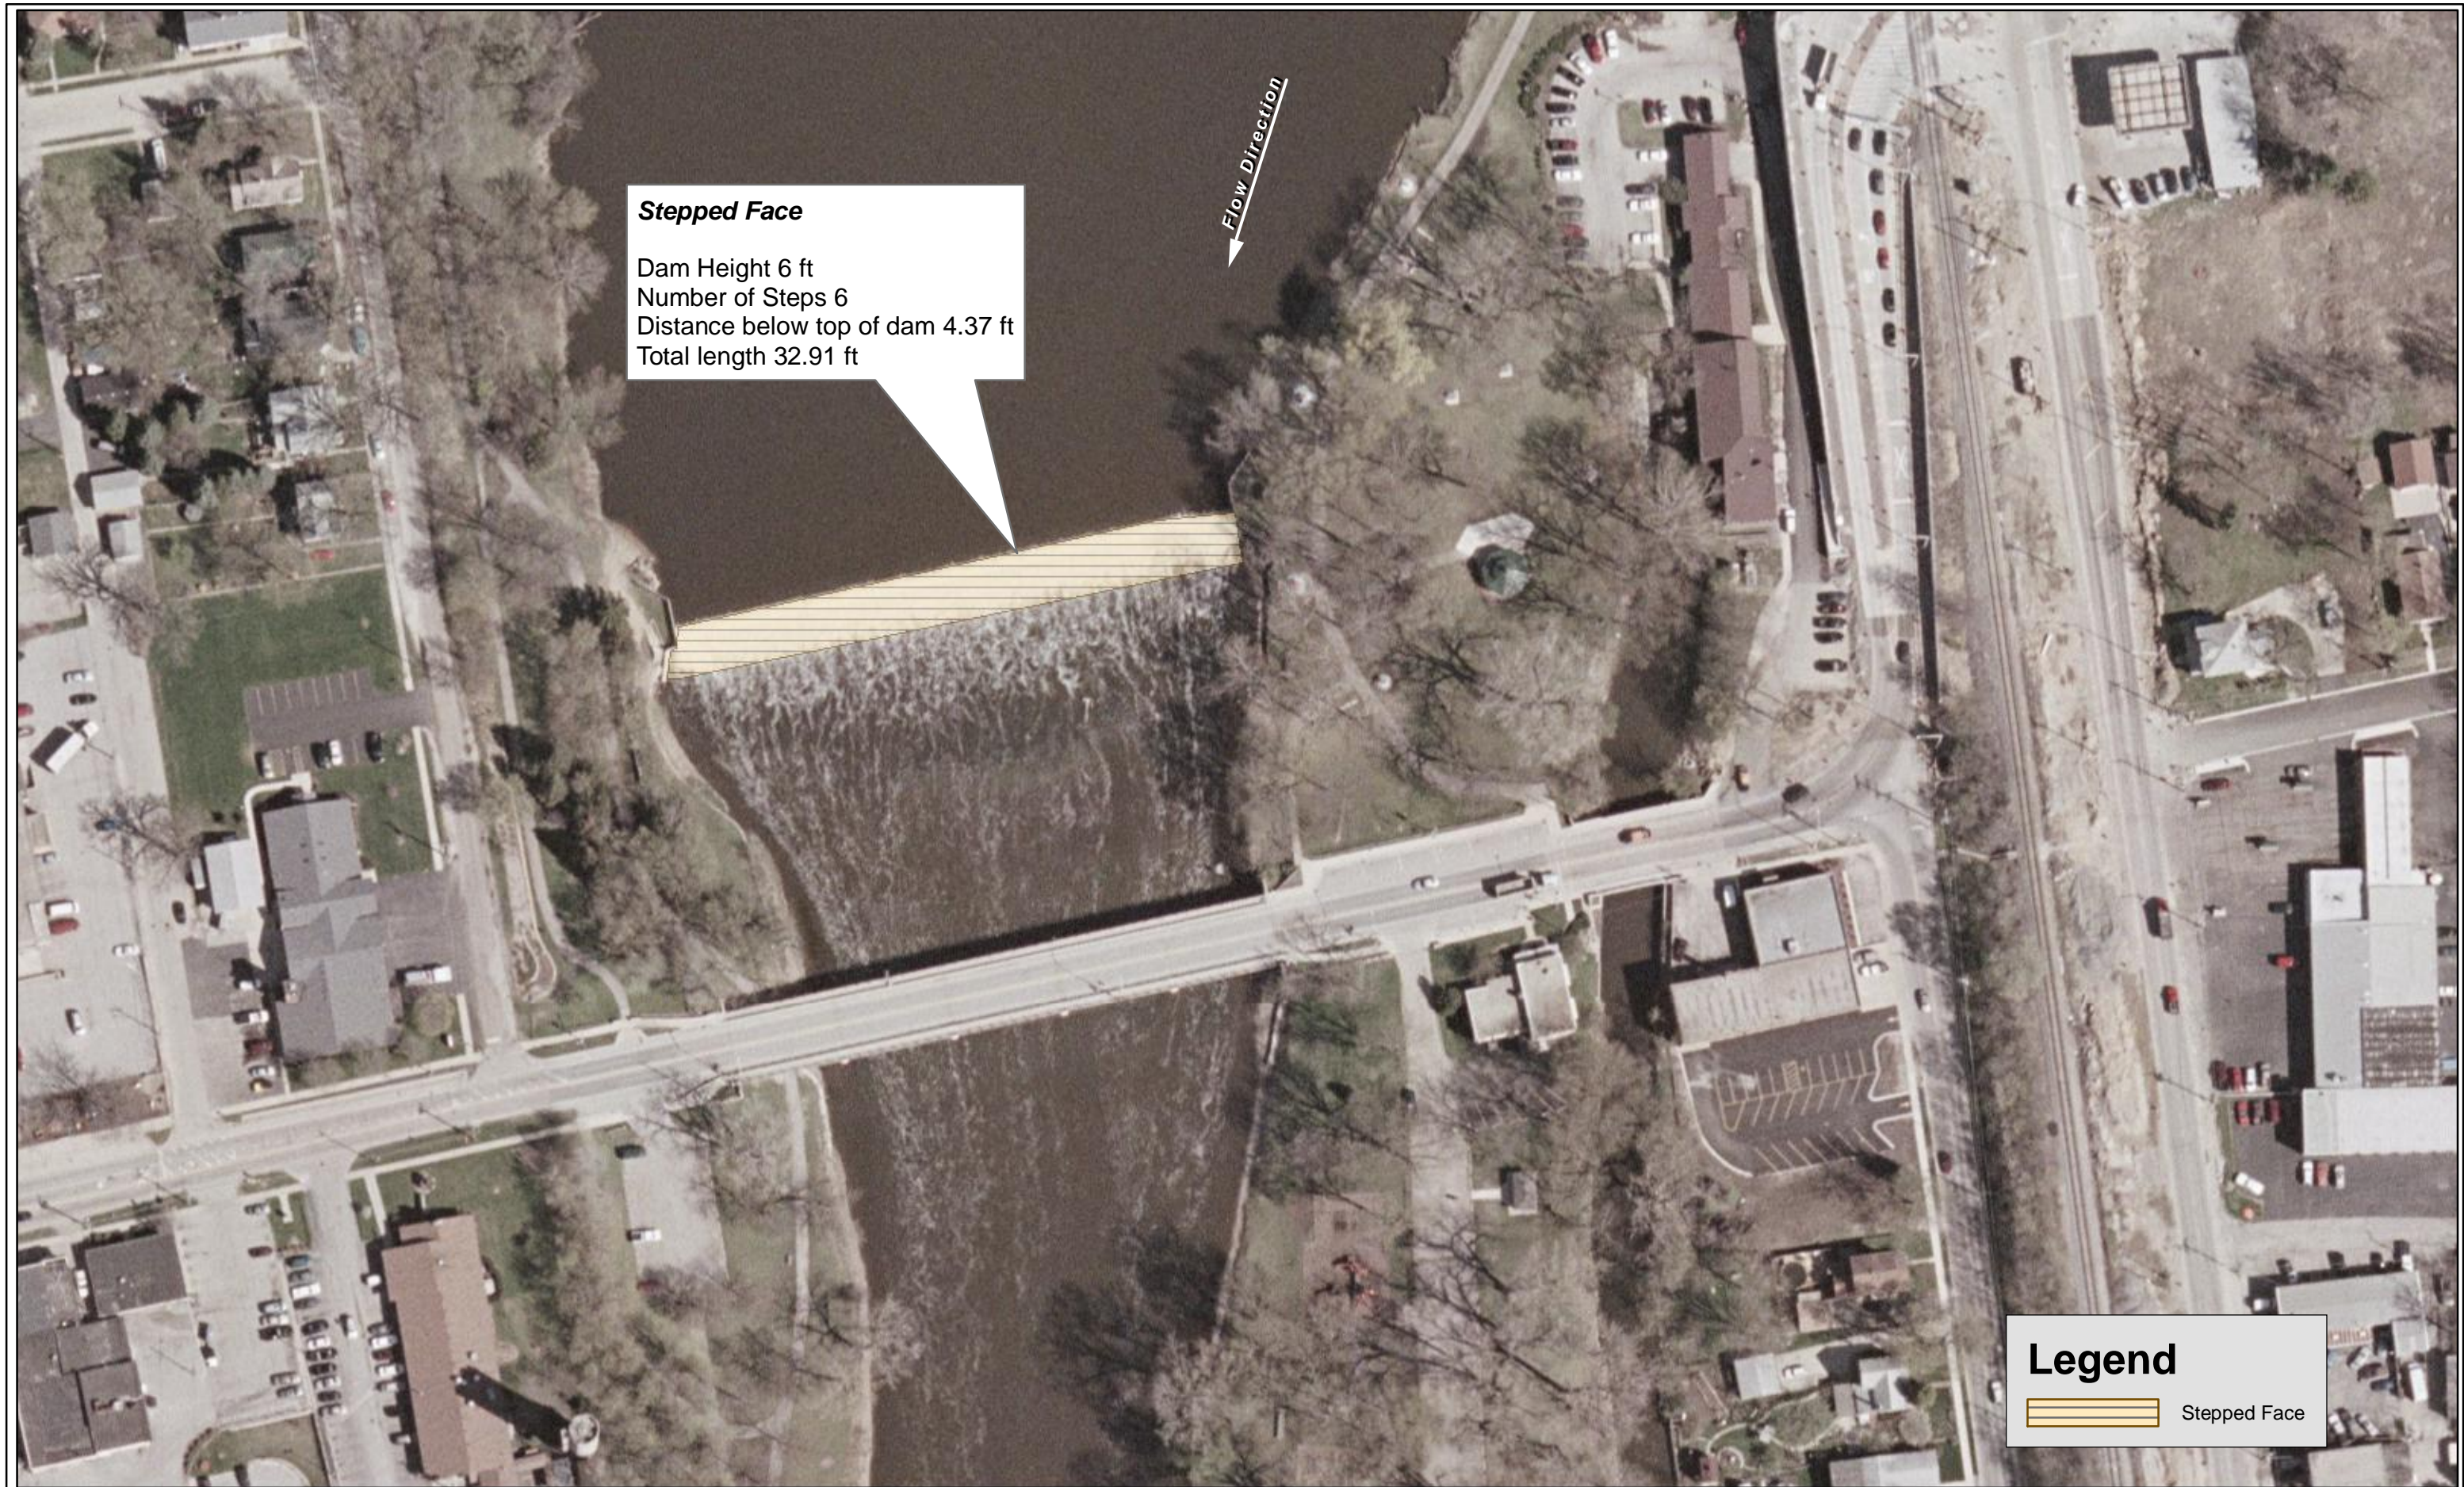
INSTREAM BYPASS

Stepped Face
Dam Height 6 ft
Number of Steps 6
Distance below top of dam 4.37 ft
Total length 32.91 ft

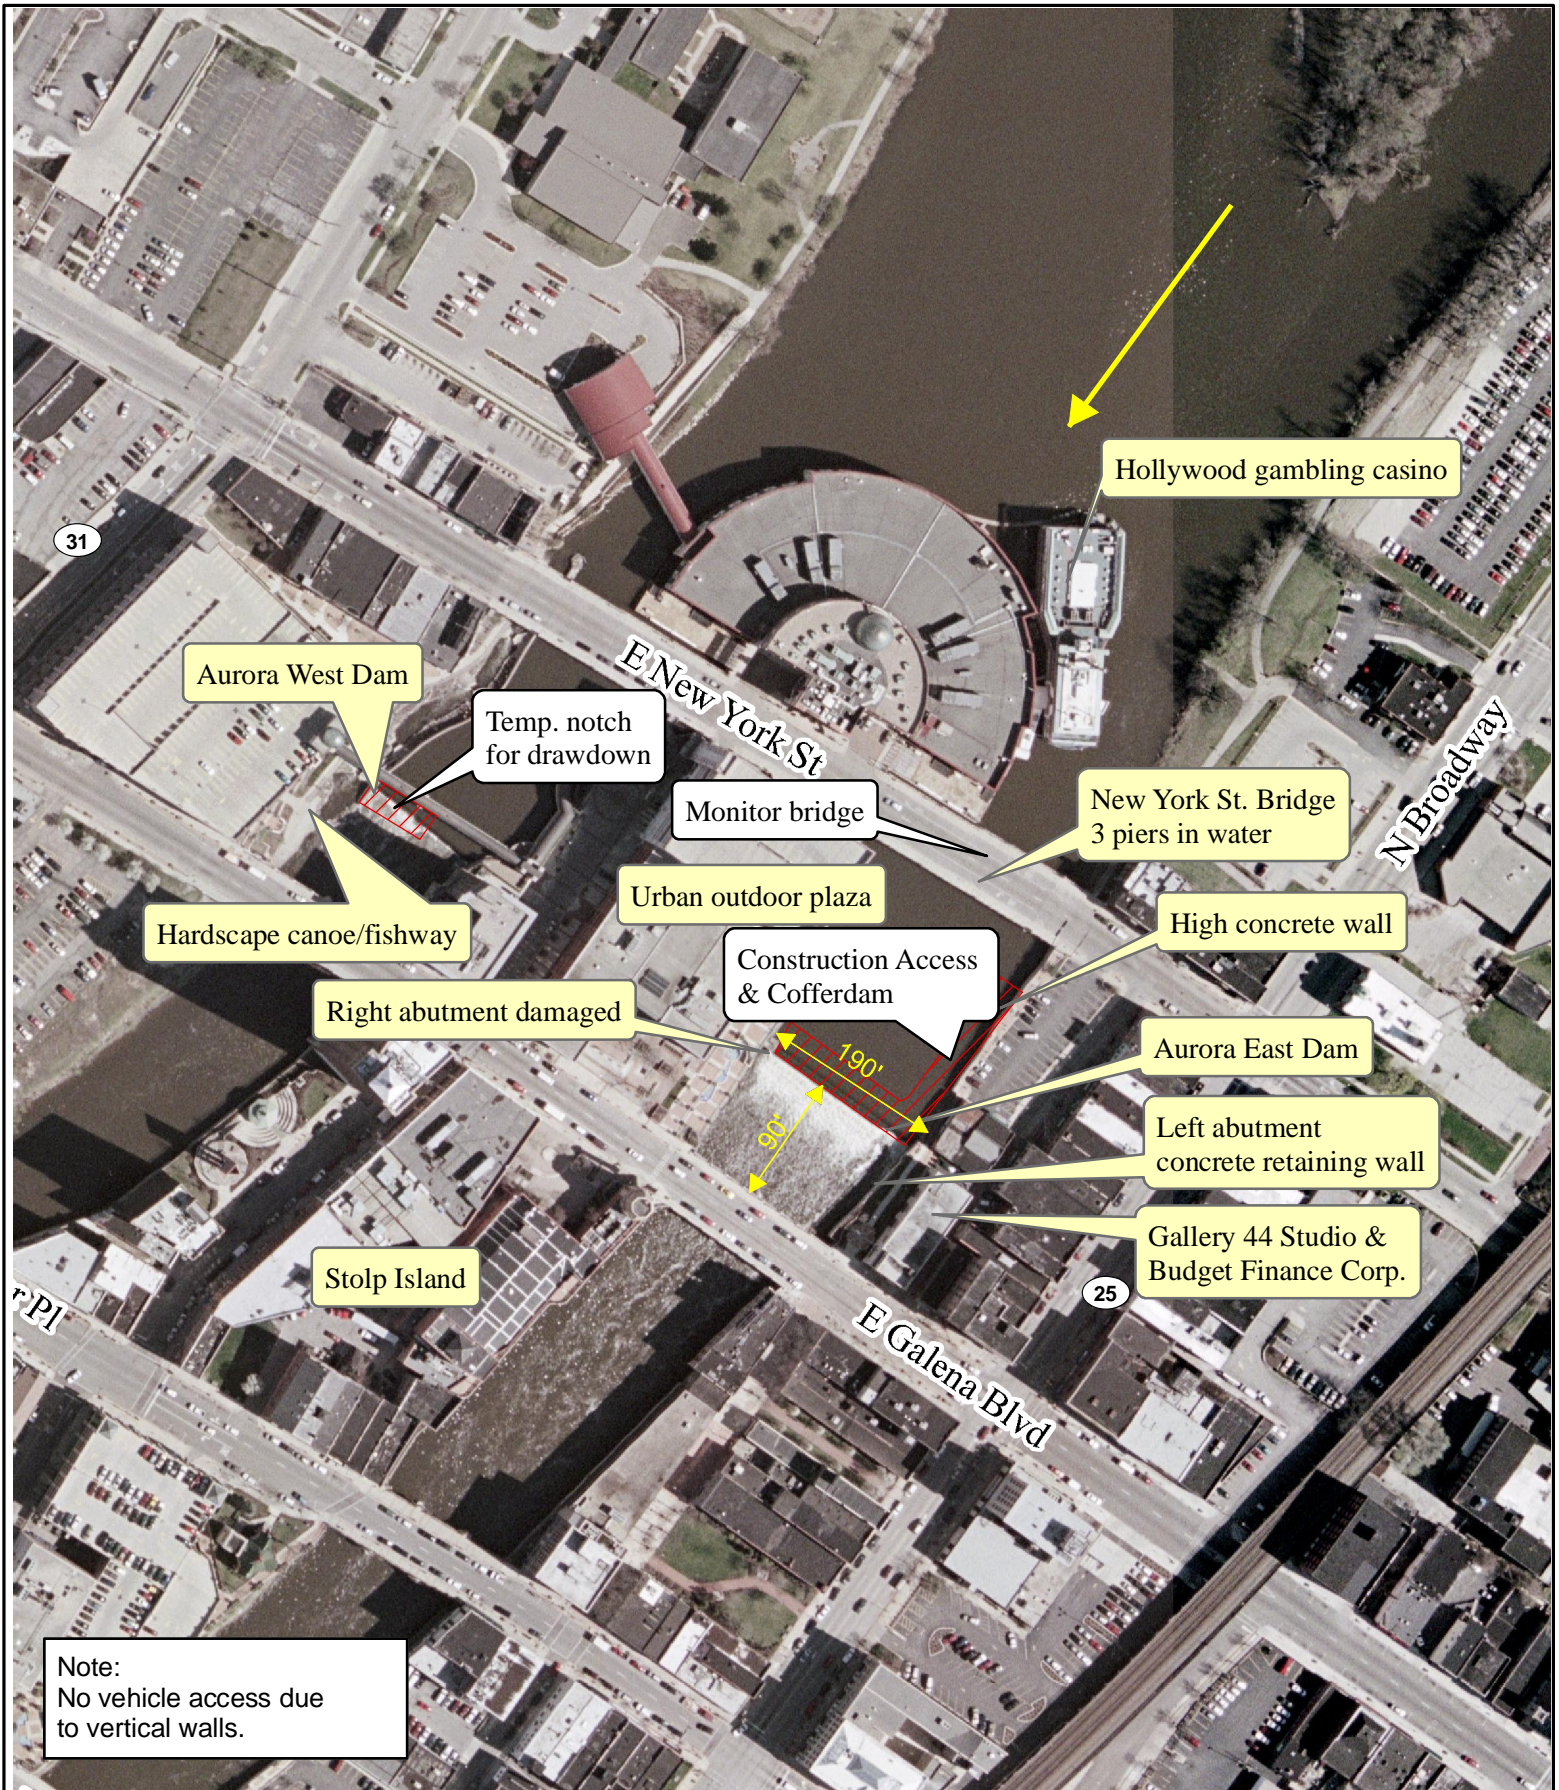
- Removing just the east dam would lower the pool below the crest of the west dam, drying the west channel and pulling all flows to the narrow east channel. A detailed hydraulic analysis is required to further evaluate this.

- If the east dam is considered for removal, then the west dam should also be considered. They are not independent hydraulic structures, but serve as a pair. Removal of just one of the two dam sections is not advisable, as flow would simply concentrate in a single cell, causing high velocities and likely result in erosion and even more dangerous conditions. The intense amount of development and uses of land in the area will make removal difficult.

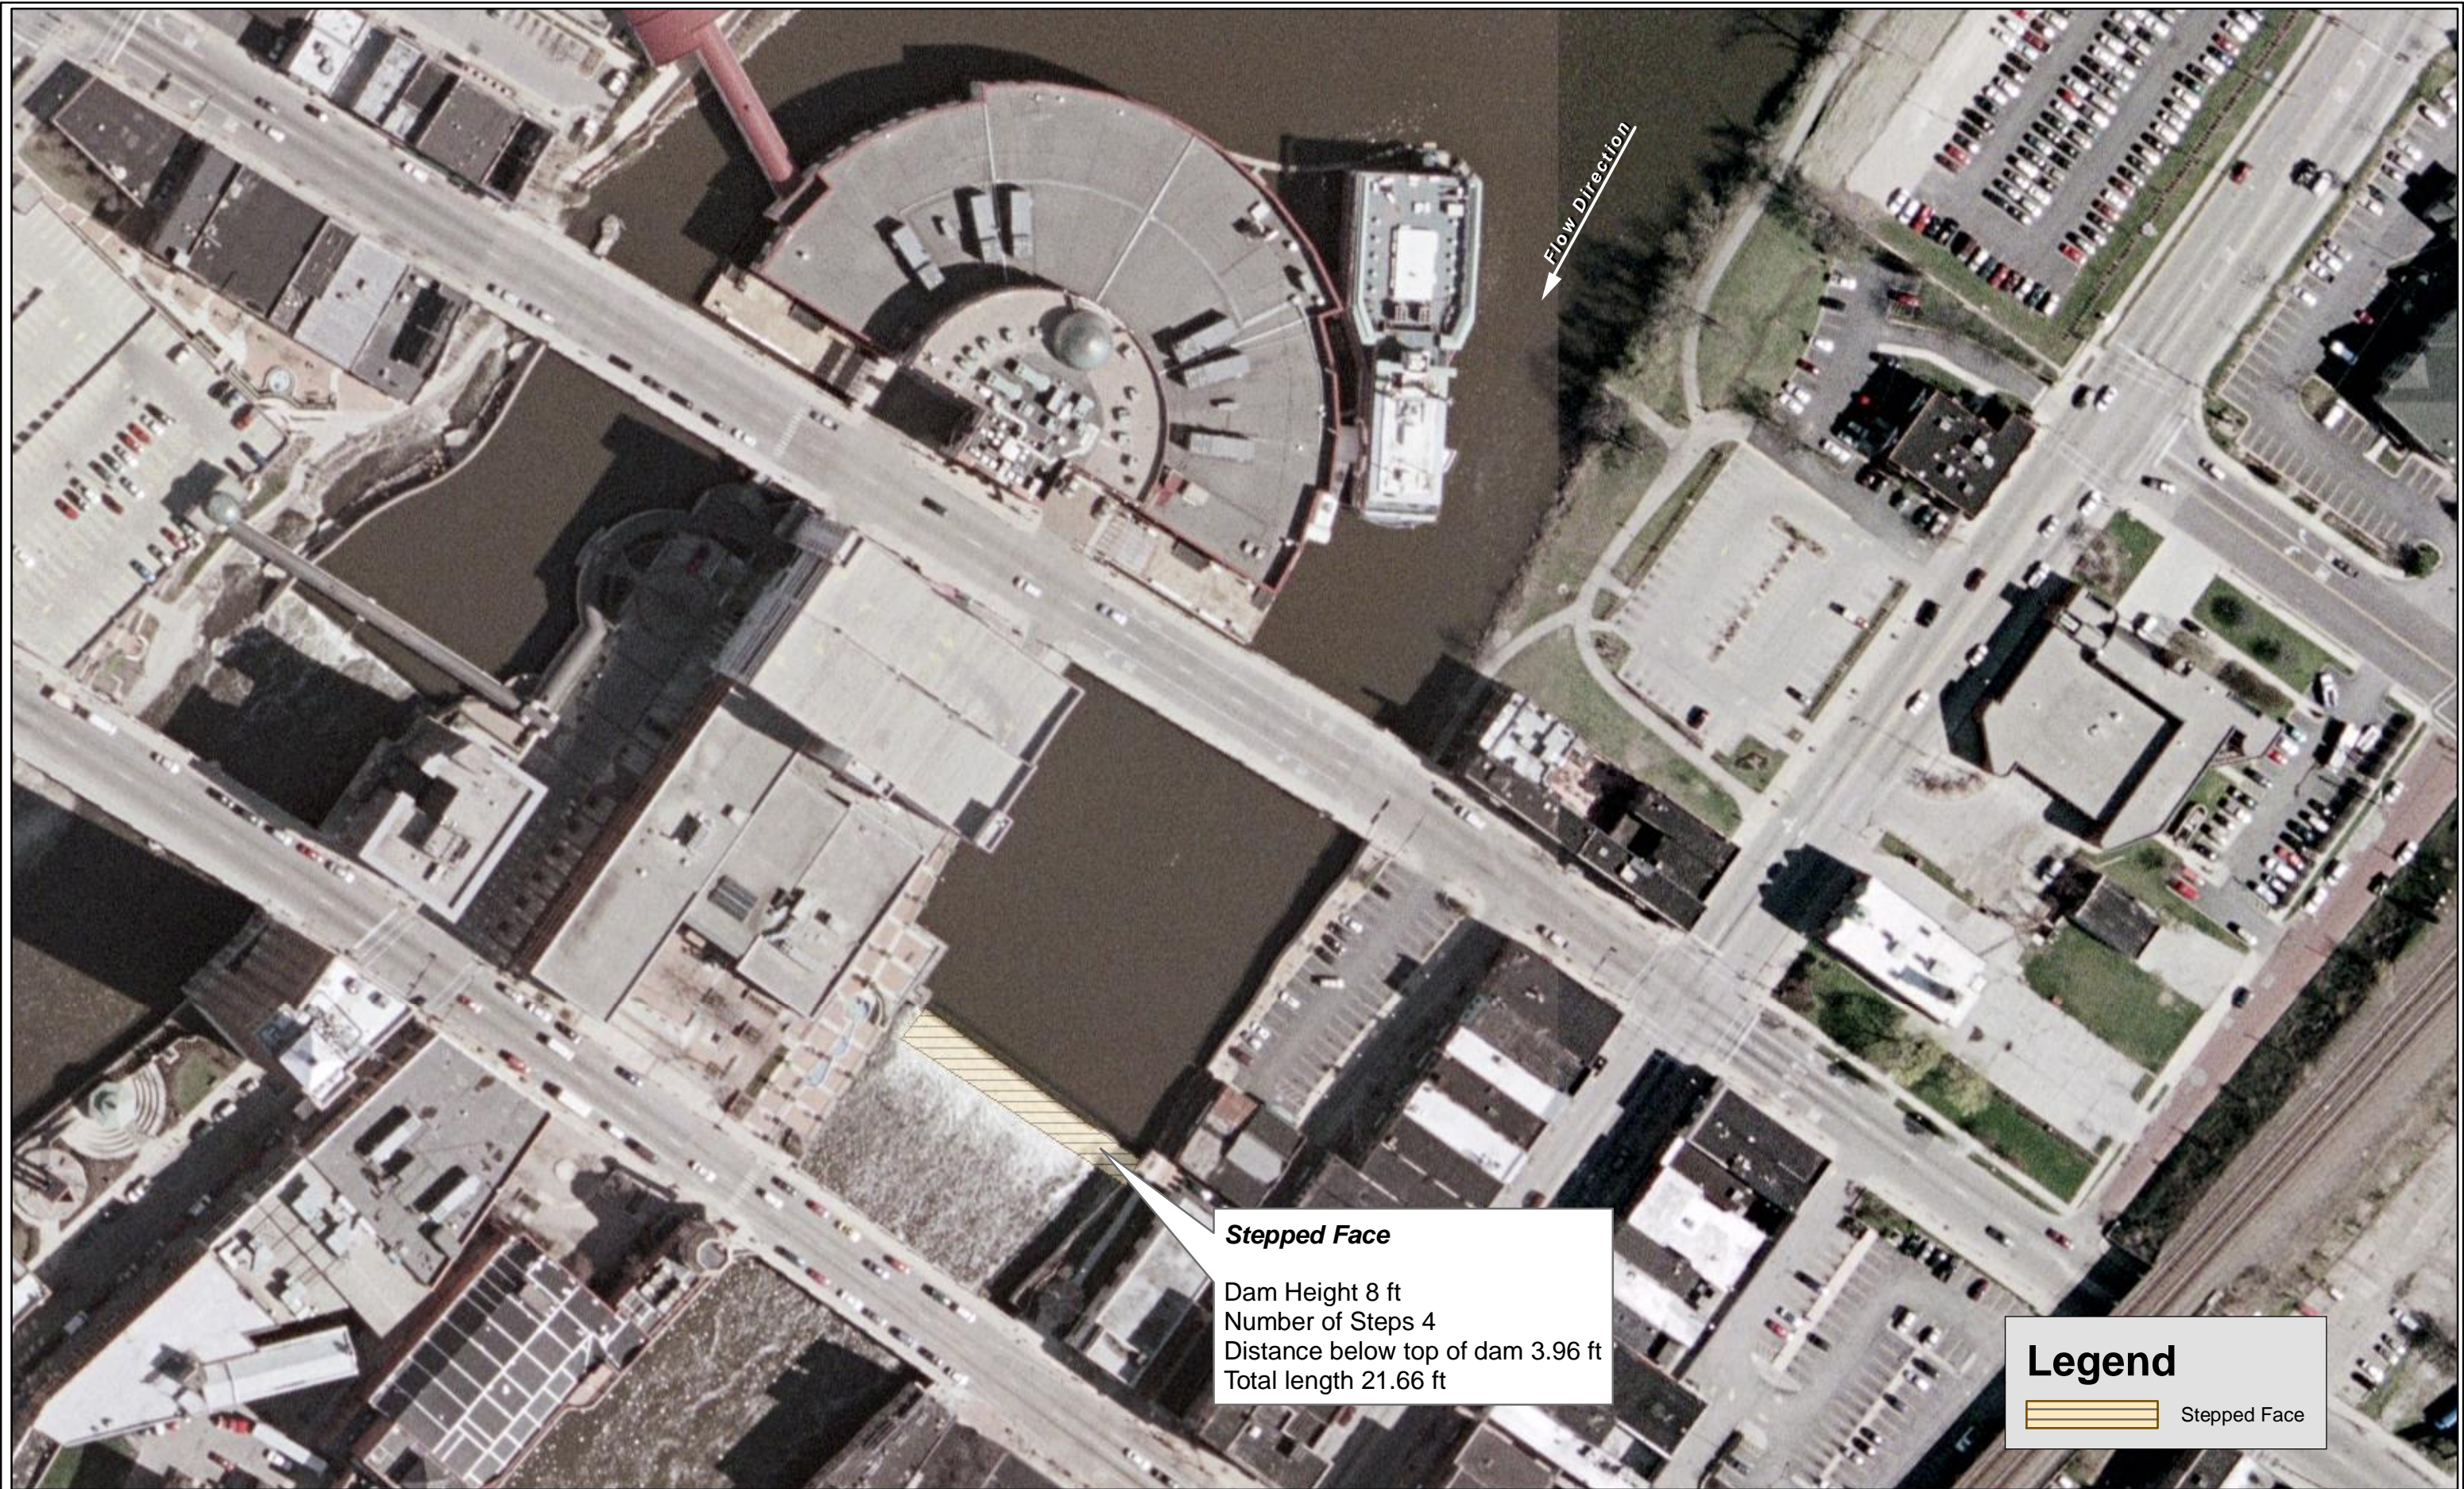
**DAM FACE
 MODIFICATION**

Stepped Face
 Dam Height 8 ft
 Number of Steps 4
 Distance below top of dam 3.96 ft
 Total length 21.66 ft

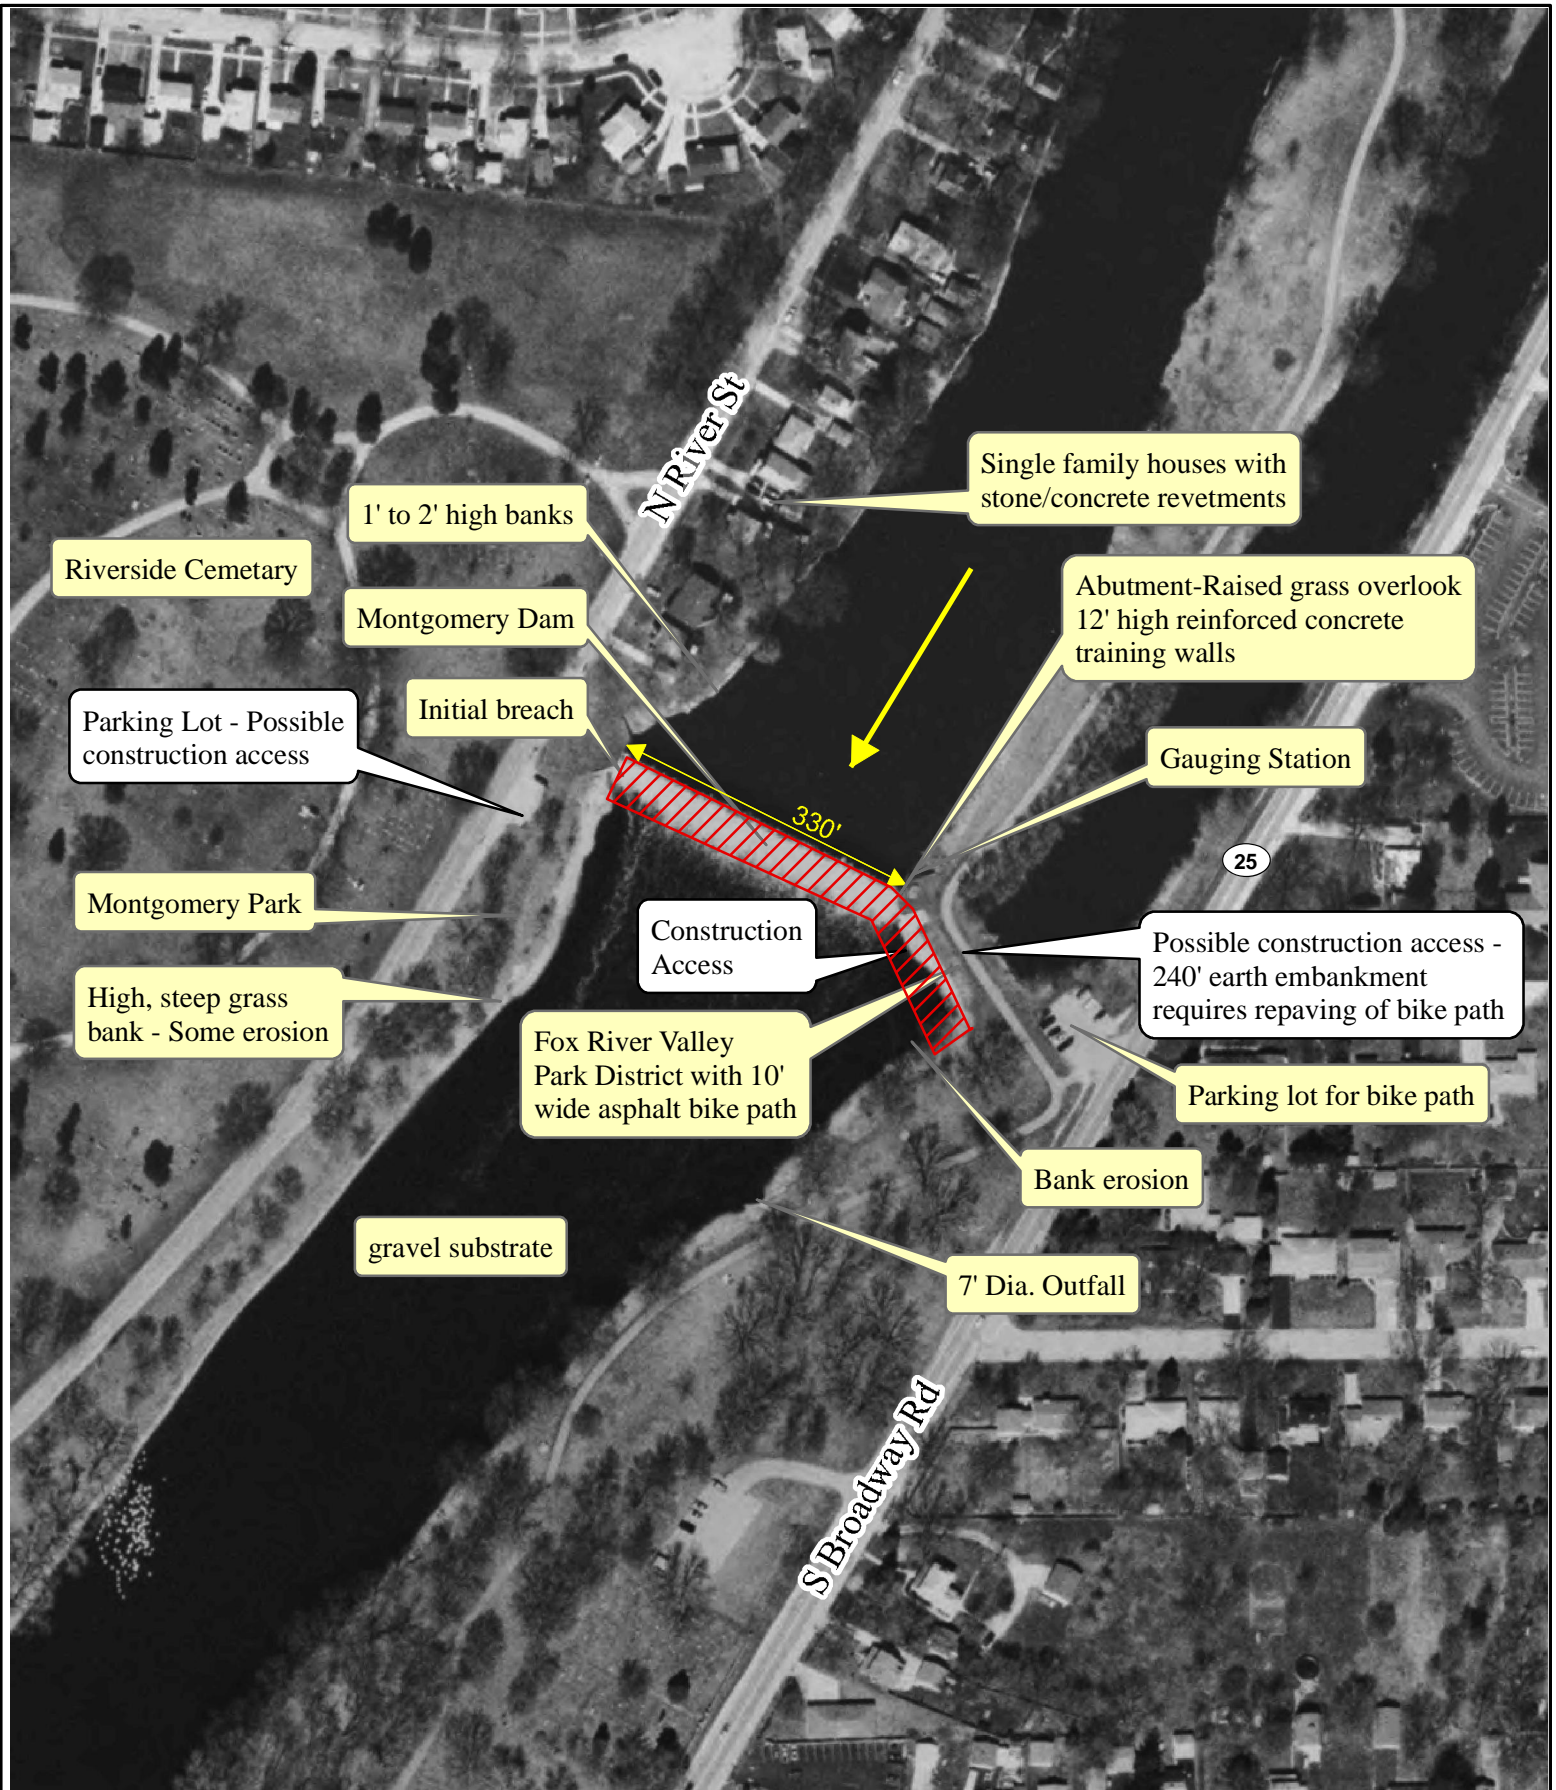
There are no special issues at this dam. As with any dam removal, evaluation of pre- and post-condition velocities, water levels, and sediment management would be necessary.

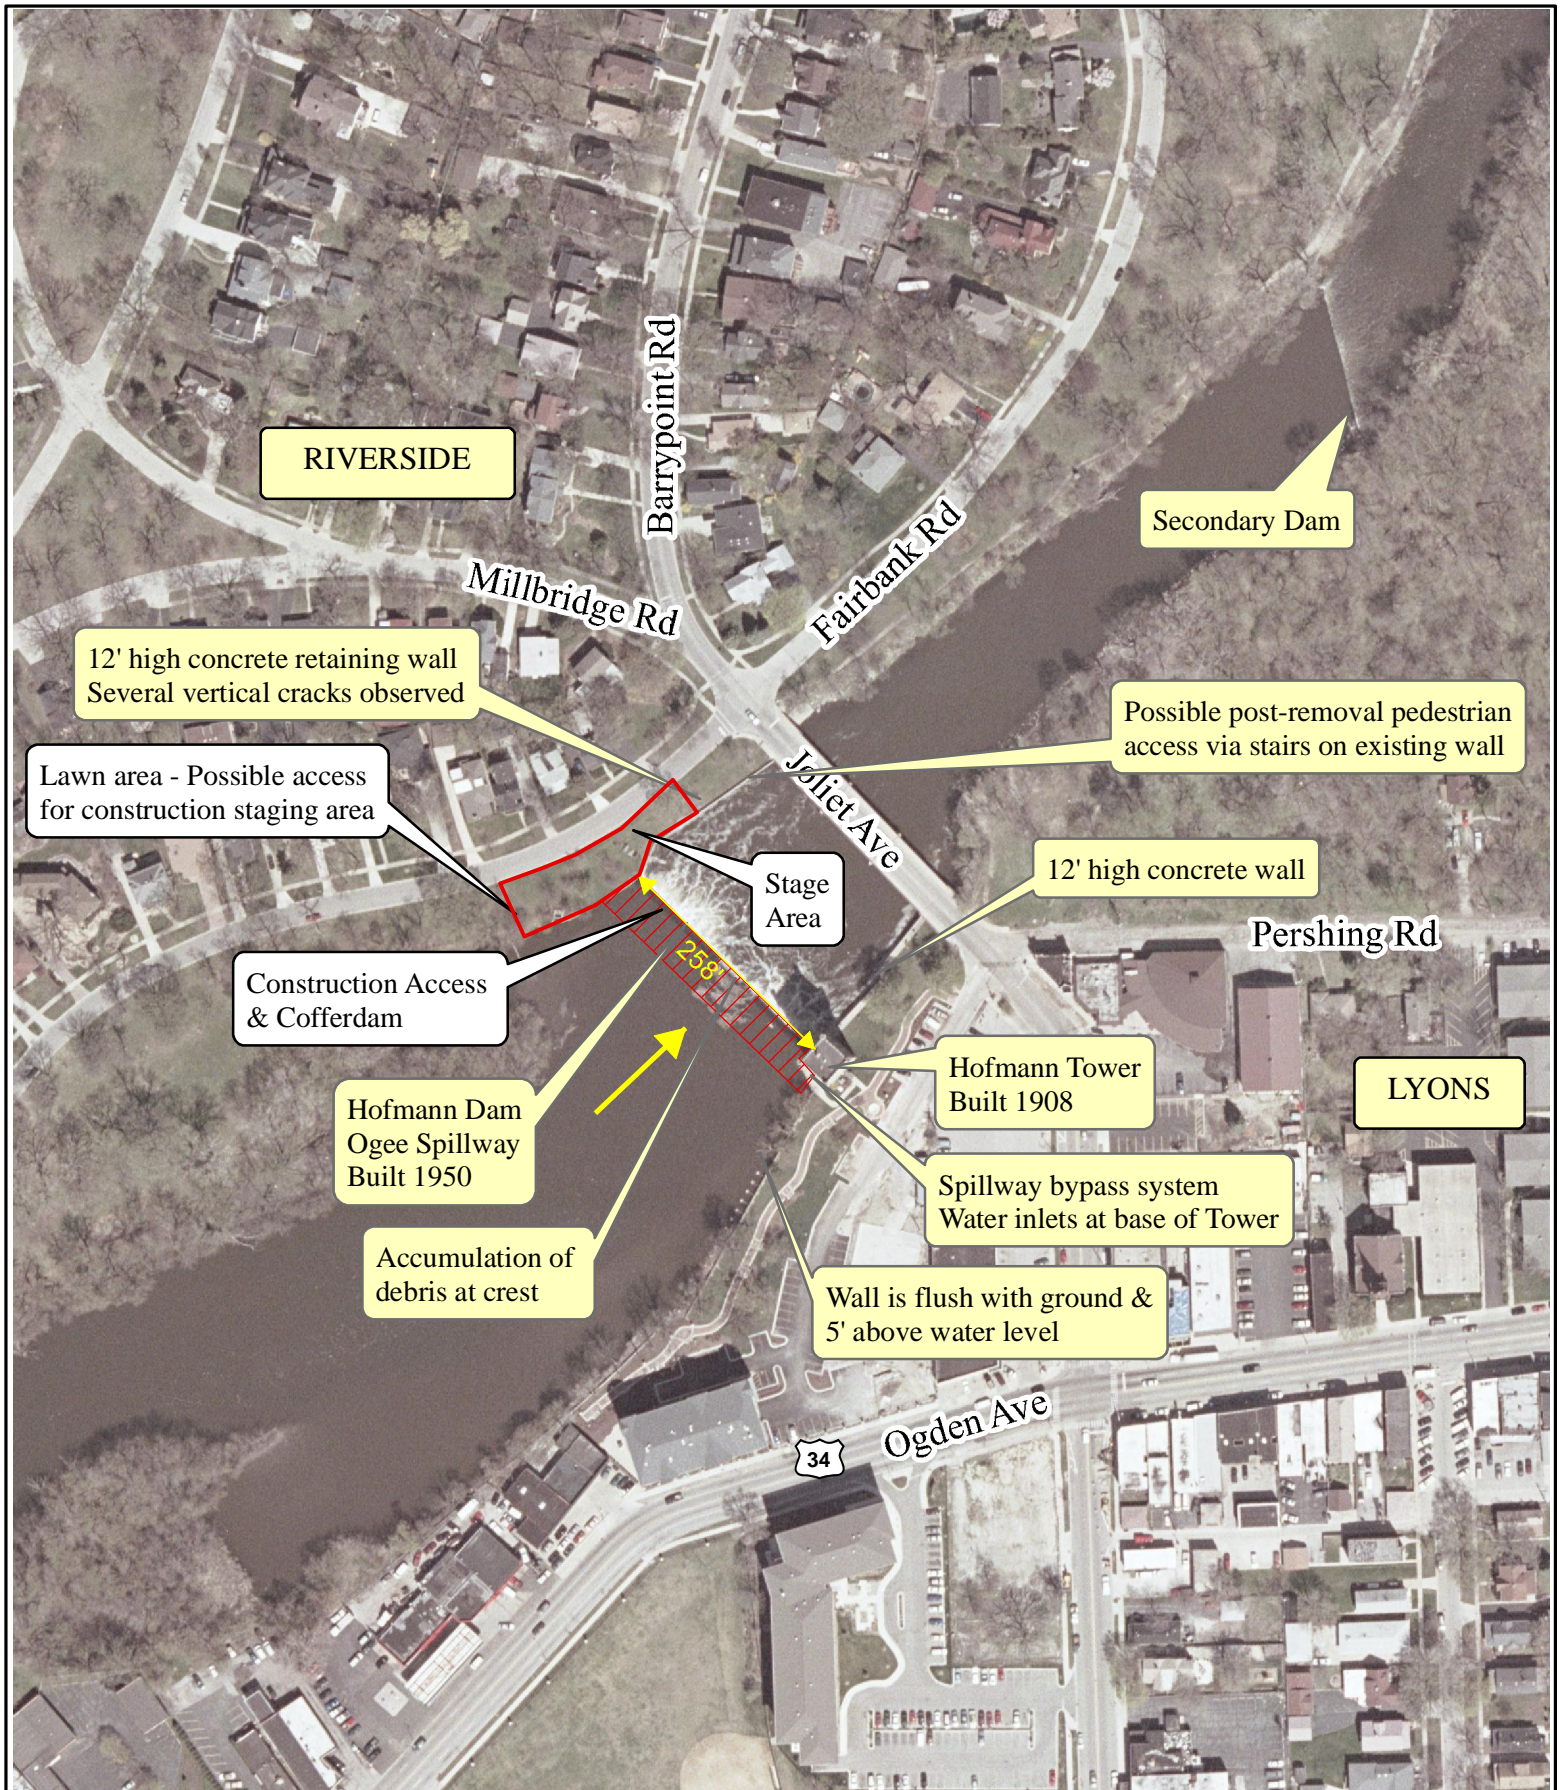
- Pedestrian access to the Des Plaines River from the Village of Lyons side could be accomplished by building upon the existing concrete retaining wall structure extending out along the top of the existing dam to create a walkway and accessway down to the newly created stream bank. Grading in this area can be designed to provide a gradual transition from the higher elevation of the upland to the new edge of river.
- Pedestrian access from the Village of Riverside bank could be accomplished through a new connection to Swan Pond Park or by constructing direct access via stairways leading down from the existing concrete wall.
- As with any dam removal, design will need to consider sediment management, erosion, and post-construction water levels.

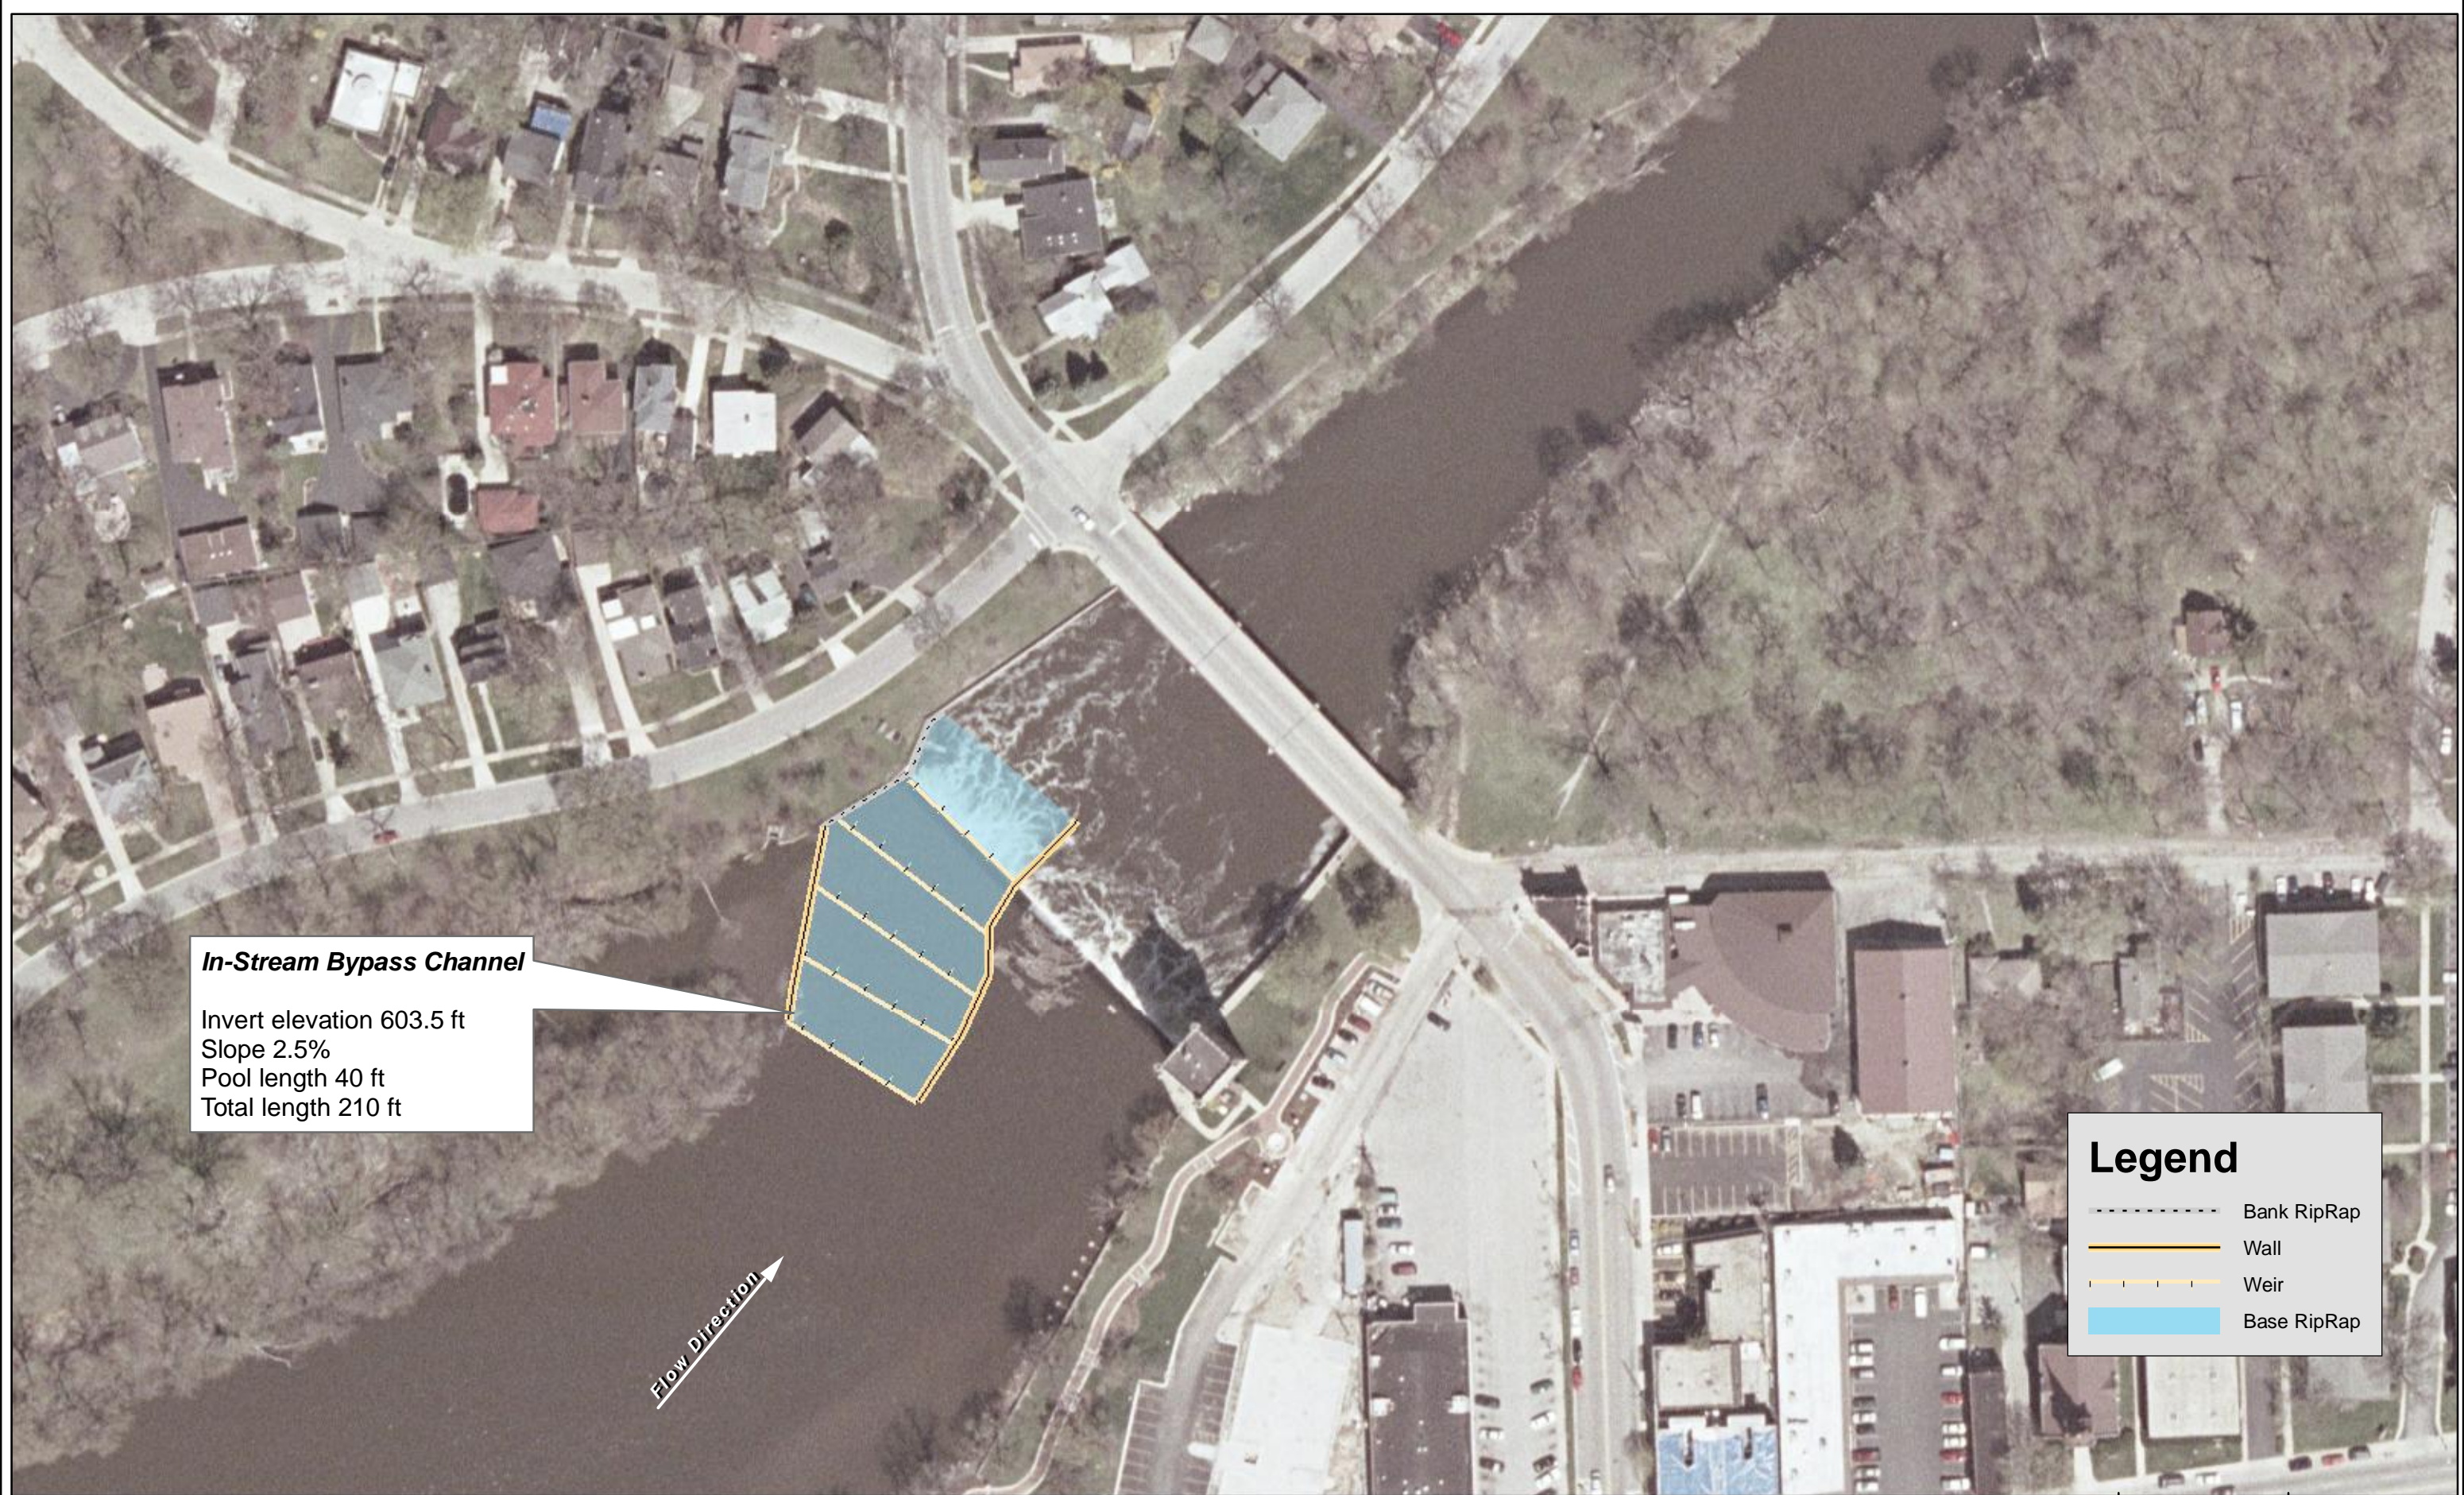
INSTREAM BYPASS

In-Stream Bypass Channel
 Invert elevation 603.5 ft
 Slope 2.5%
 Pool length 40 ft
 Total length 210 ft
