Evaluation of Public Safety at Run-of-River Dams

4.7 *Rock River Dams*

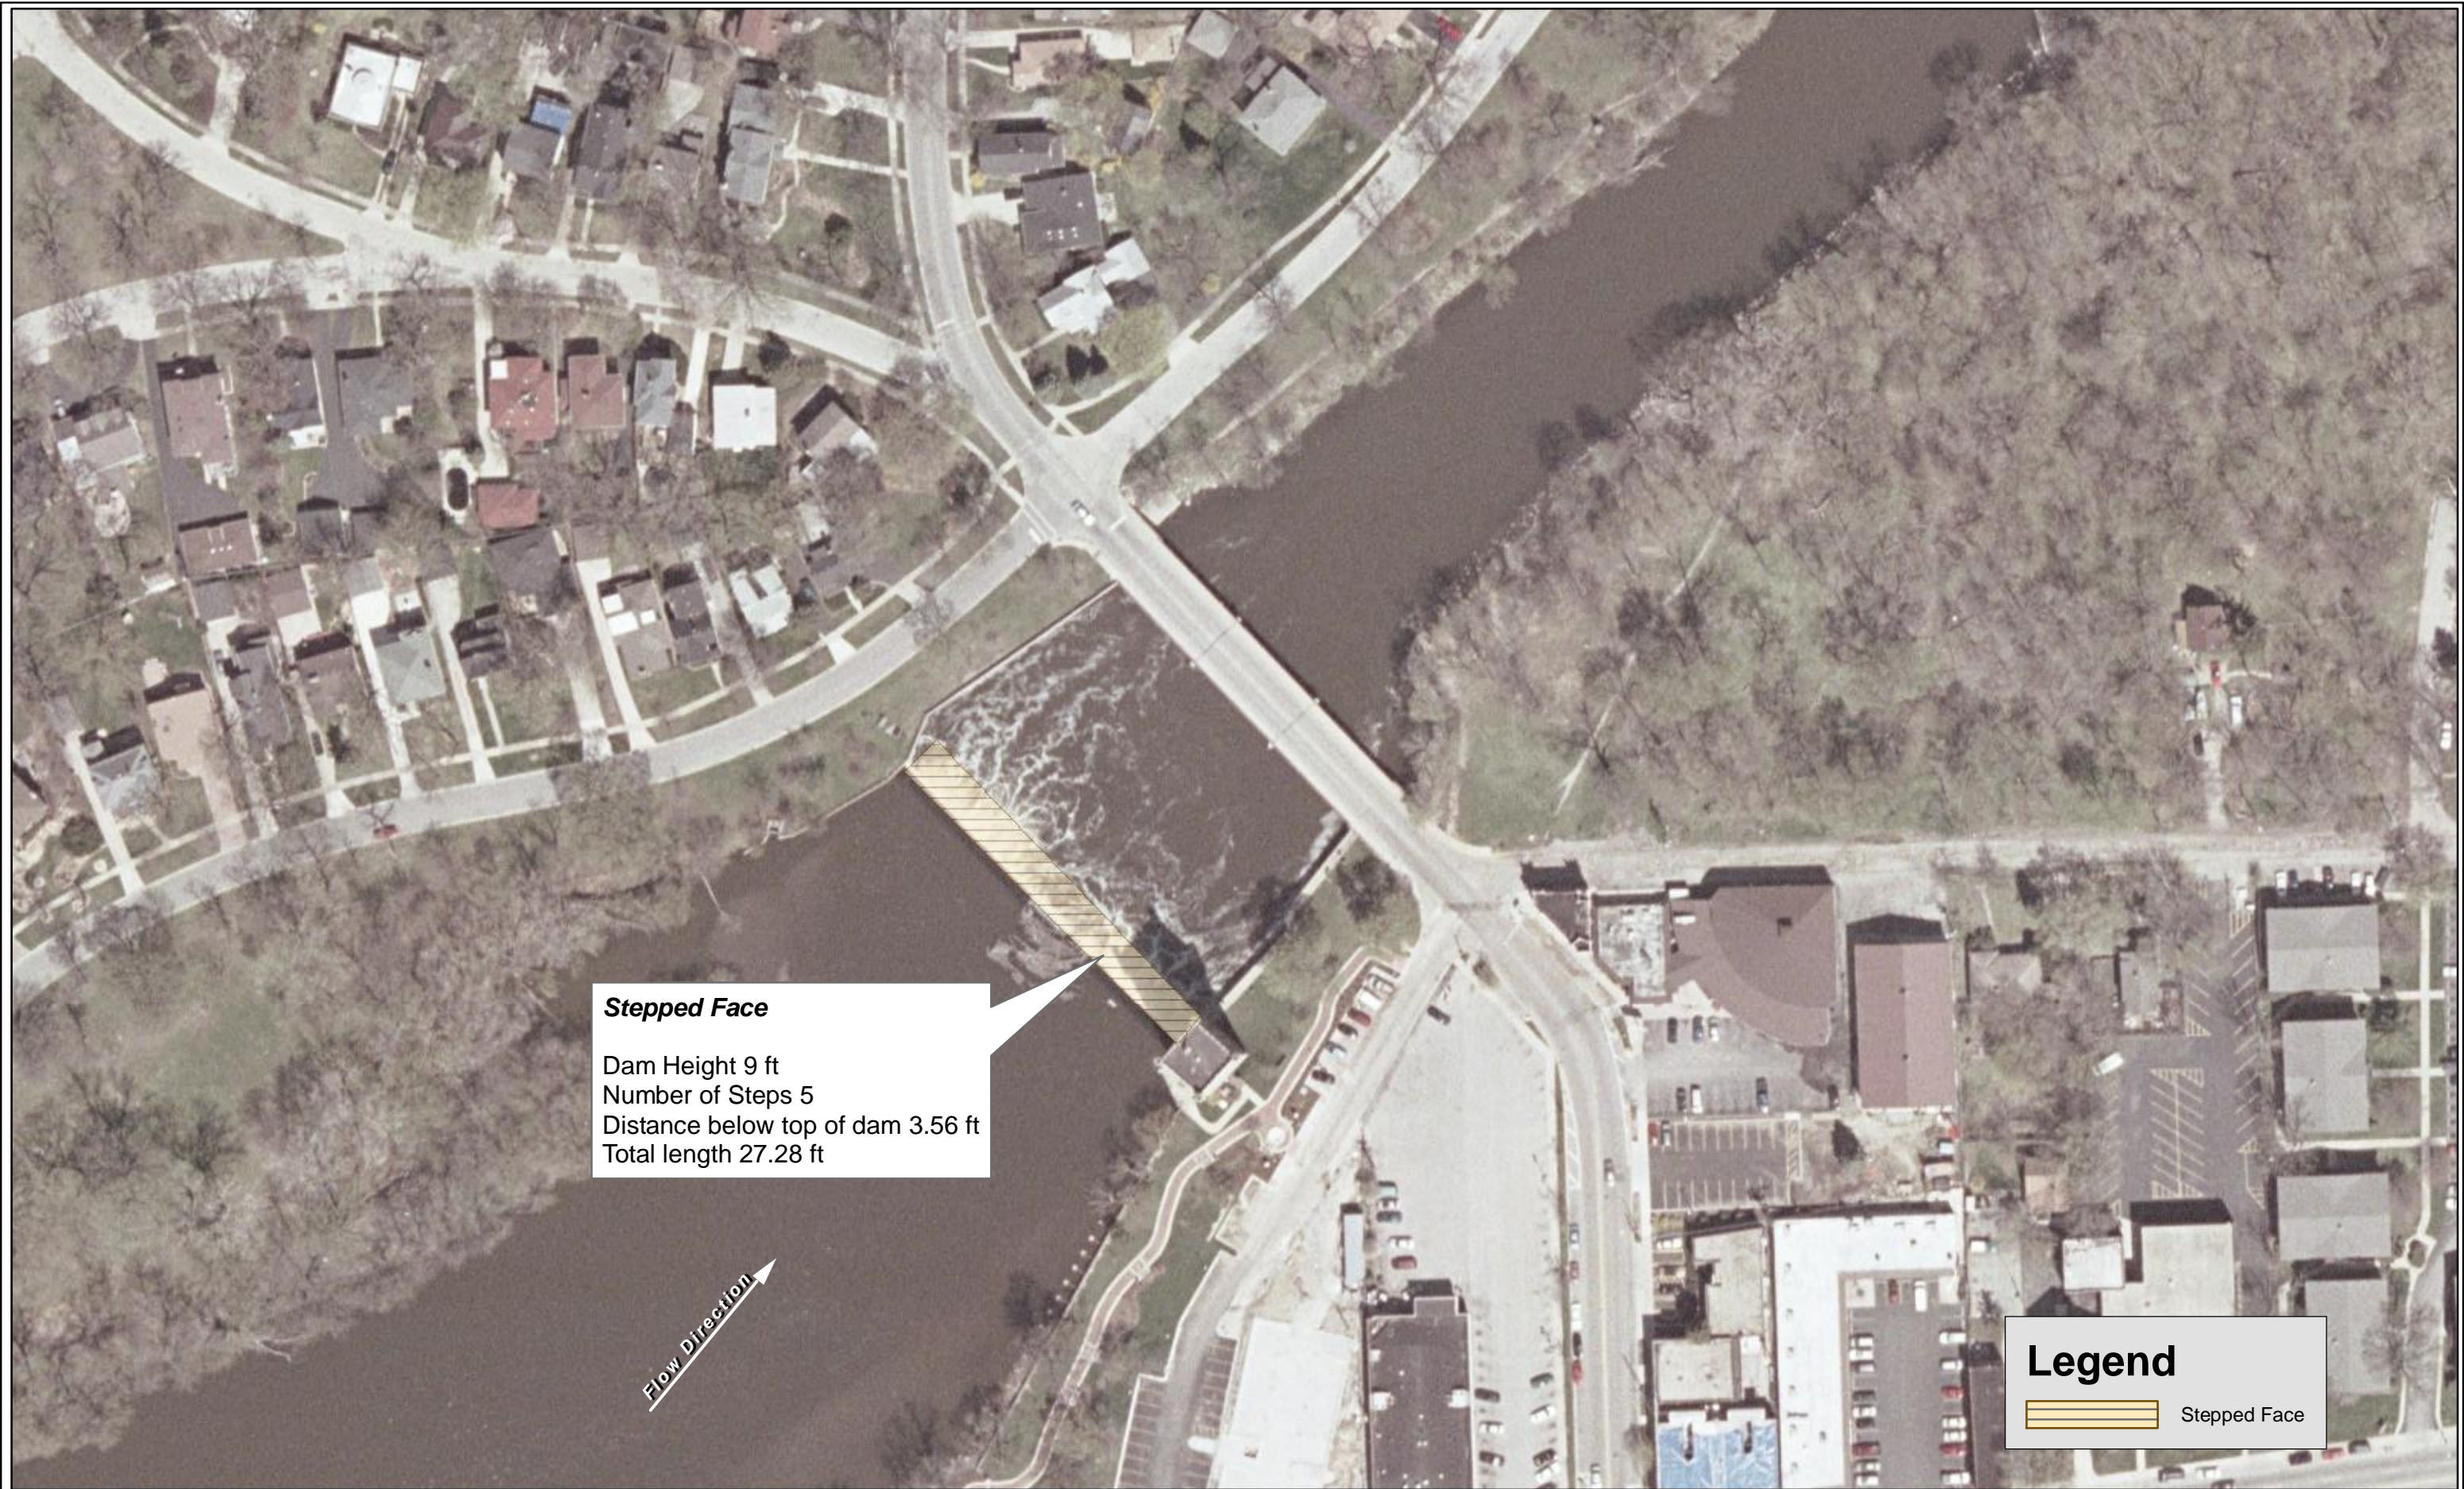
**DAM FACE
 MODIFICATION**

Stepped Face
 Dam Height 9 ft
 Number of Steps 5
 Distance below top of dam 3.56 ft
 Total length 27.28 ft

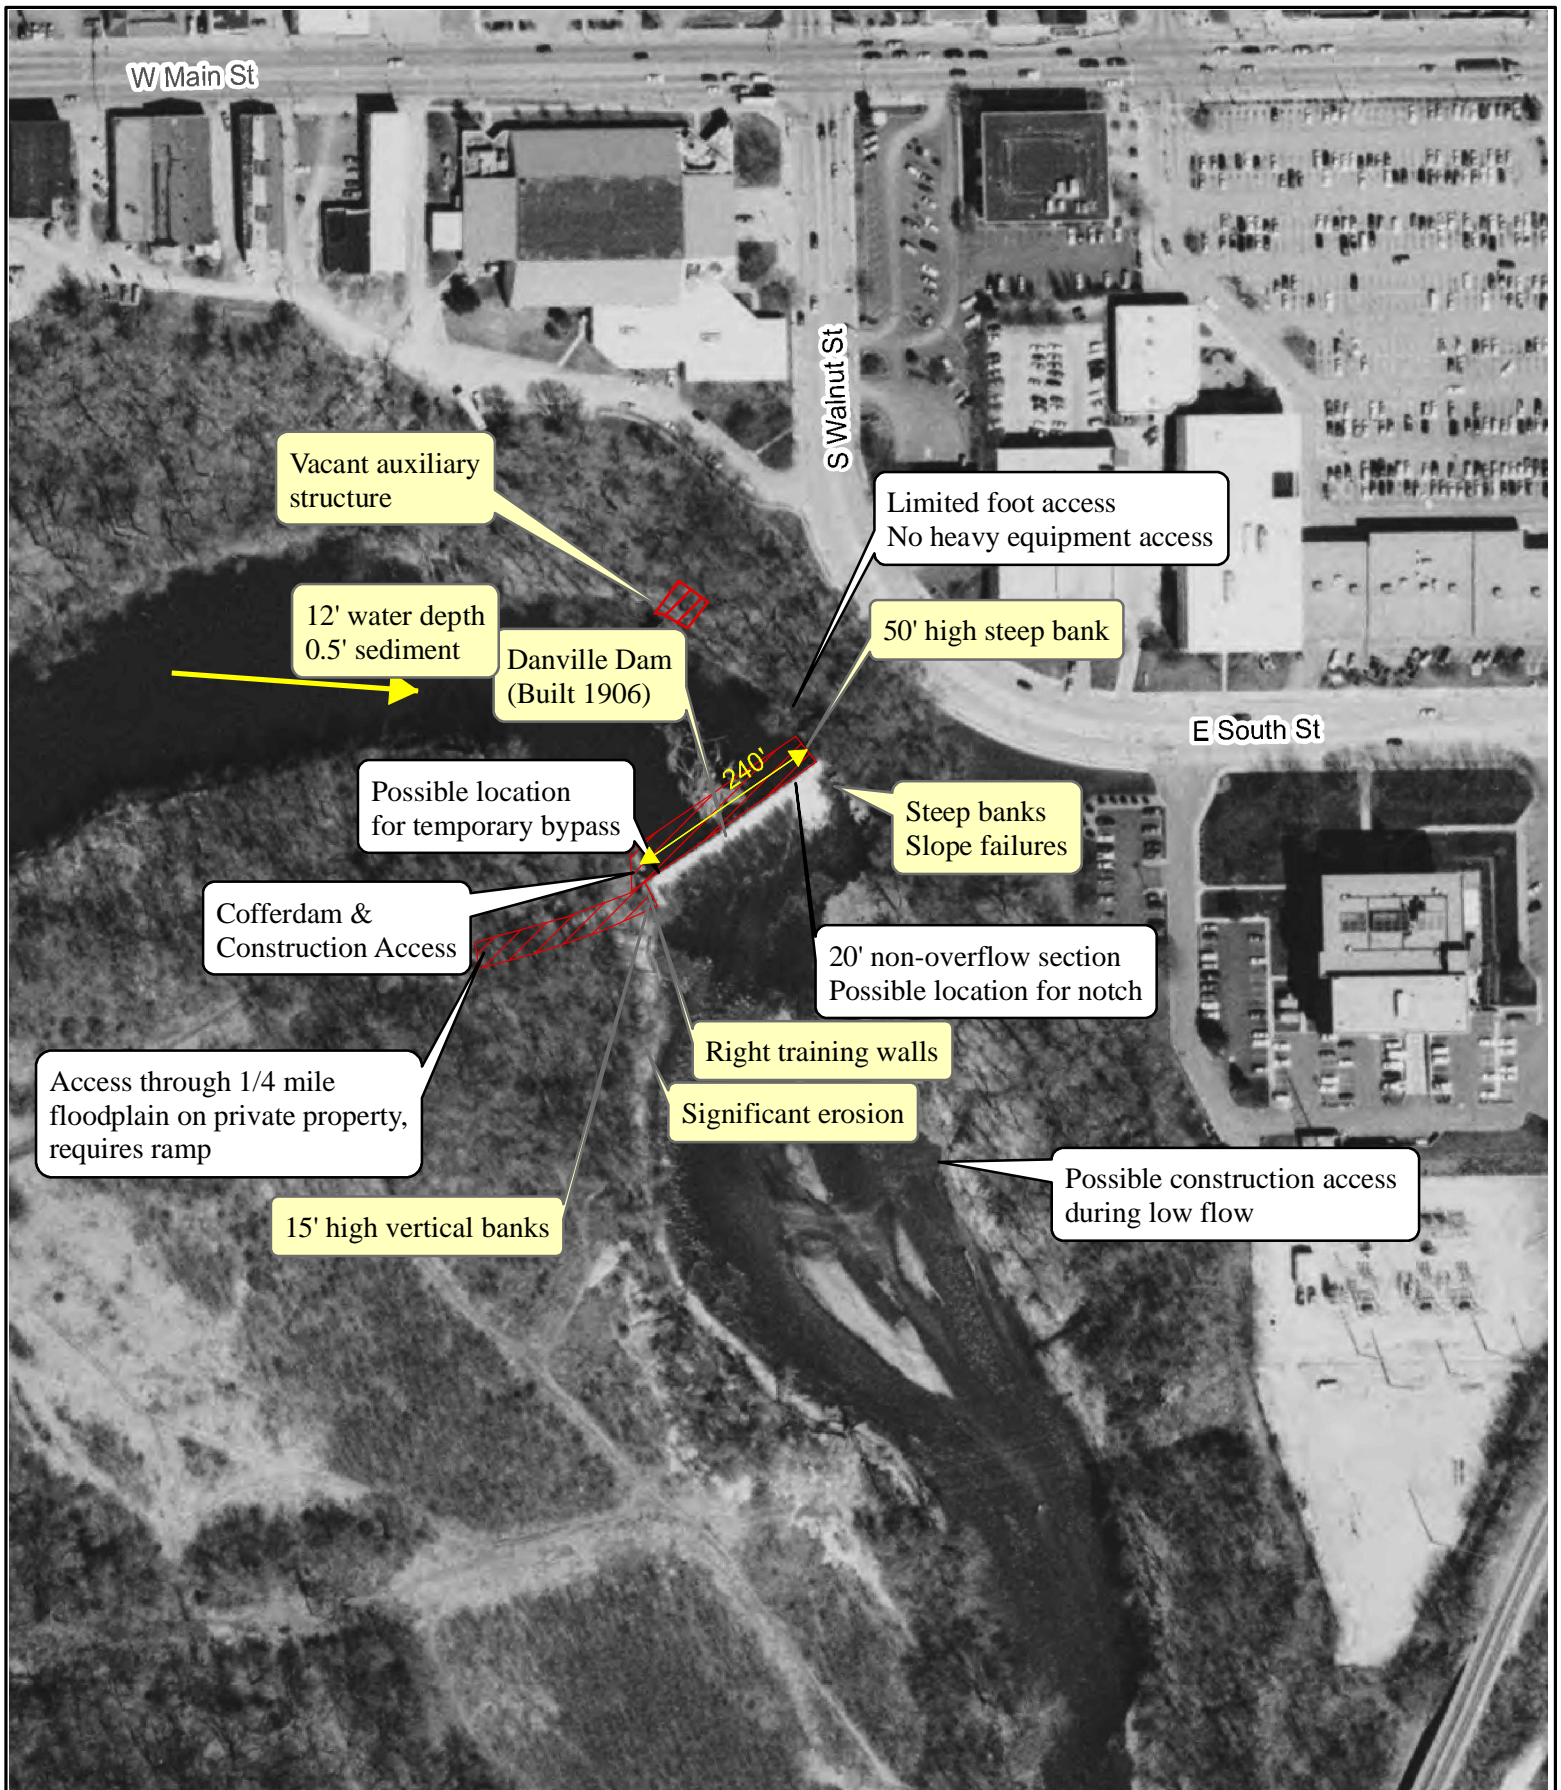
- The left and right banks downstream of the dam are both erosion-prone and could collapse if drawdown waters cause asymmetric flow or eddies. The upstream banks may also be prone to severe erosion, unless stabilized, after drawdown.
- The Route 150 bridge over the main stem and 136 bridge over the north fork upstream of the dam both have piers in the water that could be prone to scour and need to be checked, along with the Ellsworth Park area channel, dams, and outfalls.
- Secondary structures, namely concrete piers, at the Danville Dam should be secured or removed. They are an unattractive nuisance.

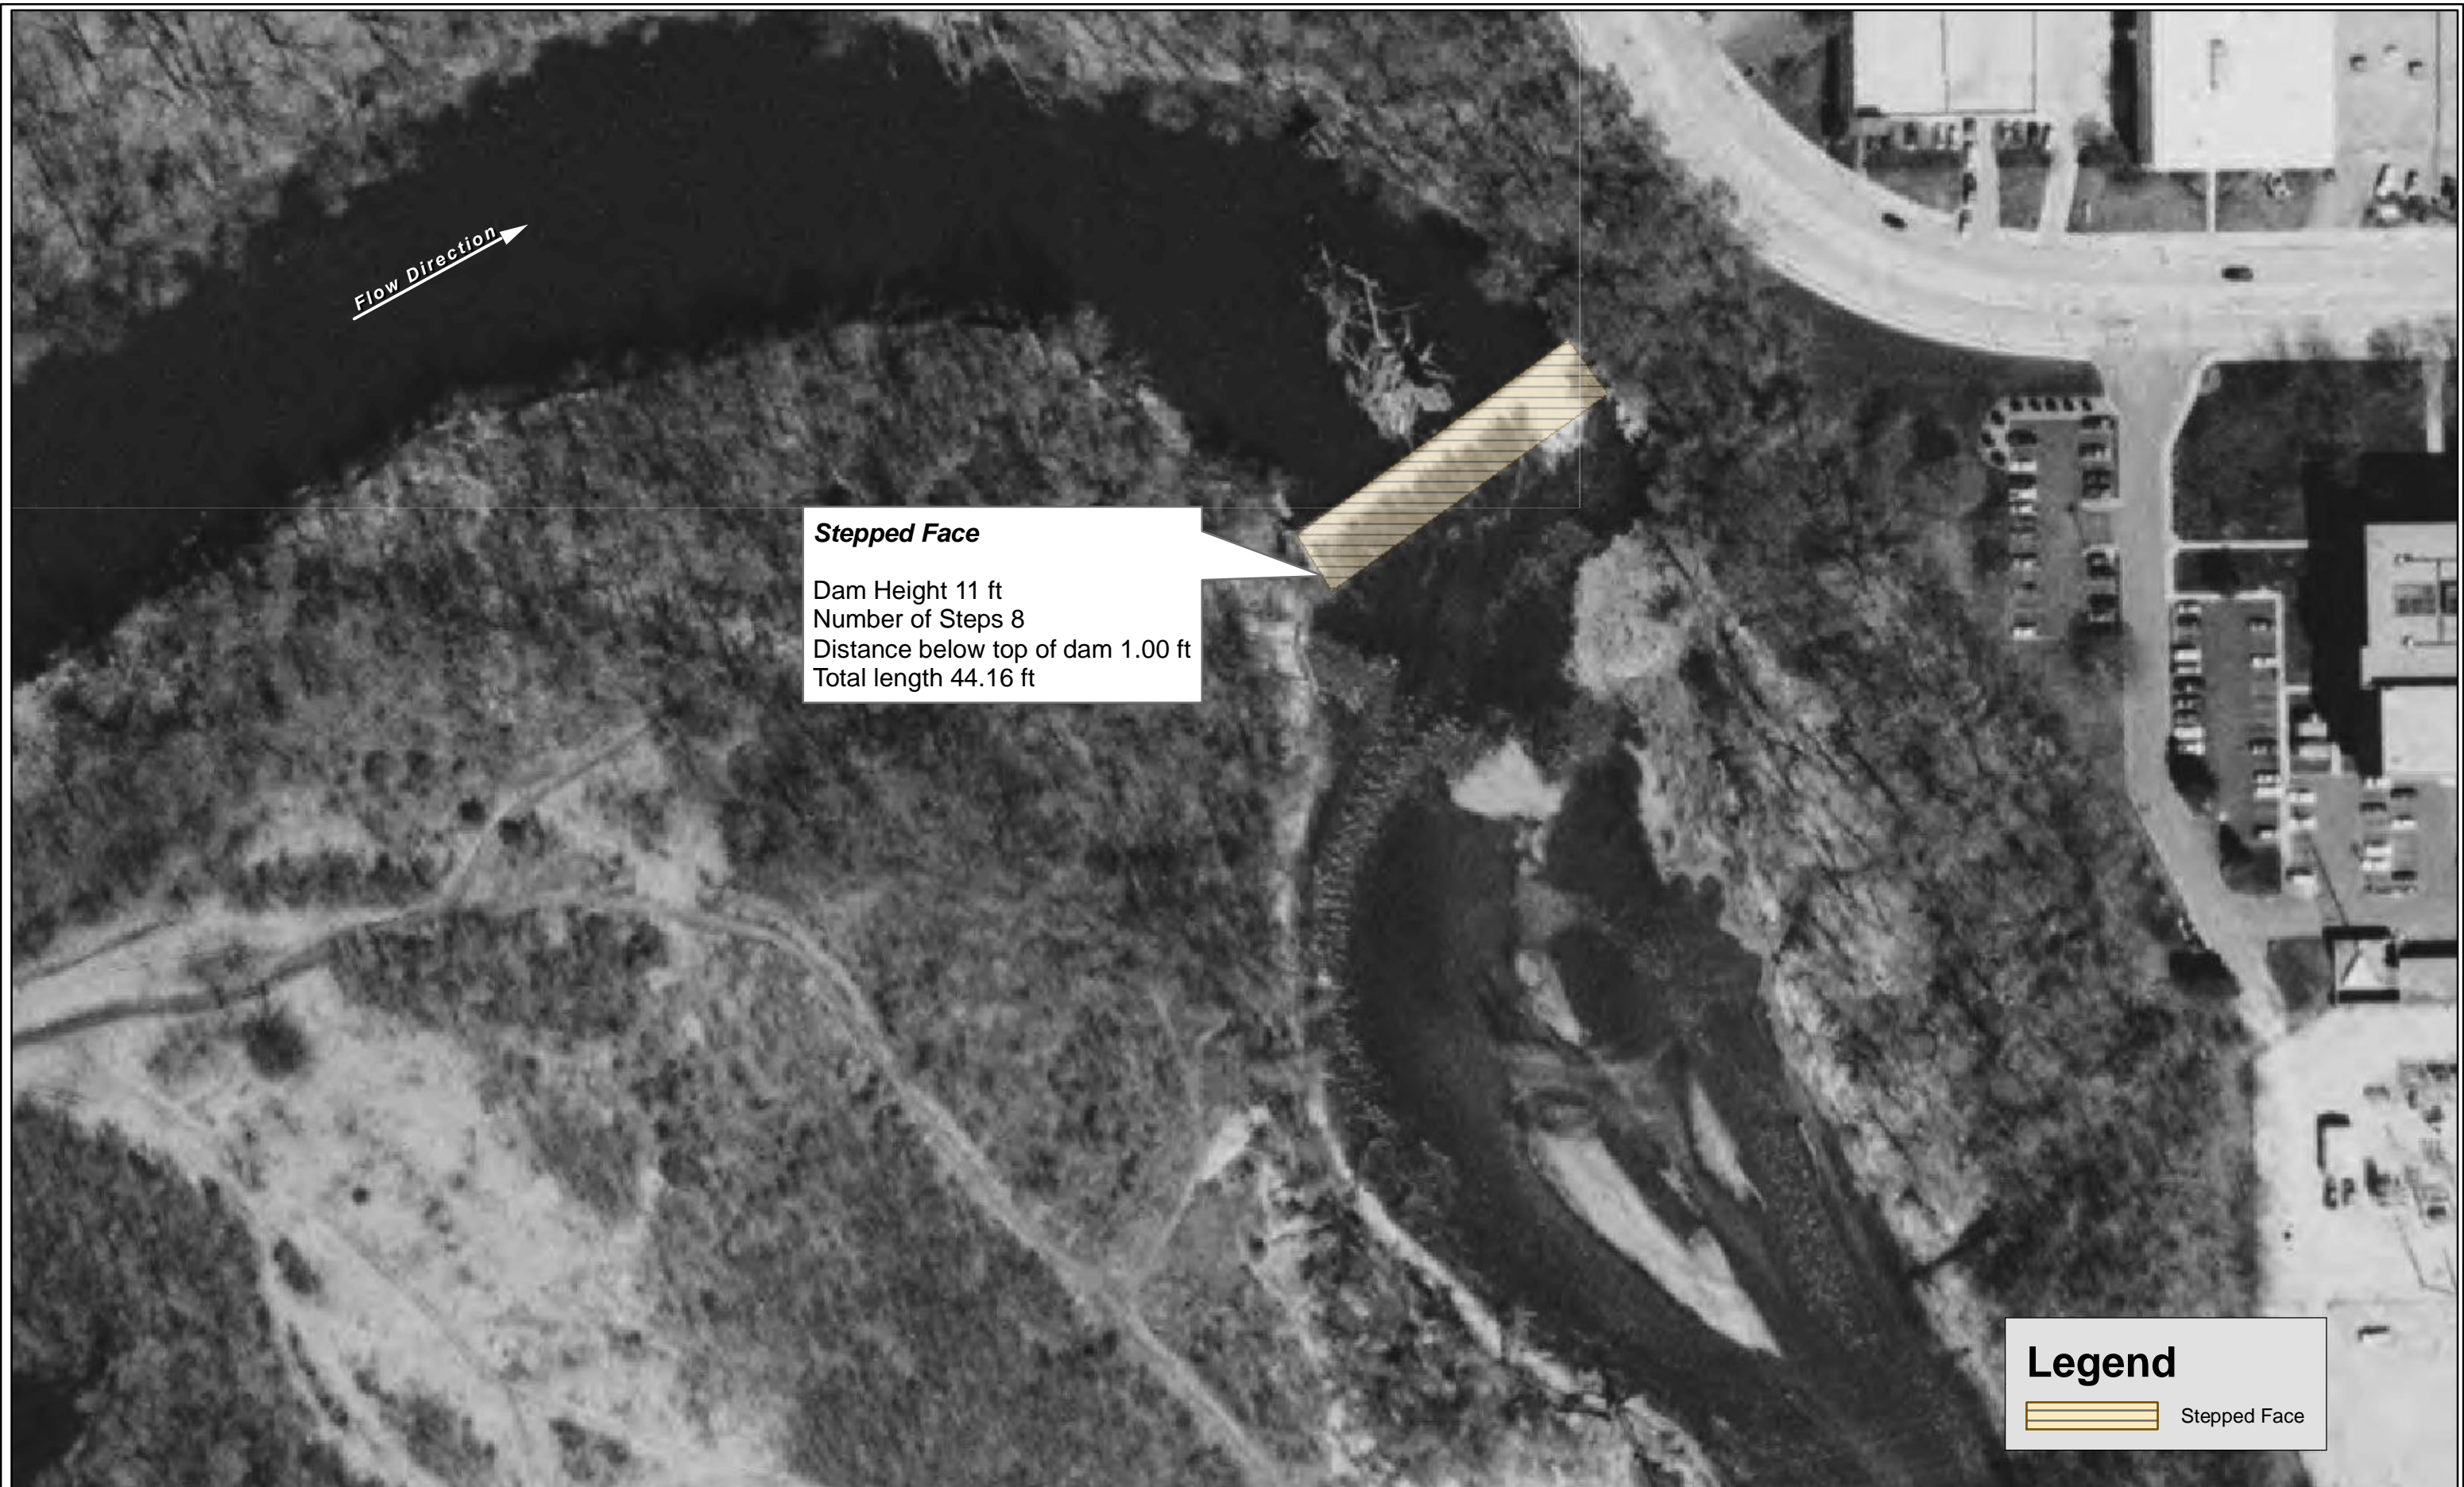
**DAM FACE
 MODIFICATION**

Stepped Face
 Dam Height 11 ft
 Number of Steps 8
 Distance below top of dam 1.00 ft
 Total length 44.16 ft

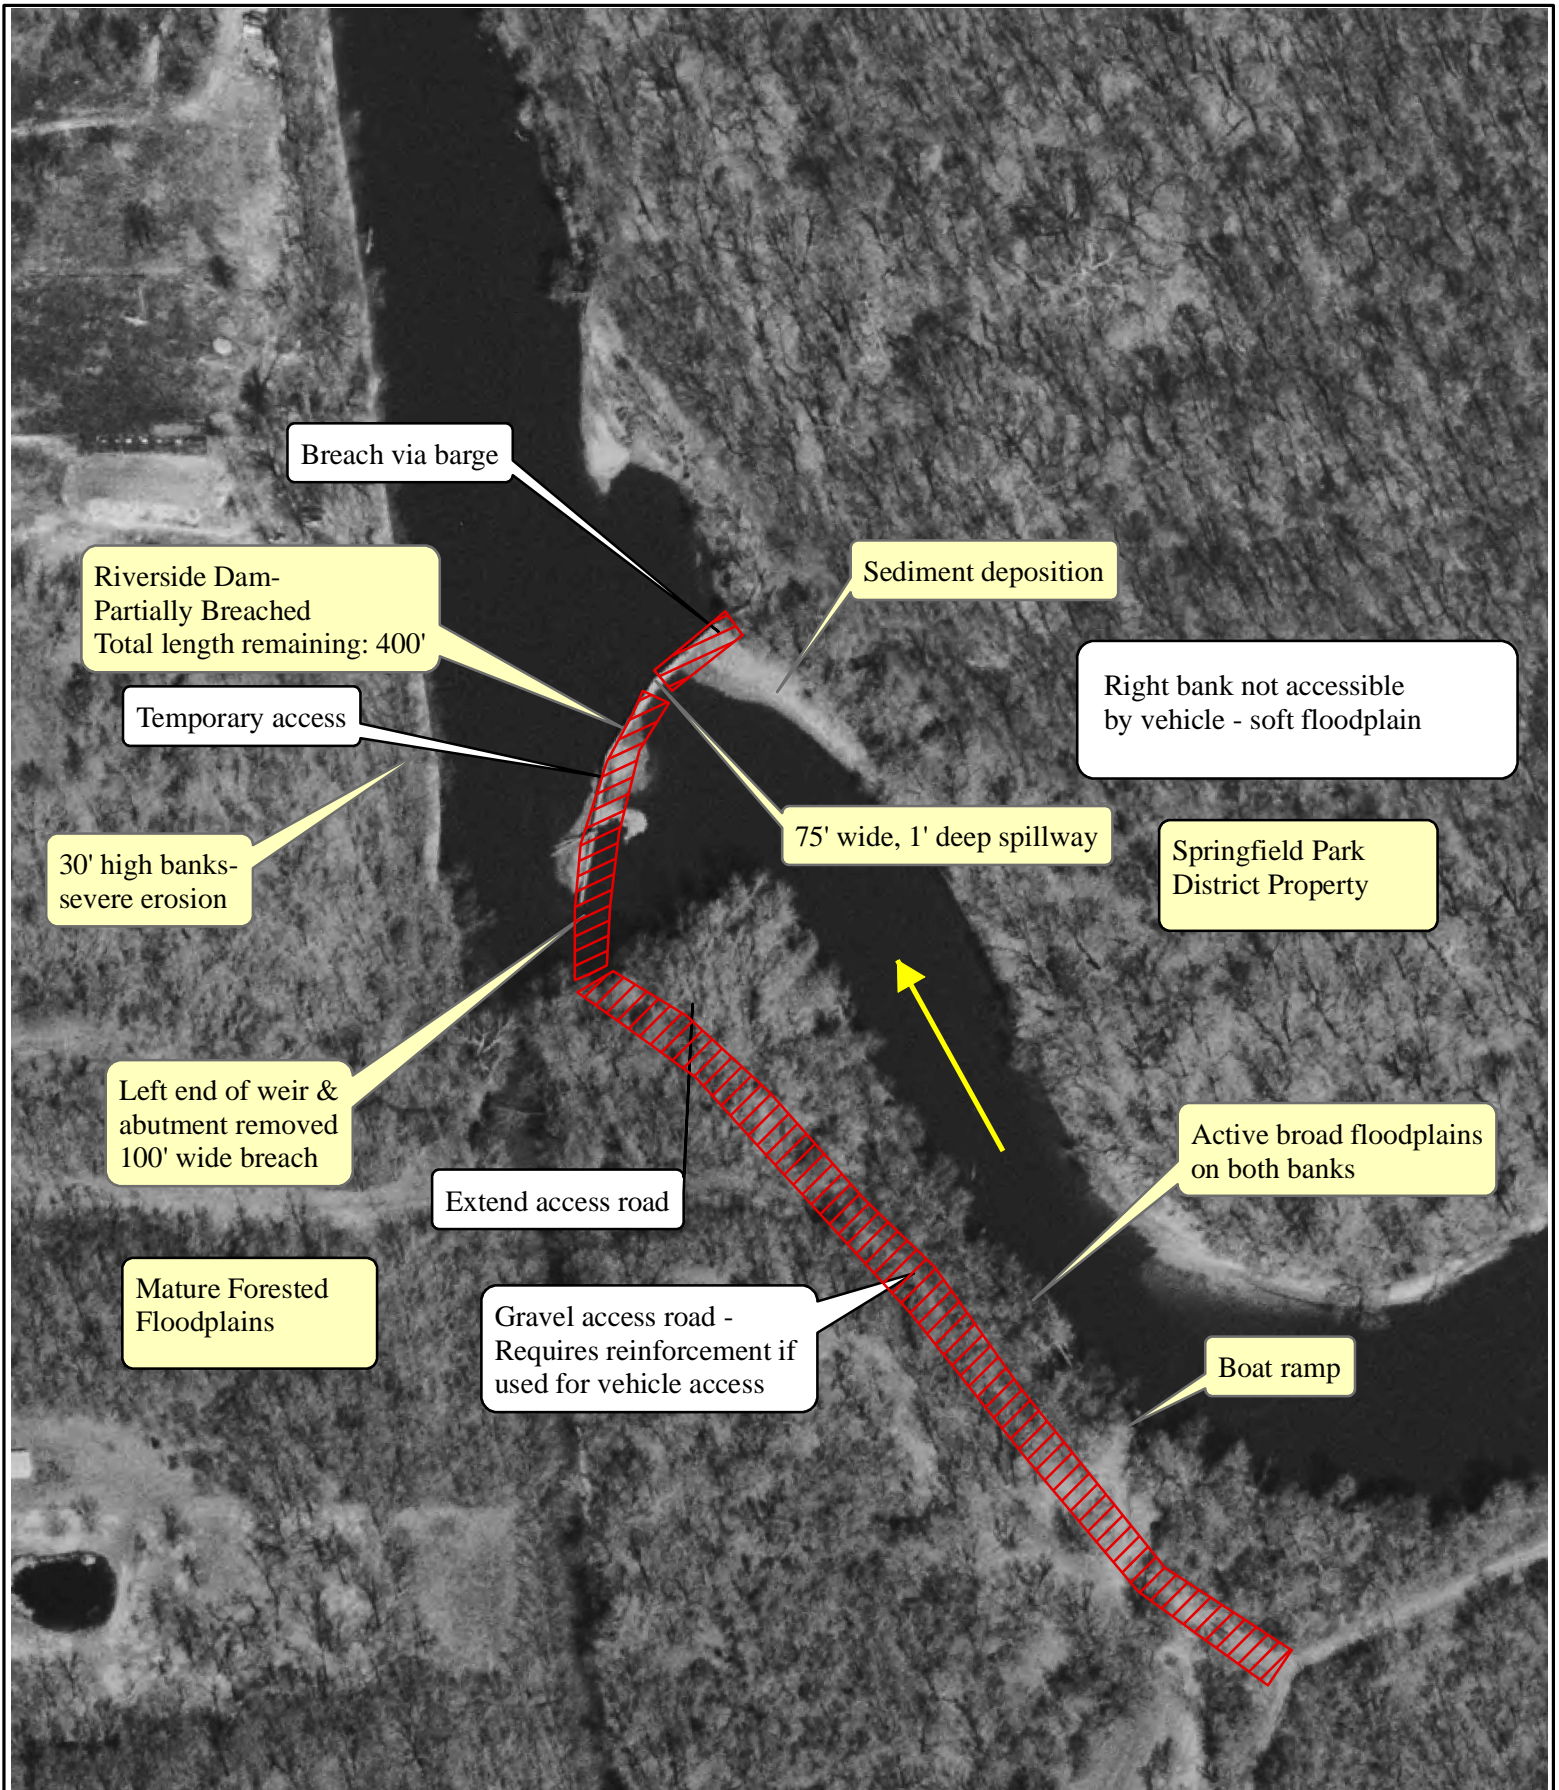
- The light duty gravel access road from Old Water Works Road to the dam was probably used to construct the original dam and to more recently to breach the left end. This road cannot withstand heavy or extensive traffic for construction equipment and will need to be reinforced with stone for support.
- The area surrounding the dam is subject to flooding and has several vernal pools. There may be wetland regulatory issues.

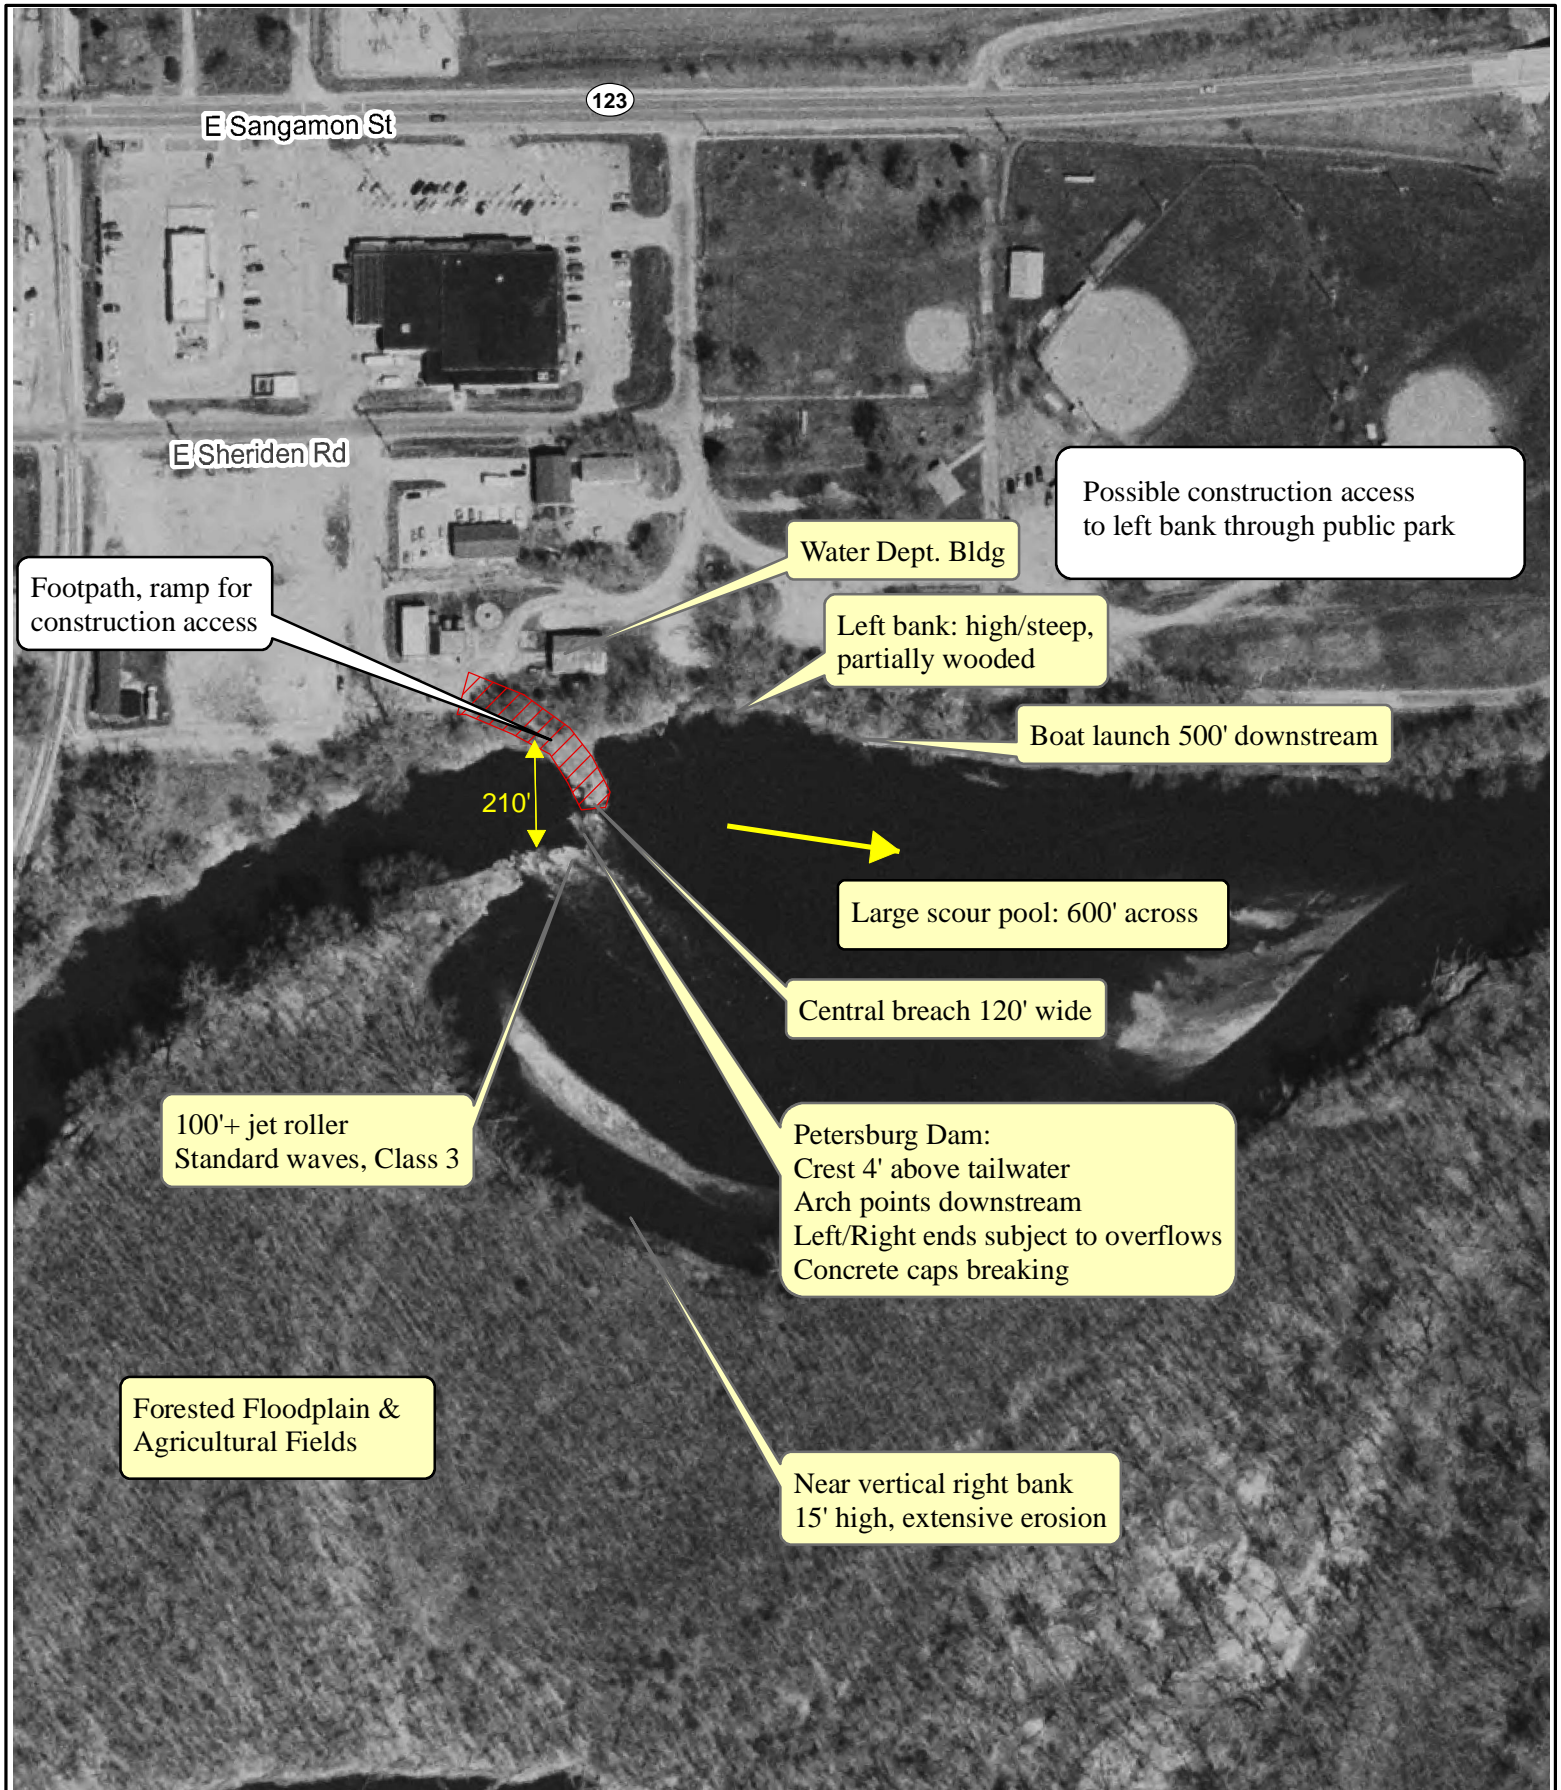
- The City of Petersburg Water Department appears to have a water supply well in the public park downstream of the dam. Water quality protection measures during construction would need to be implemented.
- There is extensive bank erosion downstream of the dam on the right bank.
- The left bank, partially armored with demolition waste concrete, is also susceptible to toe erosion. Removal design will need to consider the position, shape and power of the flow jet.
