Evaluation of Public Safety at Run-of-River Dams

An Illinois Statewide Program

July 20, 2007

CTE | AECOM

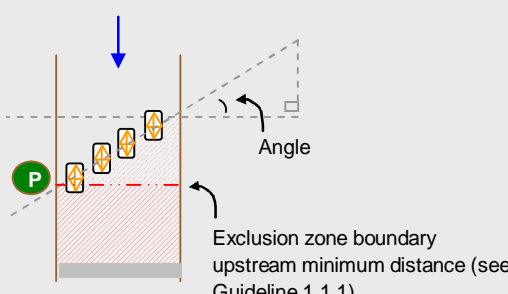
Guideline	Sign (see Table 2.3-2)
<p>1.2.5 - When approved portages are located at the edge of the exclusion zone, buoy lines should be angled to direct river users to the portage (see Figure 1.2.5-1). The angle should be large enough to be apparent to upstream river users (approximately 10 to 30 degrees).</p> <p>Figure 1.2.5-1</p>

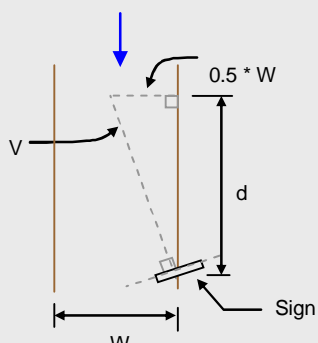
Guideline	Sign (see Table 2.3-2)
<p>1.3.4 - Signage Guidelines 1.3.1 and 1.3.2 should be designed such that the <i>largest text</i> (i.e., $1.5 \cdot A$) is readable from the center of the river at a minimum distance V (see Figure 1.3.4-1 and Eq. 1.3.4-1). When the immediate river width (dimension W) is less than or equal 300 ft, a minimum value of 300 ft should be used for dimension d. When the immediate river width is greater than 300 ft, a minimum value of 300 ft plus $\frac{1}{2} \cdot (\text{river width} - 300 \text{ ft})$ should be used for dimension d. Color palletes and font styles equivalent to Sign Standards Manual¹ should be used. If the signage is not visible from the required distance due to an obstruction in the river, additional signage should be placed upstream of the obstruction.</p> <p>Equations 1.3.4-1 and 1.3.4-2 are used to determine font and sign size, where A, <i>the font size</i>, is in inches.¹</p> <p>Eq. 1.3.4-1 $V = \sqrt{d^2 + (0.5 \cdot W)^2}$</p> <p>Eq. 1.3.4-2 $A = \left(\frac{V}{28} \right) \cdot \frac{1}{1.5}$</p> <p>Figure 1.3.4-1</p>

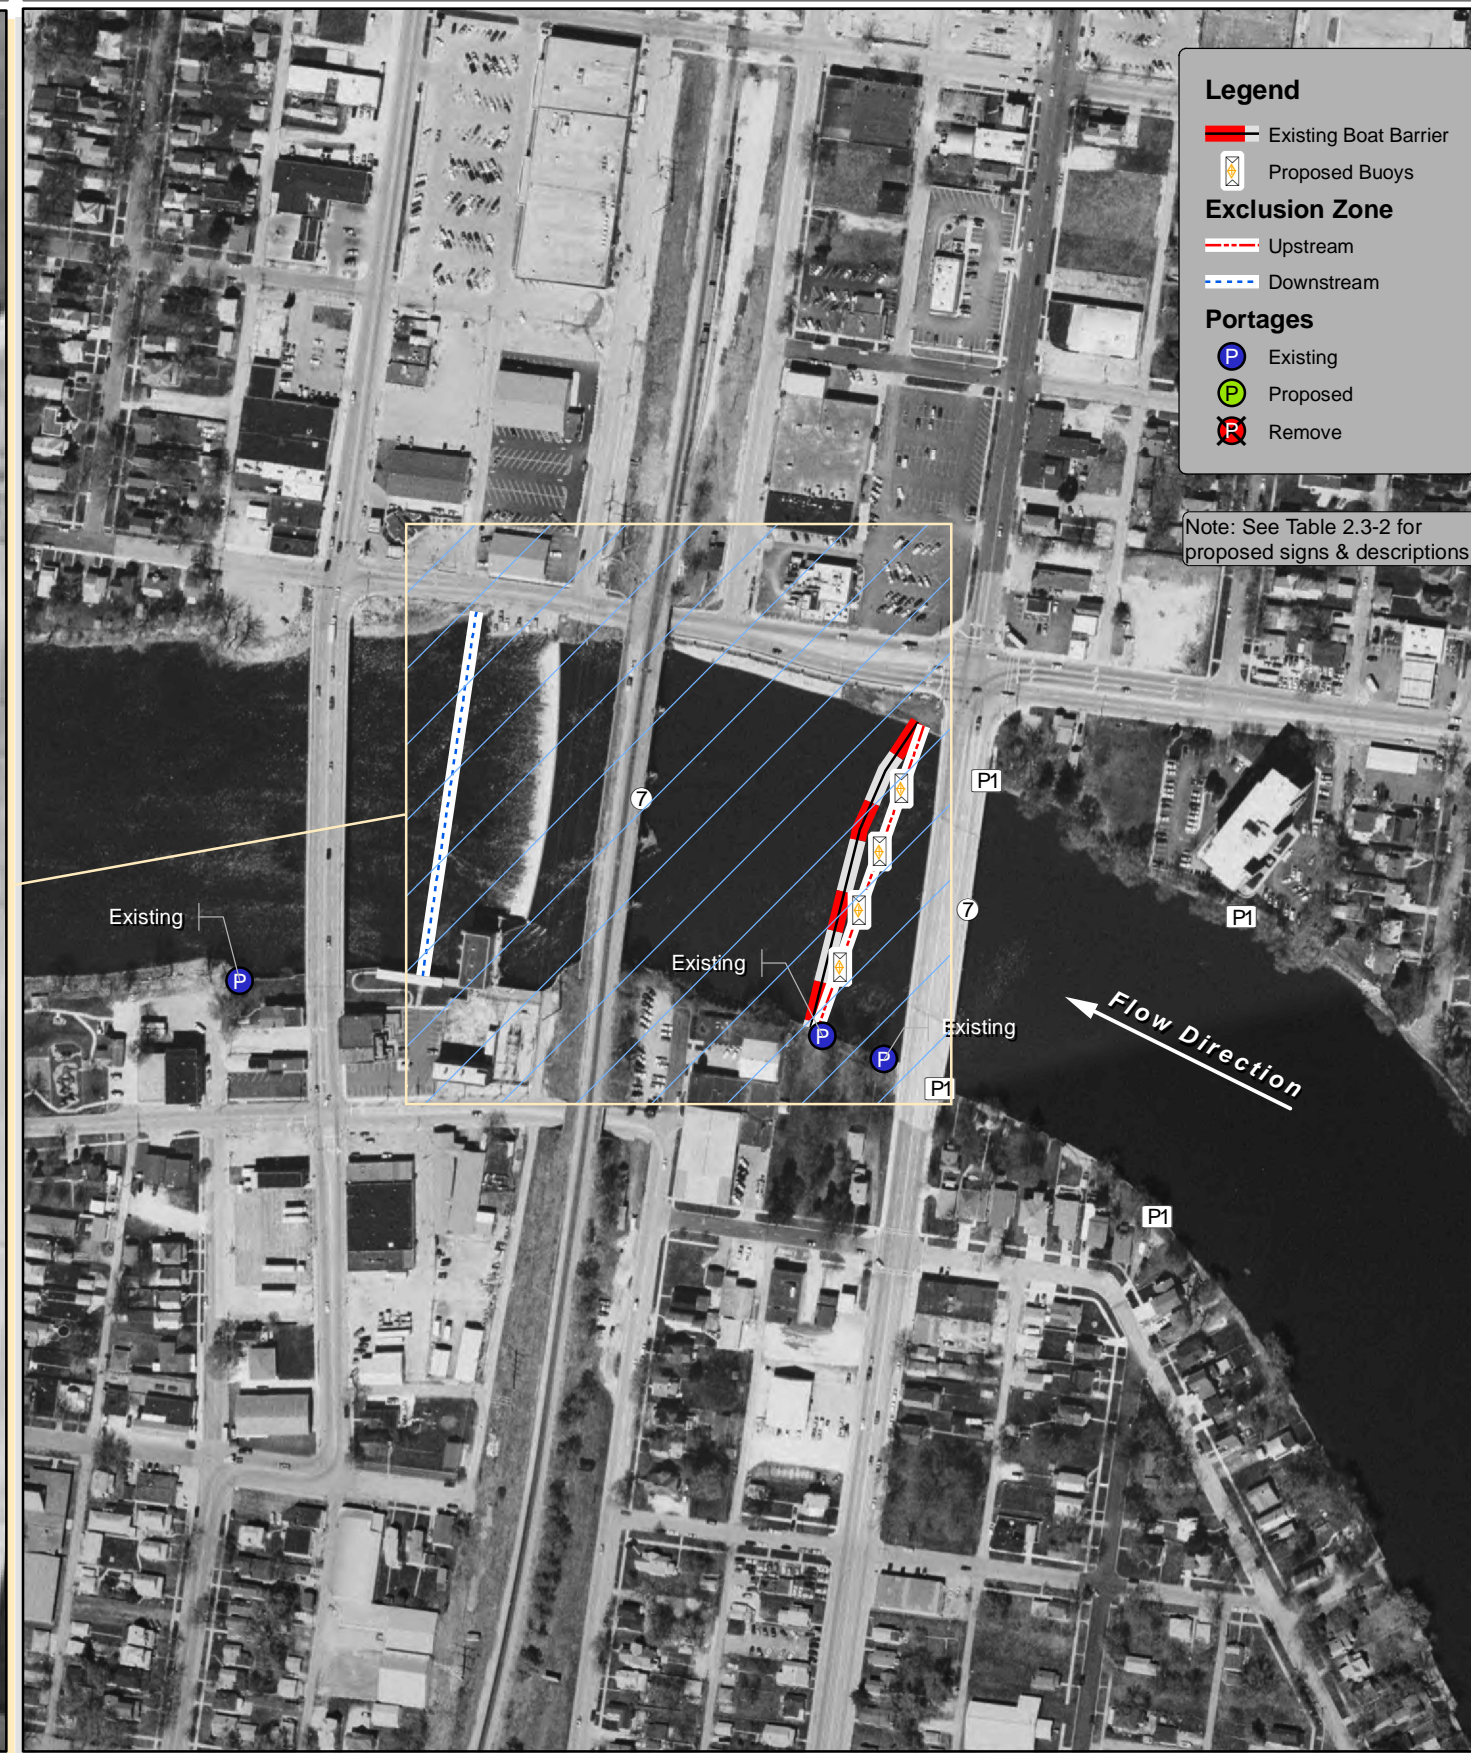
Figure 2.4.2
Kankakee

- Existing Boat Barrier
- Proposed Buoys

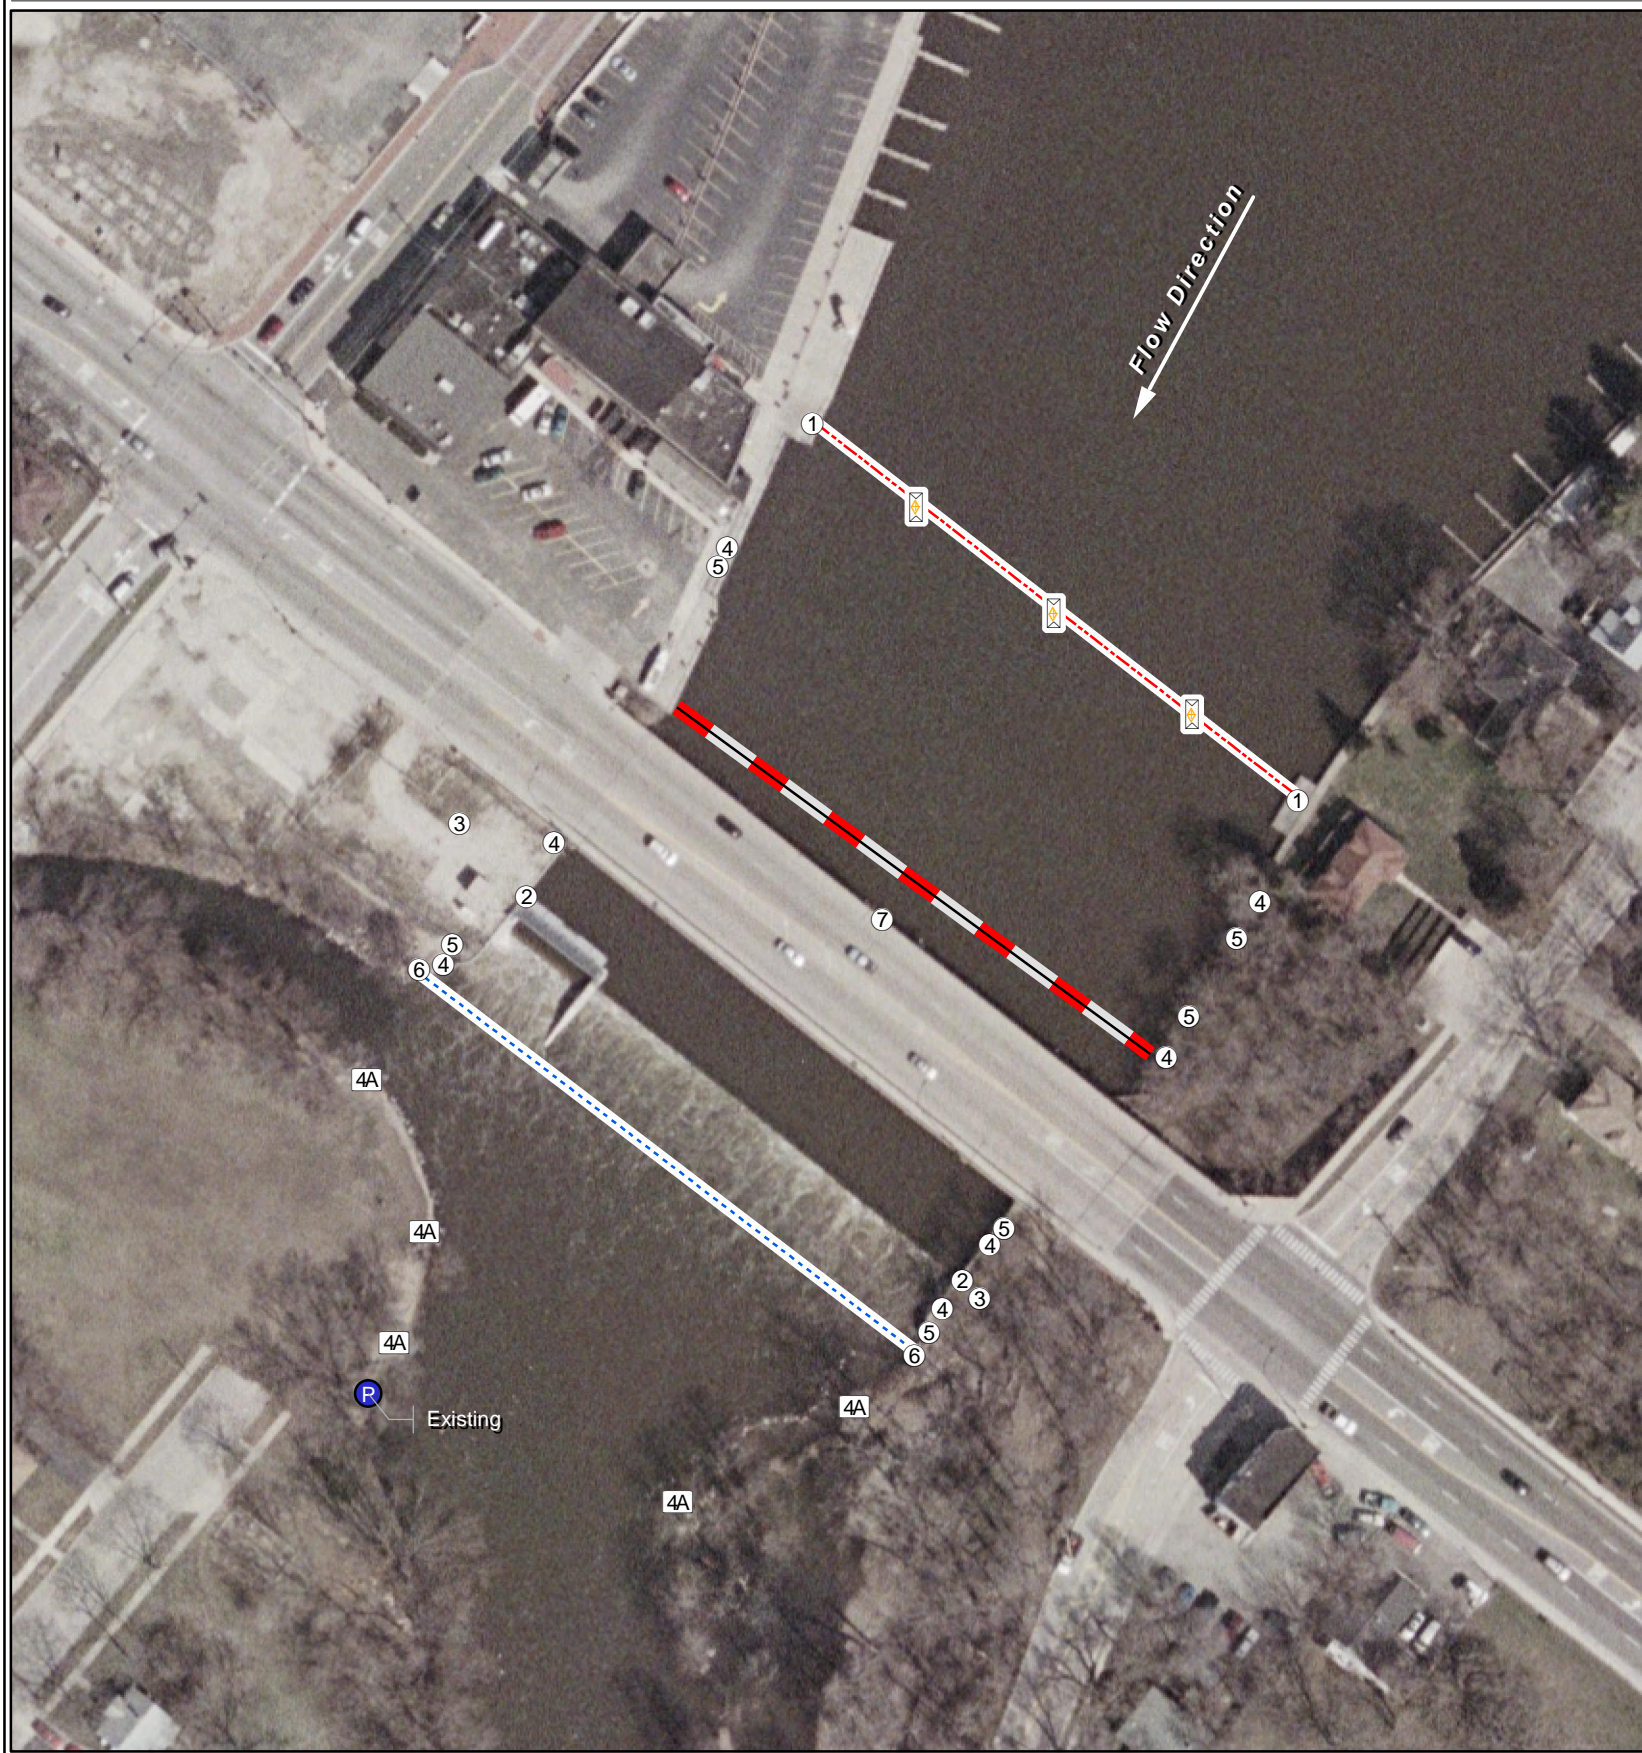
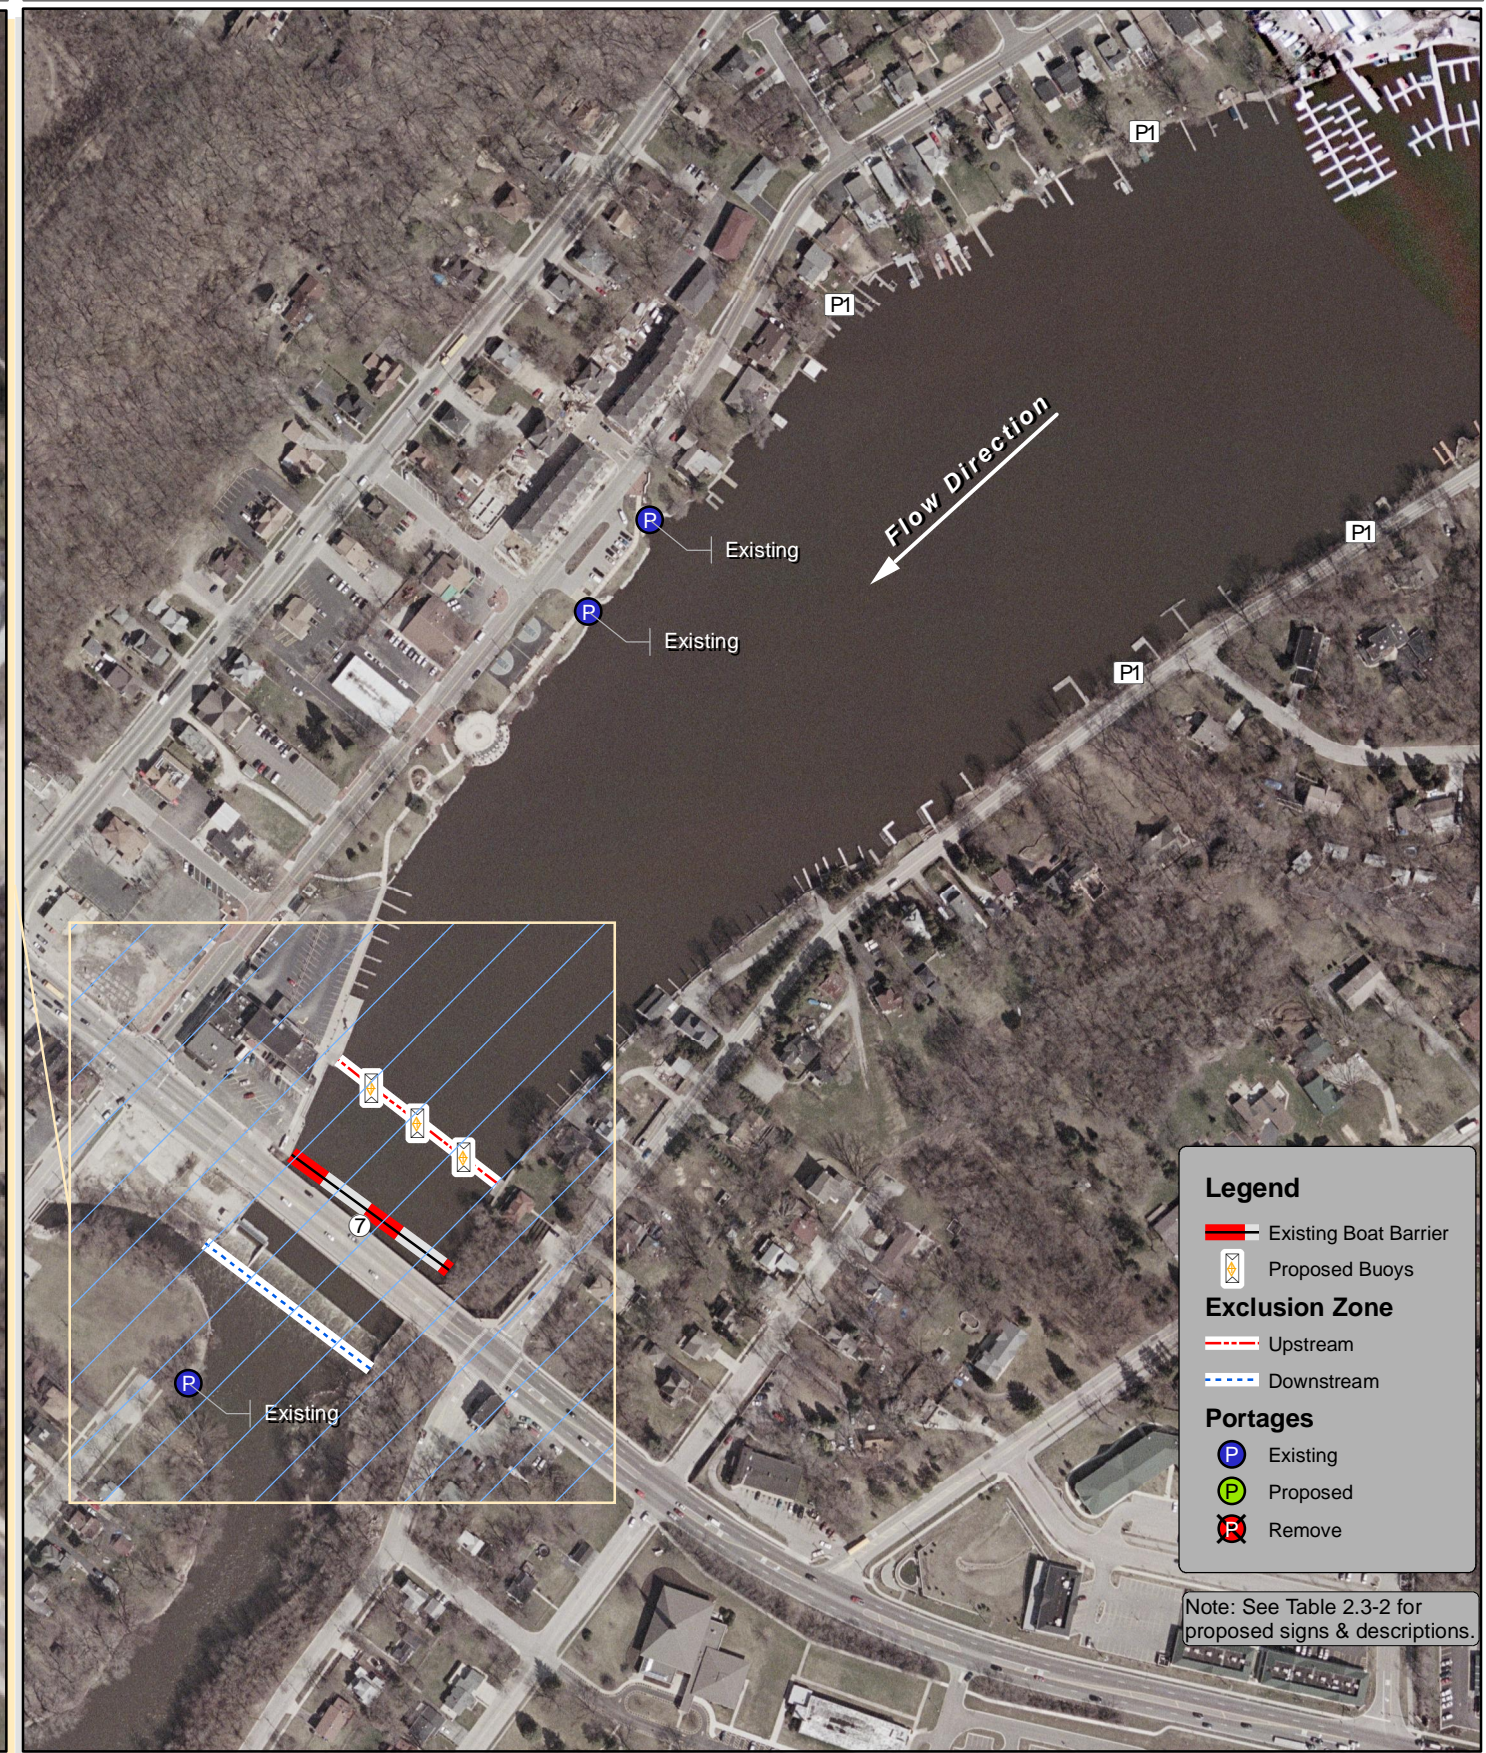
Figure 2.6.2
Algonquin

- Existing Boat Barrier
- Proposed Buoys

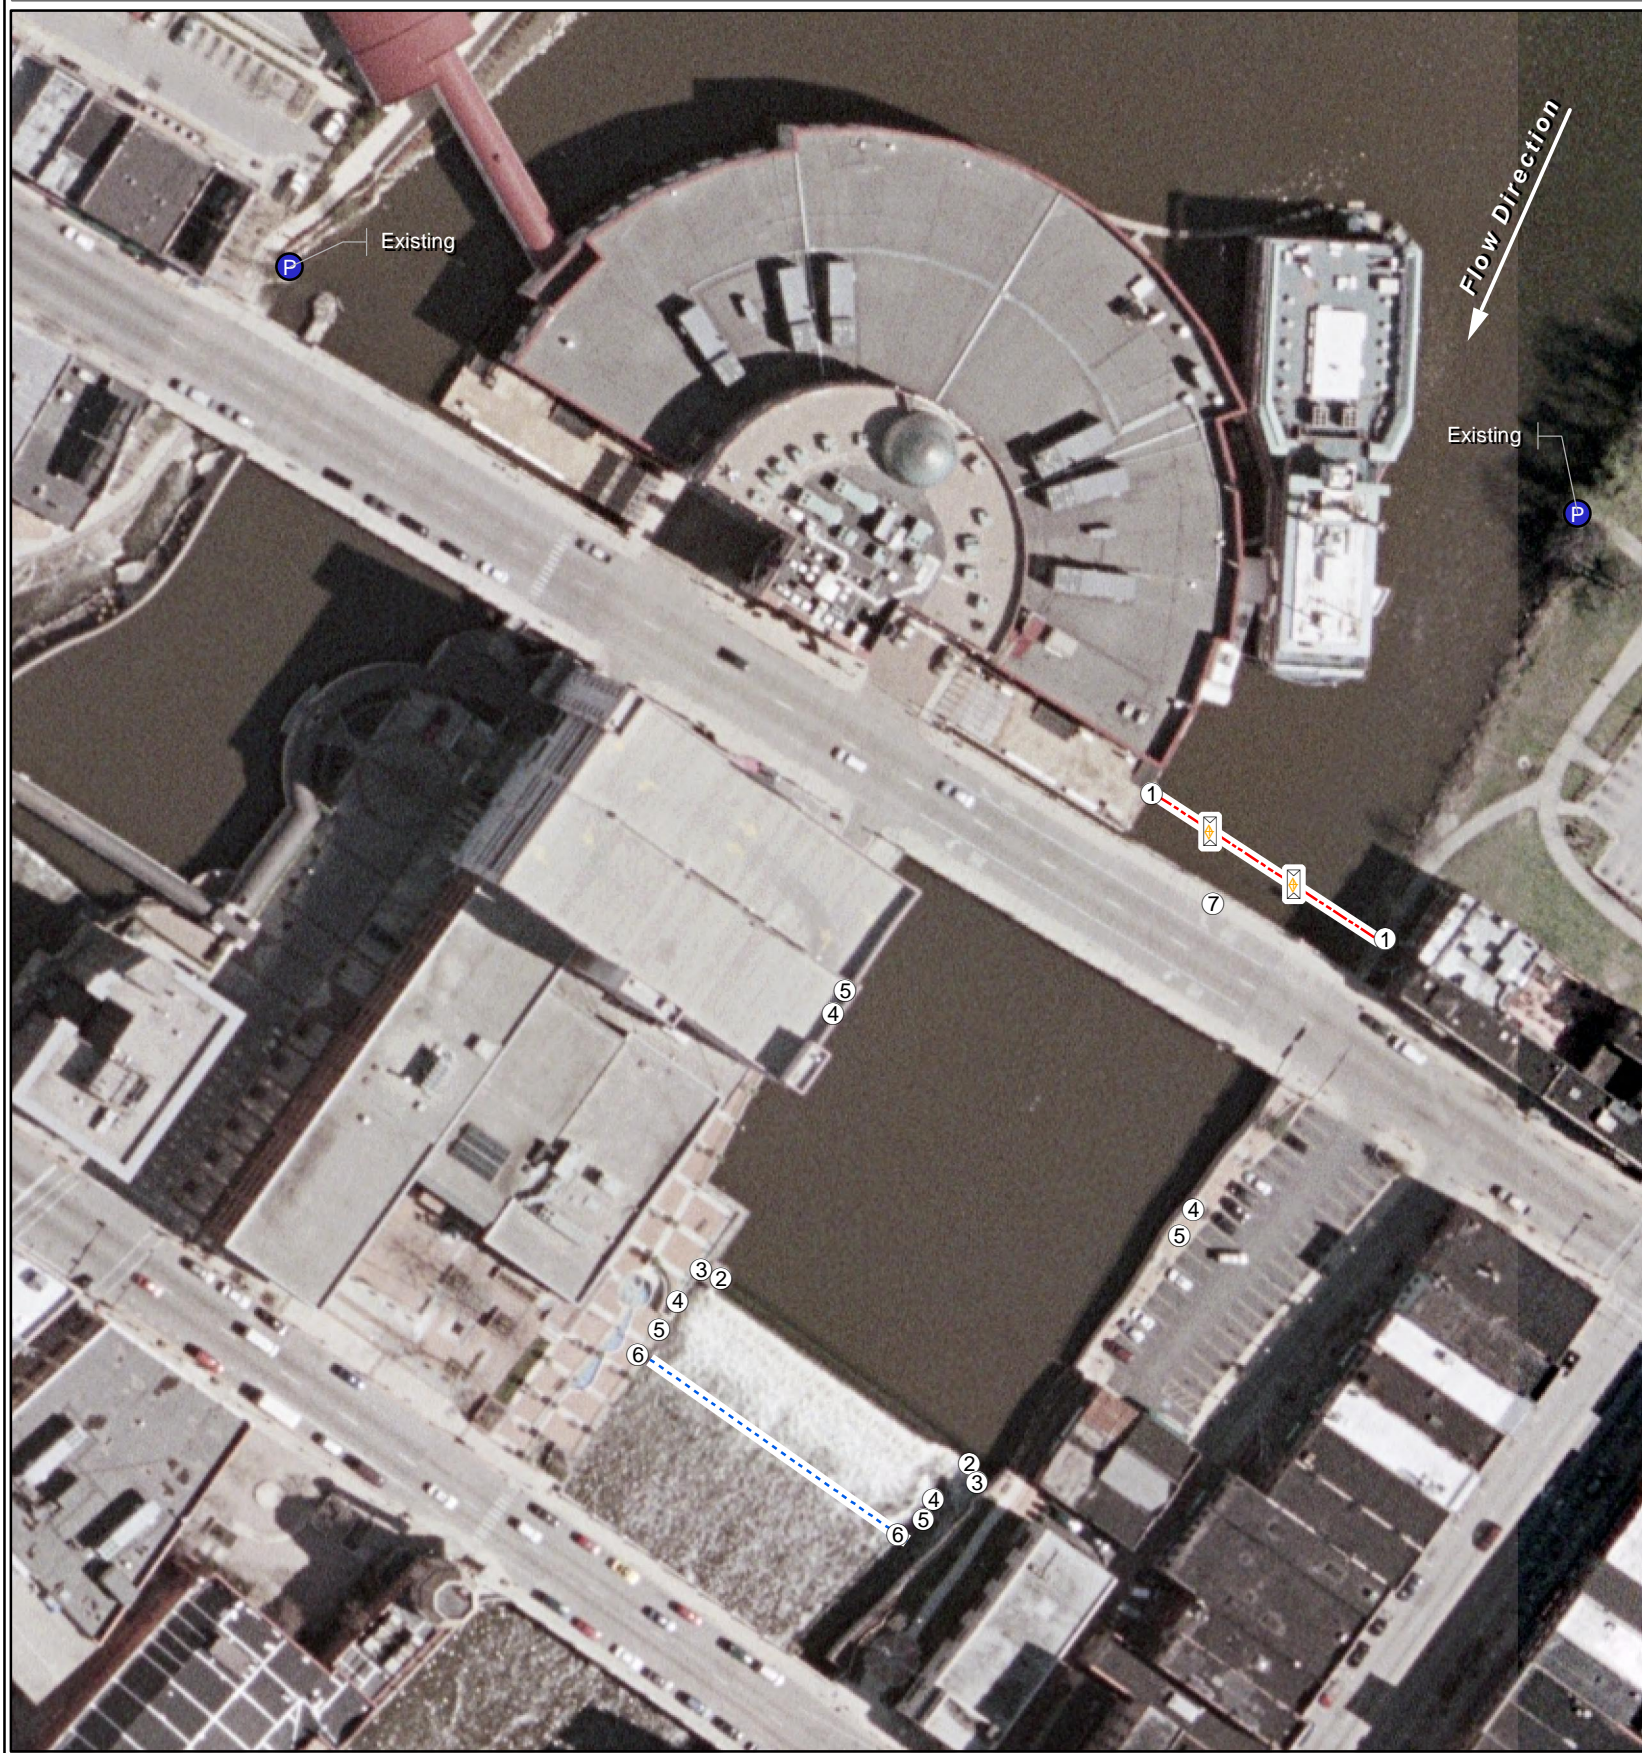
Signage Plan

Aurora East Dam - Fox River
Aurora East, Illinois

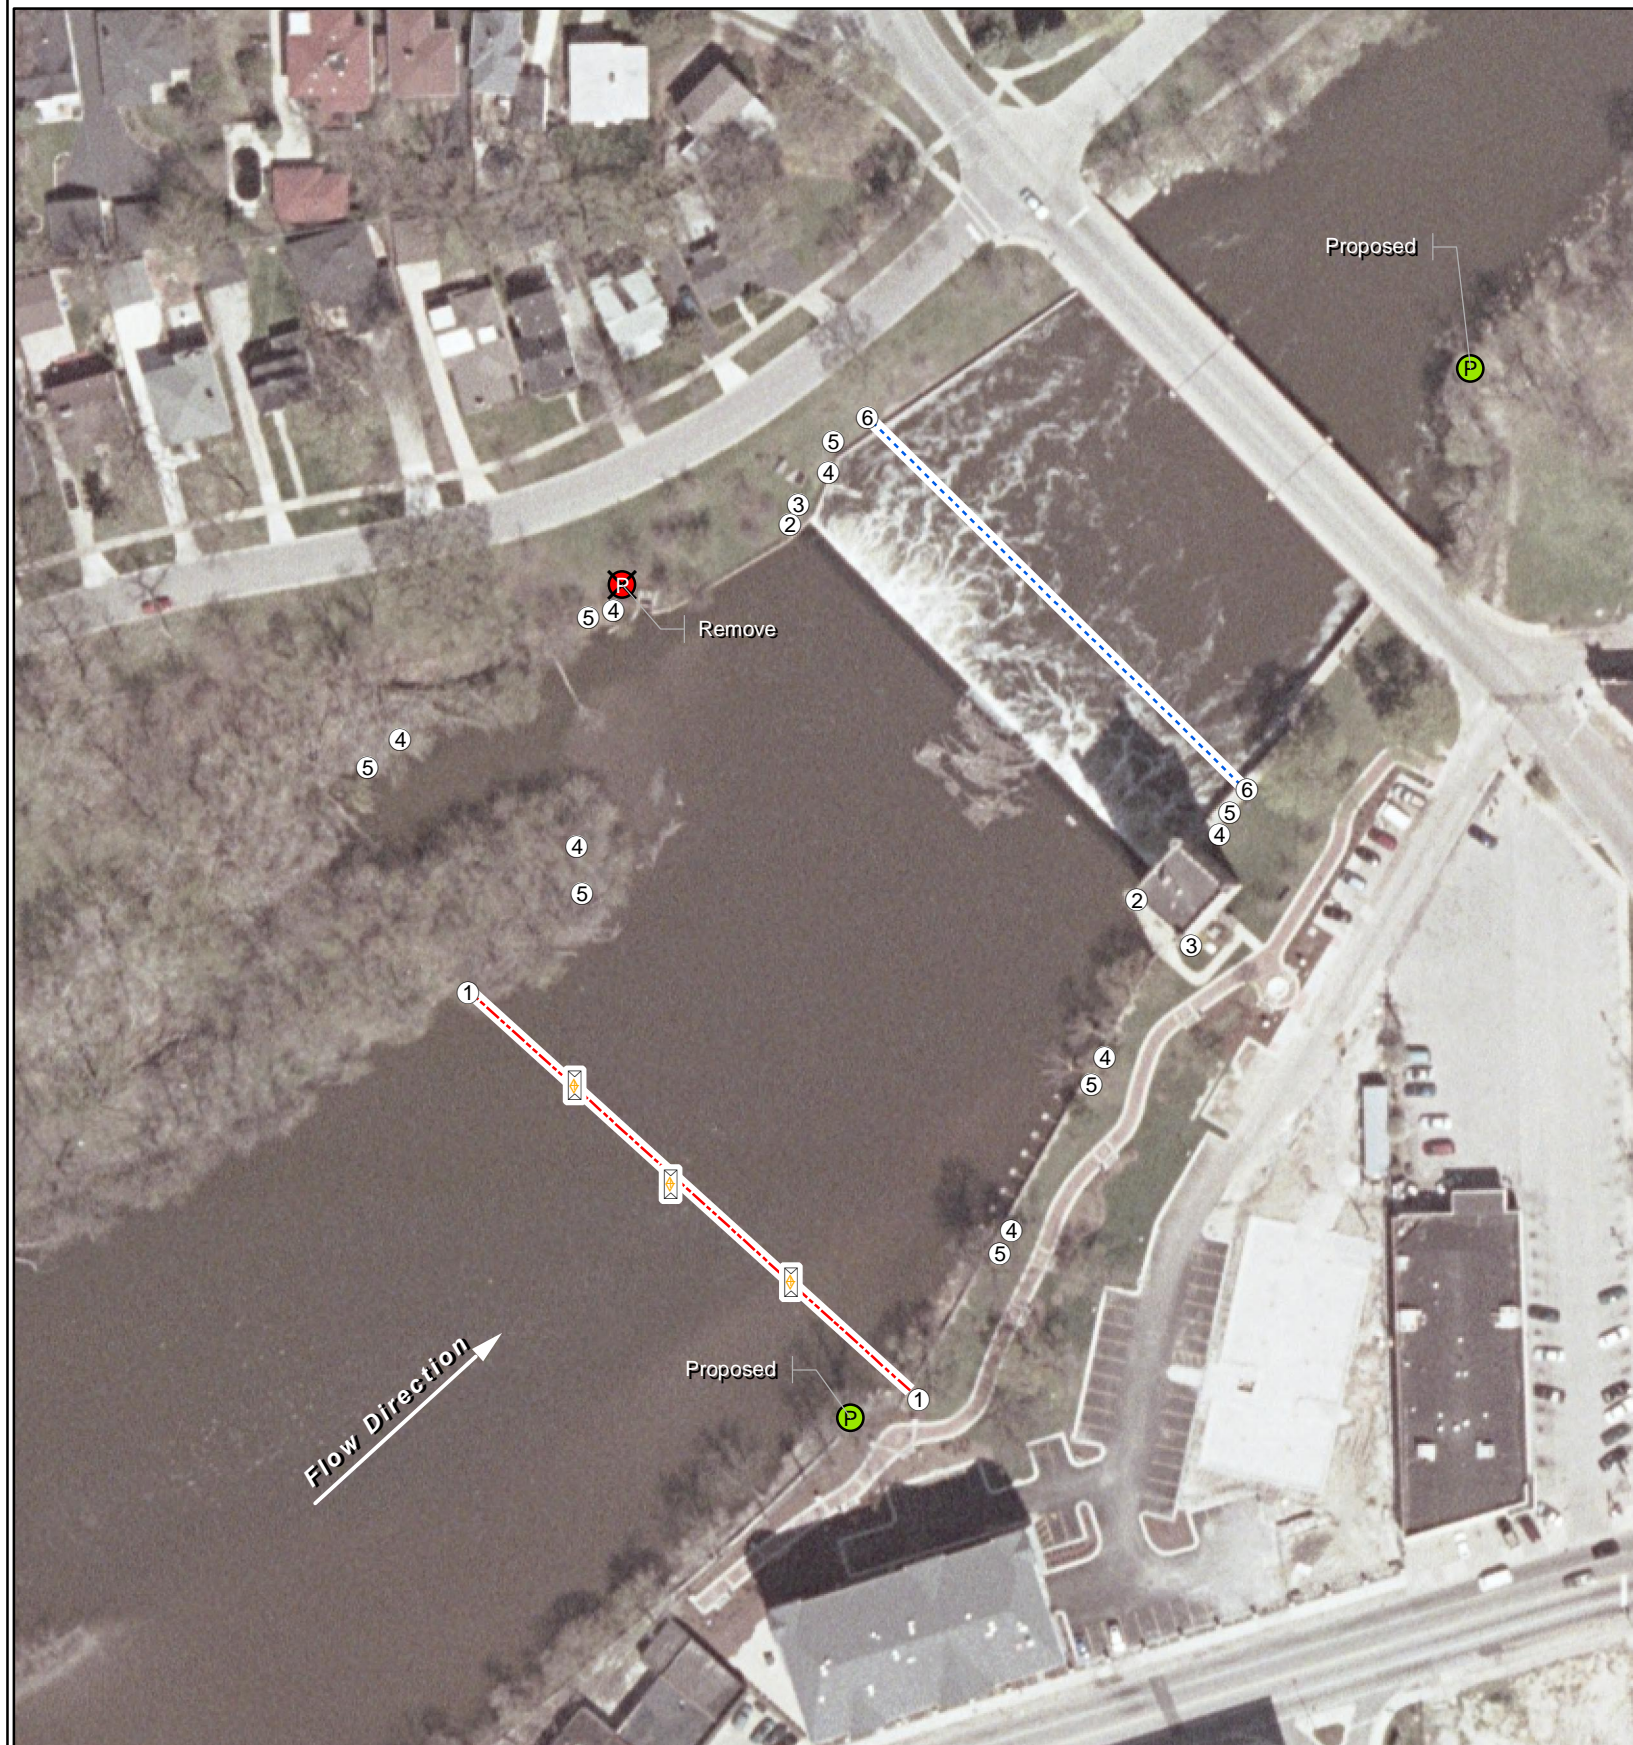
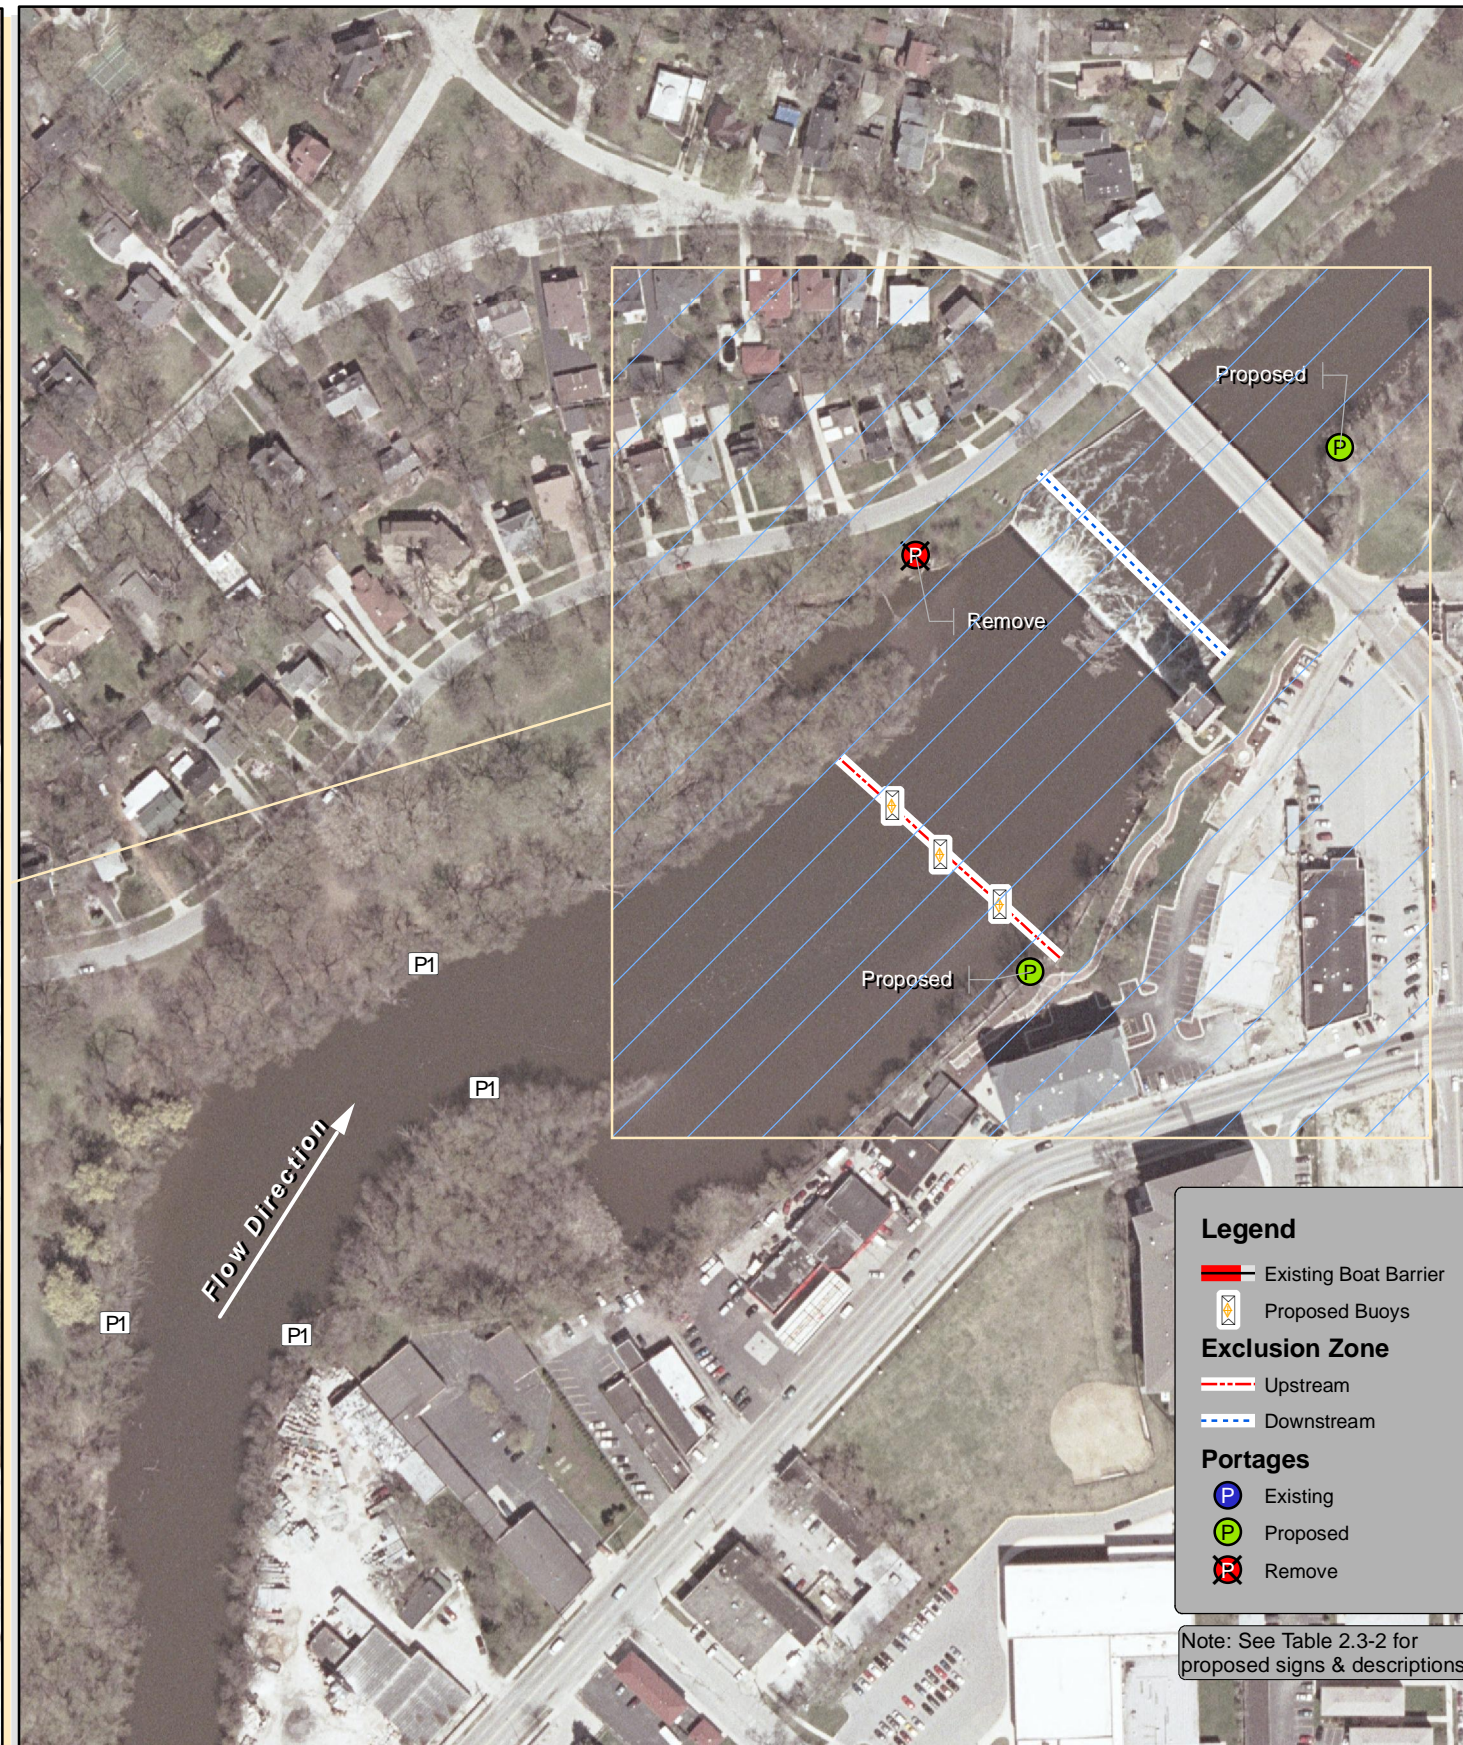
Signage Plan

Hofmann Dam - Des Plaines River Riverside, Illinois

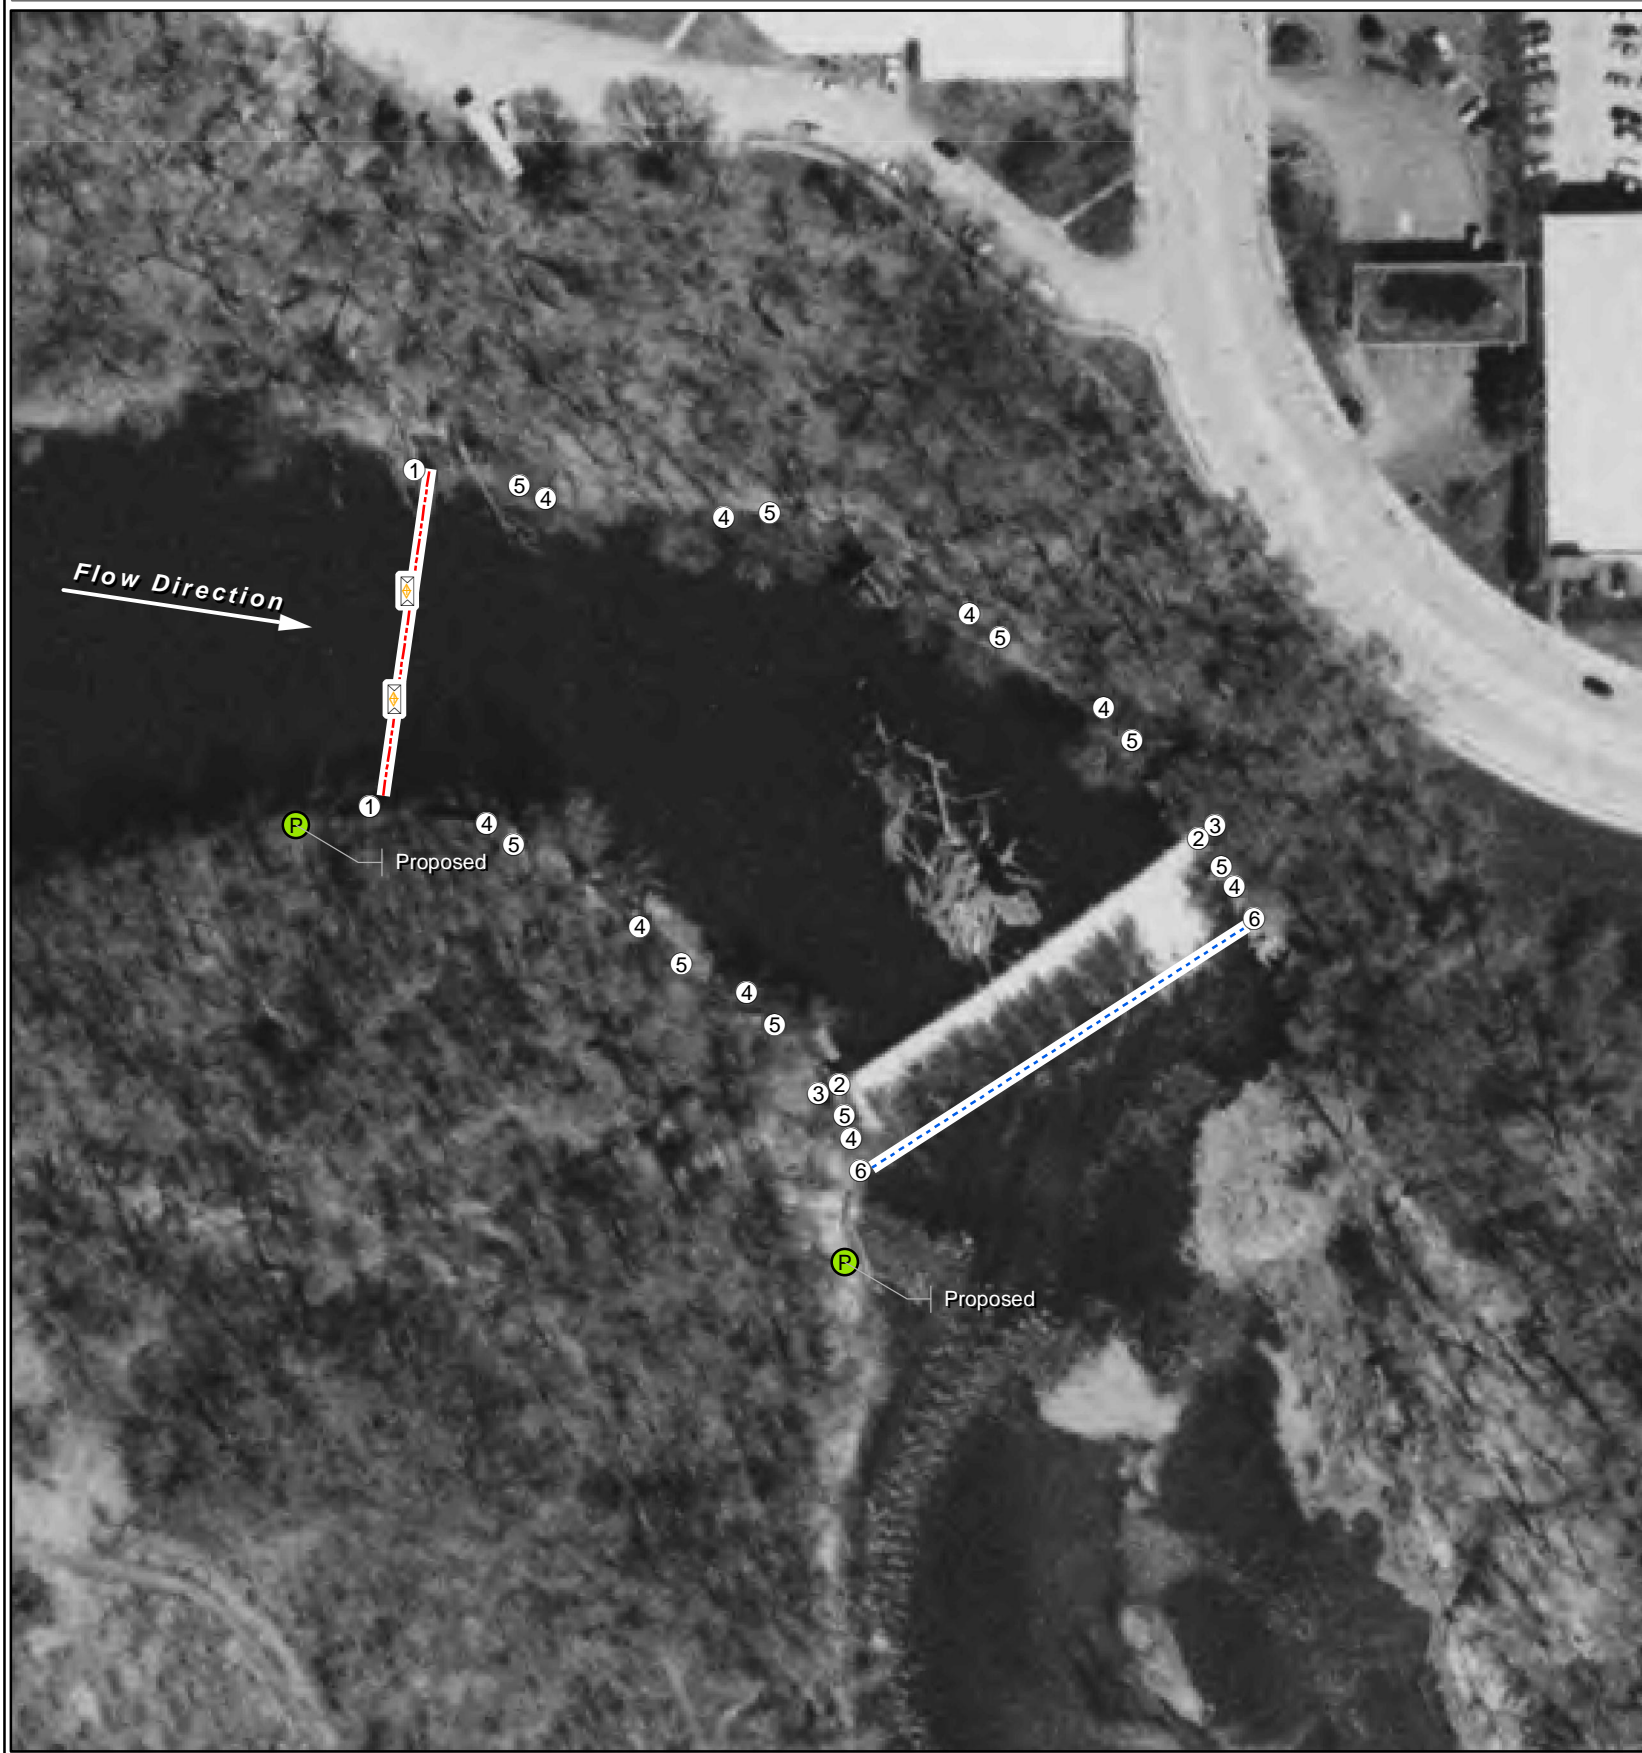
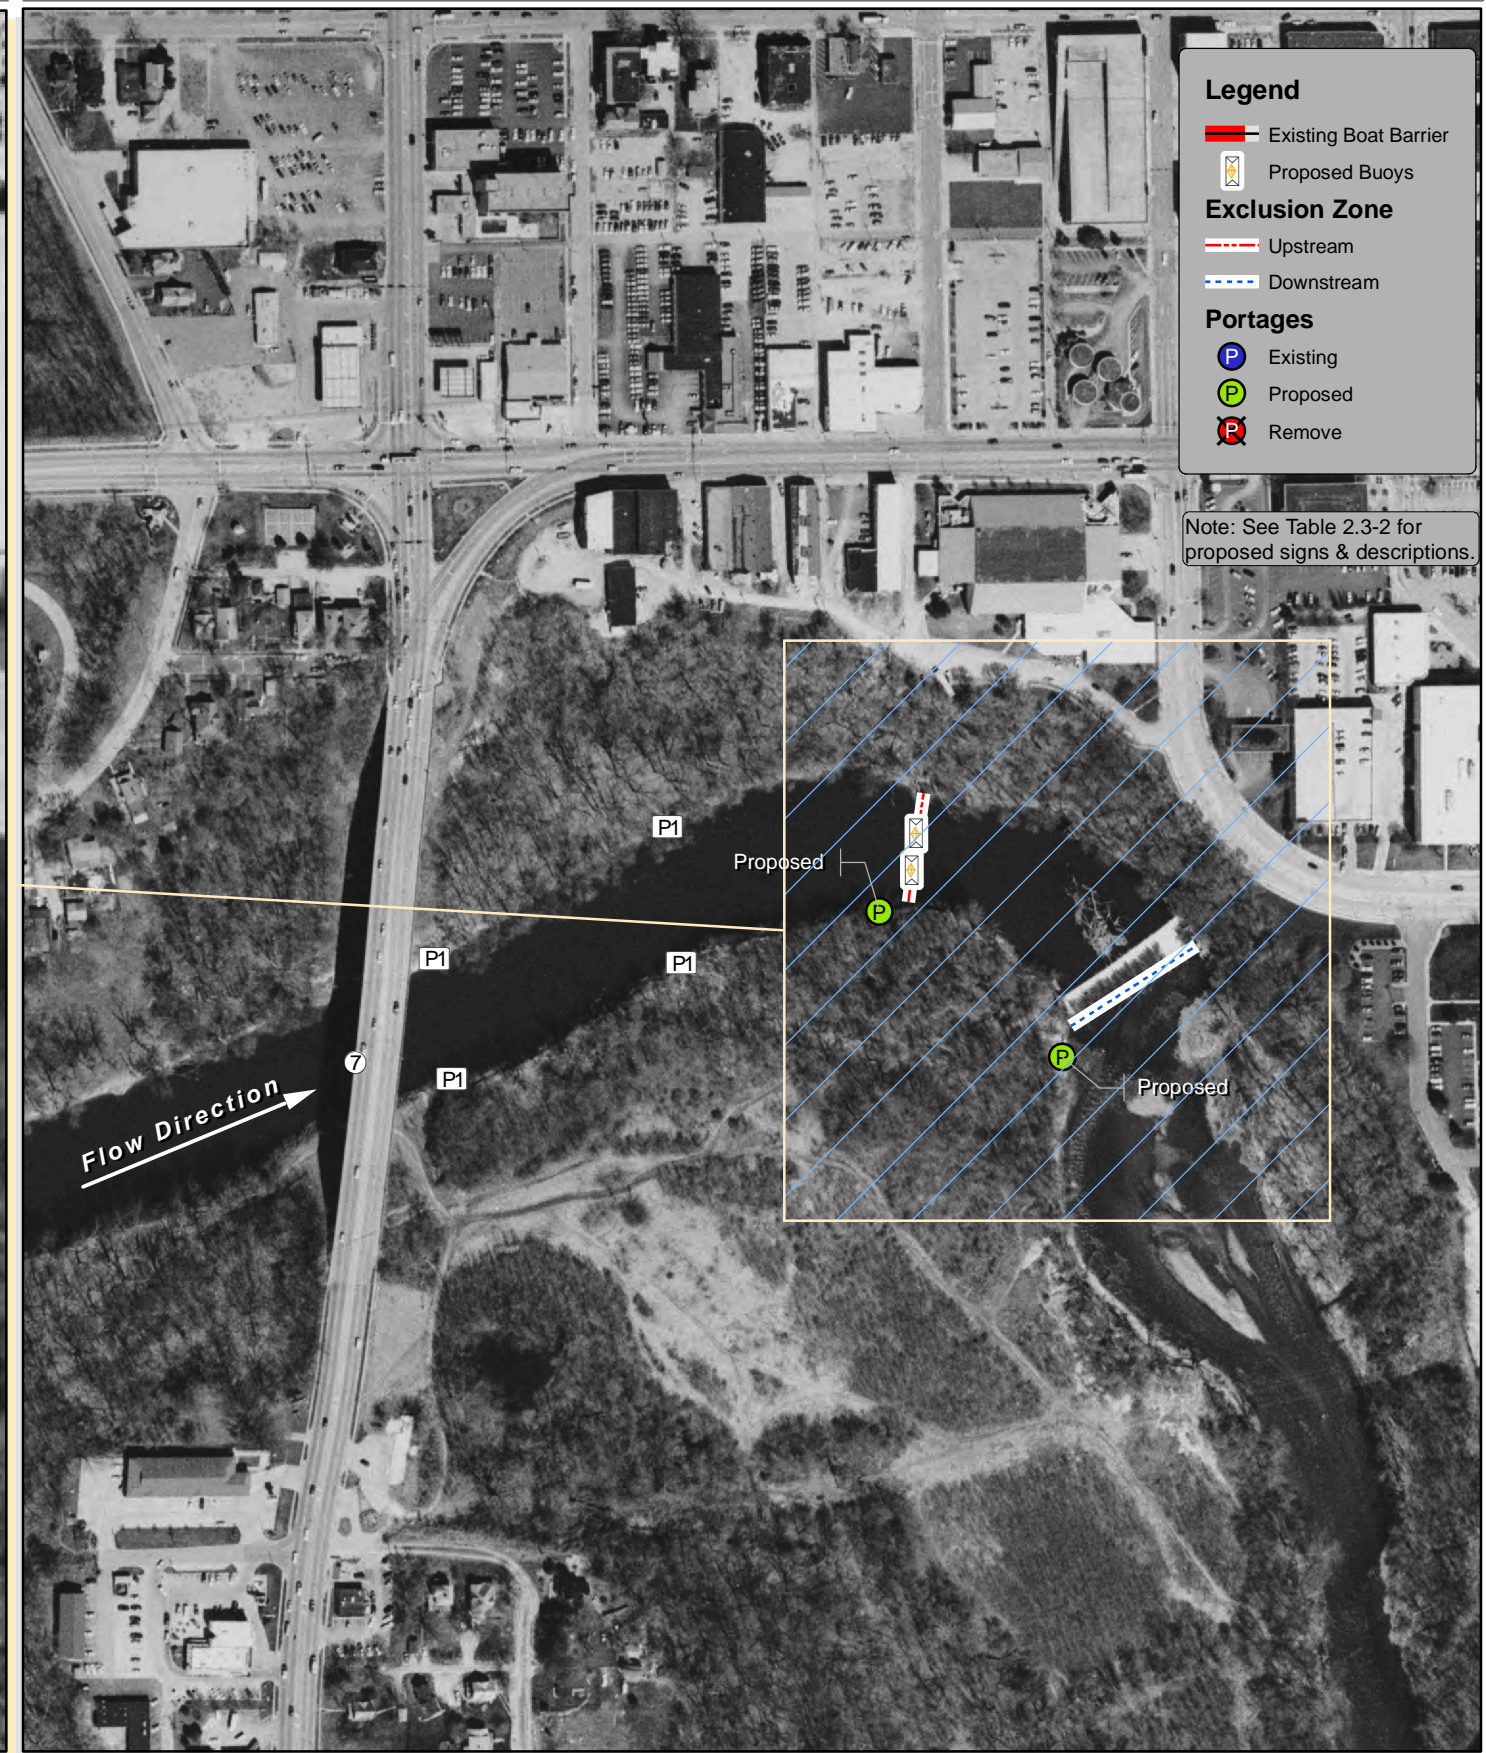
Signage Plan

The following page includes a signage plan for the Danville Dam on the Vermillion River.

Danville Dam - Vermillion River Danville, Illinois
