Evaluation of Public Safety at Run-of-River Dams

An Illinois Statewide Program

July 20, 2007

CTE | AECOM

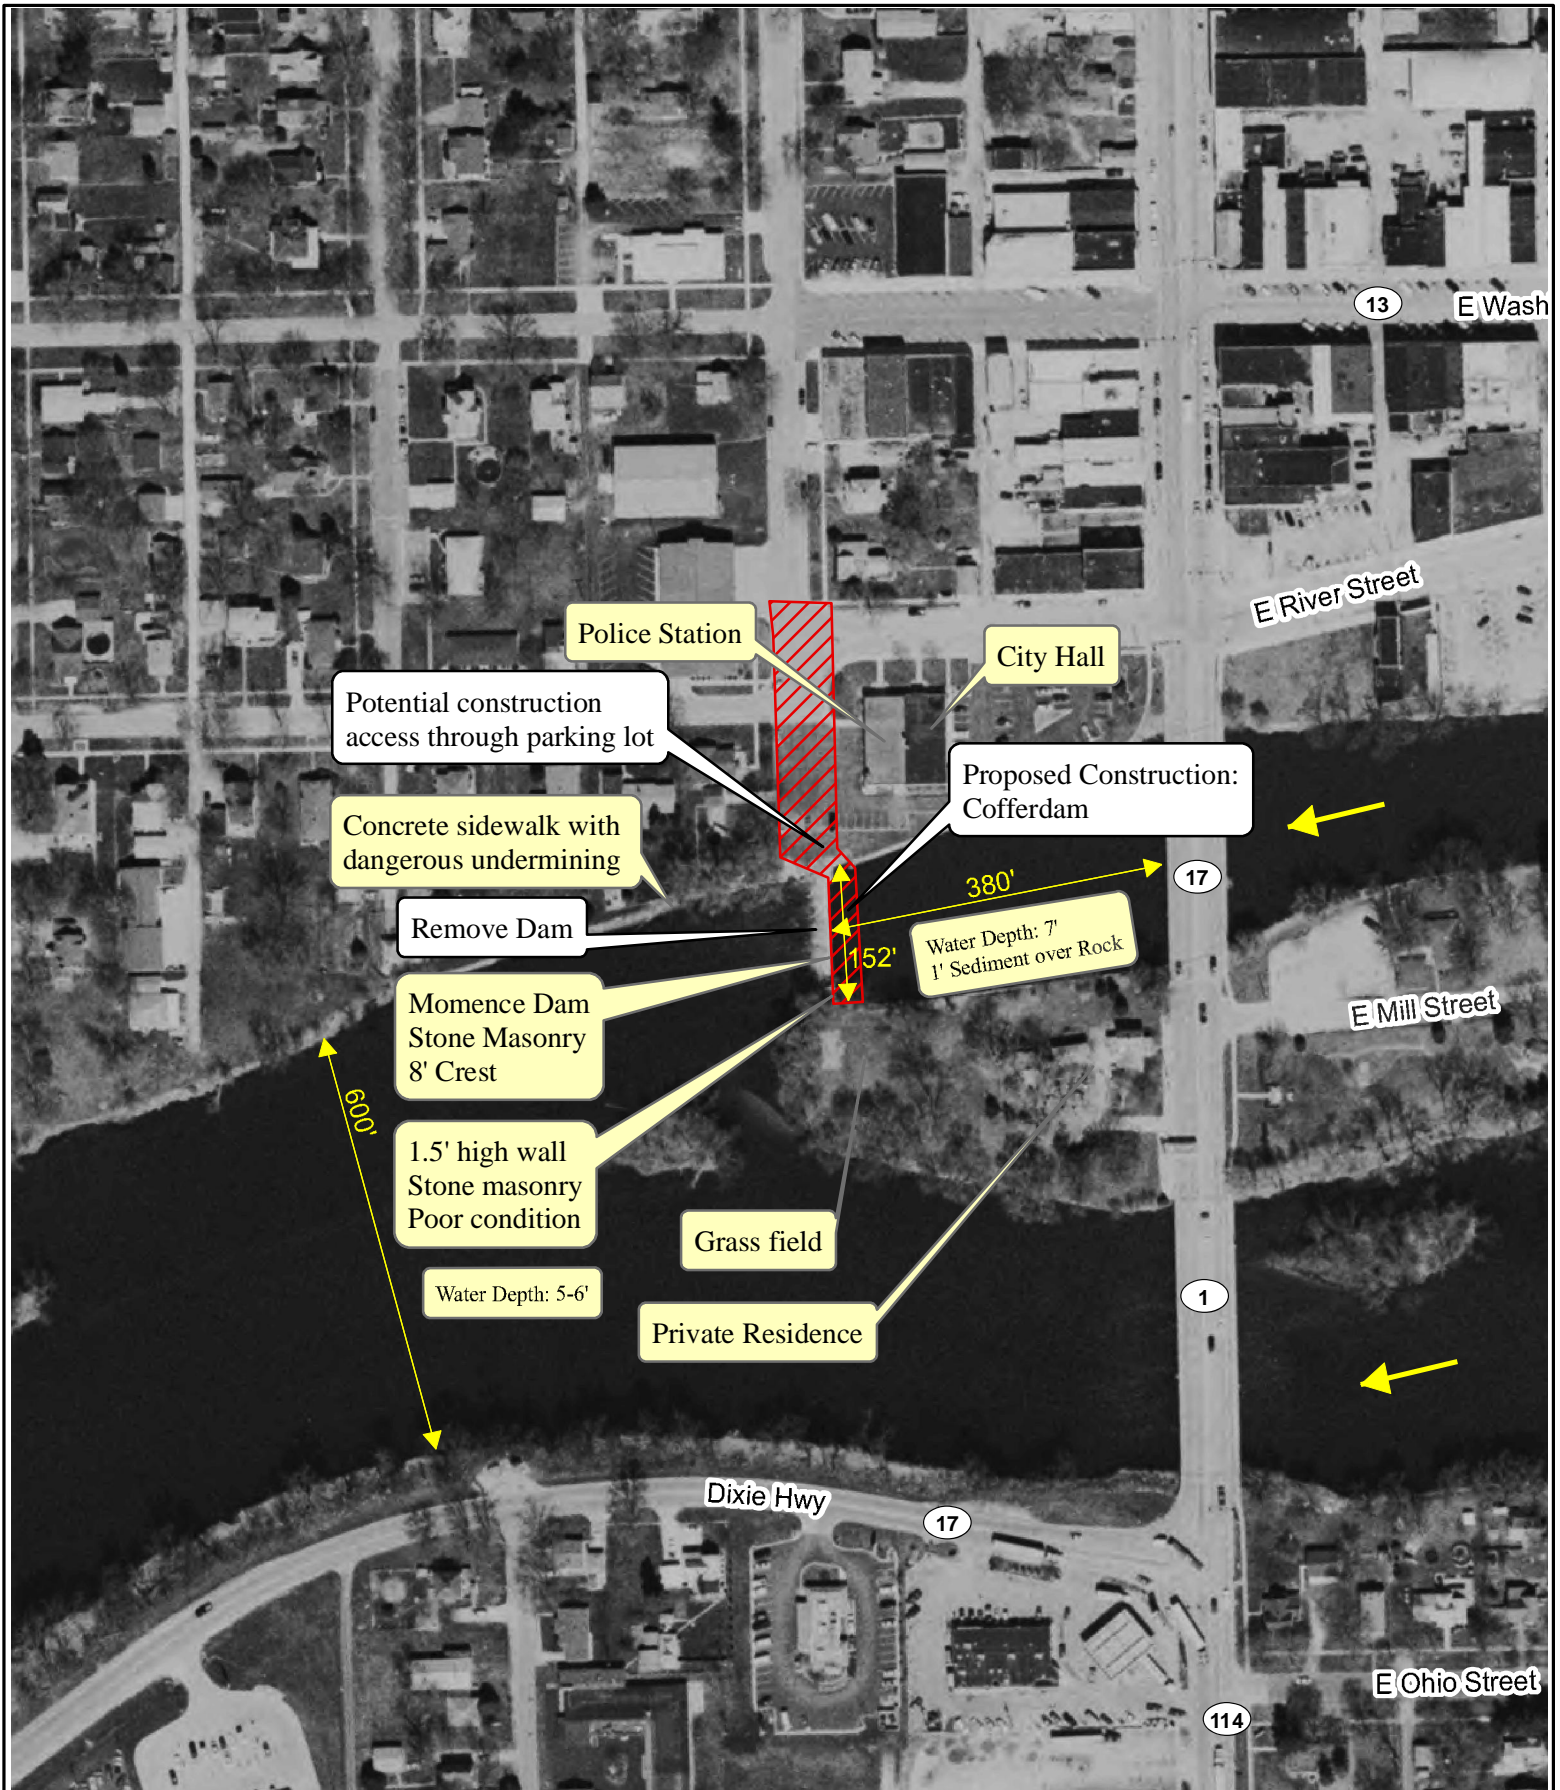
<p>Engineering, Landscape Architecture and Environmental Science</p> <p>MILONE & MACBROOM®</p> <p>99 Realty Drive Cheshire, Connecticut 06410 (203) 271-1773 Fax: (203) 272-9733 www.miloneandmacbroom.com</p>	<p>IL Dam Removal Project</p> <p>Momence Dam - Kankakee River</p>		<p>LOCATION: Momence, IL</p>	
	<p>MMI#: 3131-01 MXD: H:Momence.mxd SOURCE:</p>	<p>N</p> <p>Existing Conditions and Proposed Removal</p>	<p>DATE: 04/10/07 SCALE: 1"=200'</p>	<p>SHEET: Figure 4.6.1.2.2</p>

Breaching or totally removing the dam will alter the flow patterns around the island and could impact normal water surface elevations. It is anticipated that there would be less flow on the left side, more flow on the right side, unless secondary controls are implemented. Nevertheless water levels in the right channel behind City Hall would decline by approximately 2 ft. Remaining waters would likely still fill the full channel width. Initial evaluation indicates that there is minimal sediment behind the dam and is not expected to be an issue.

The dam removal design should evaluate future flow velocities along the banks of the right channel and assess bank stability, as some bank work is anticipated. The Dixie Highway Bridge over the right channel should also be checked for potential scour and its probable foundation on bedrock should be verified.

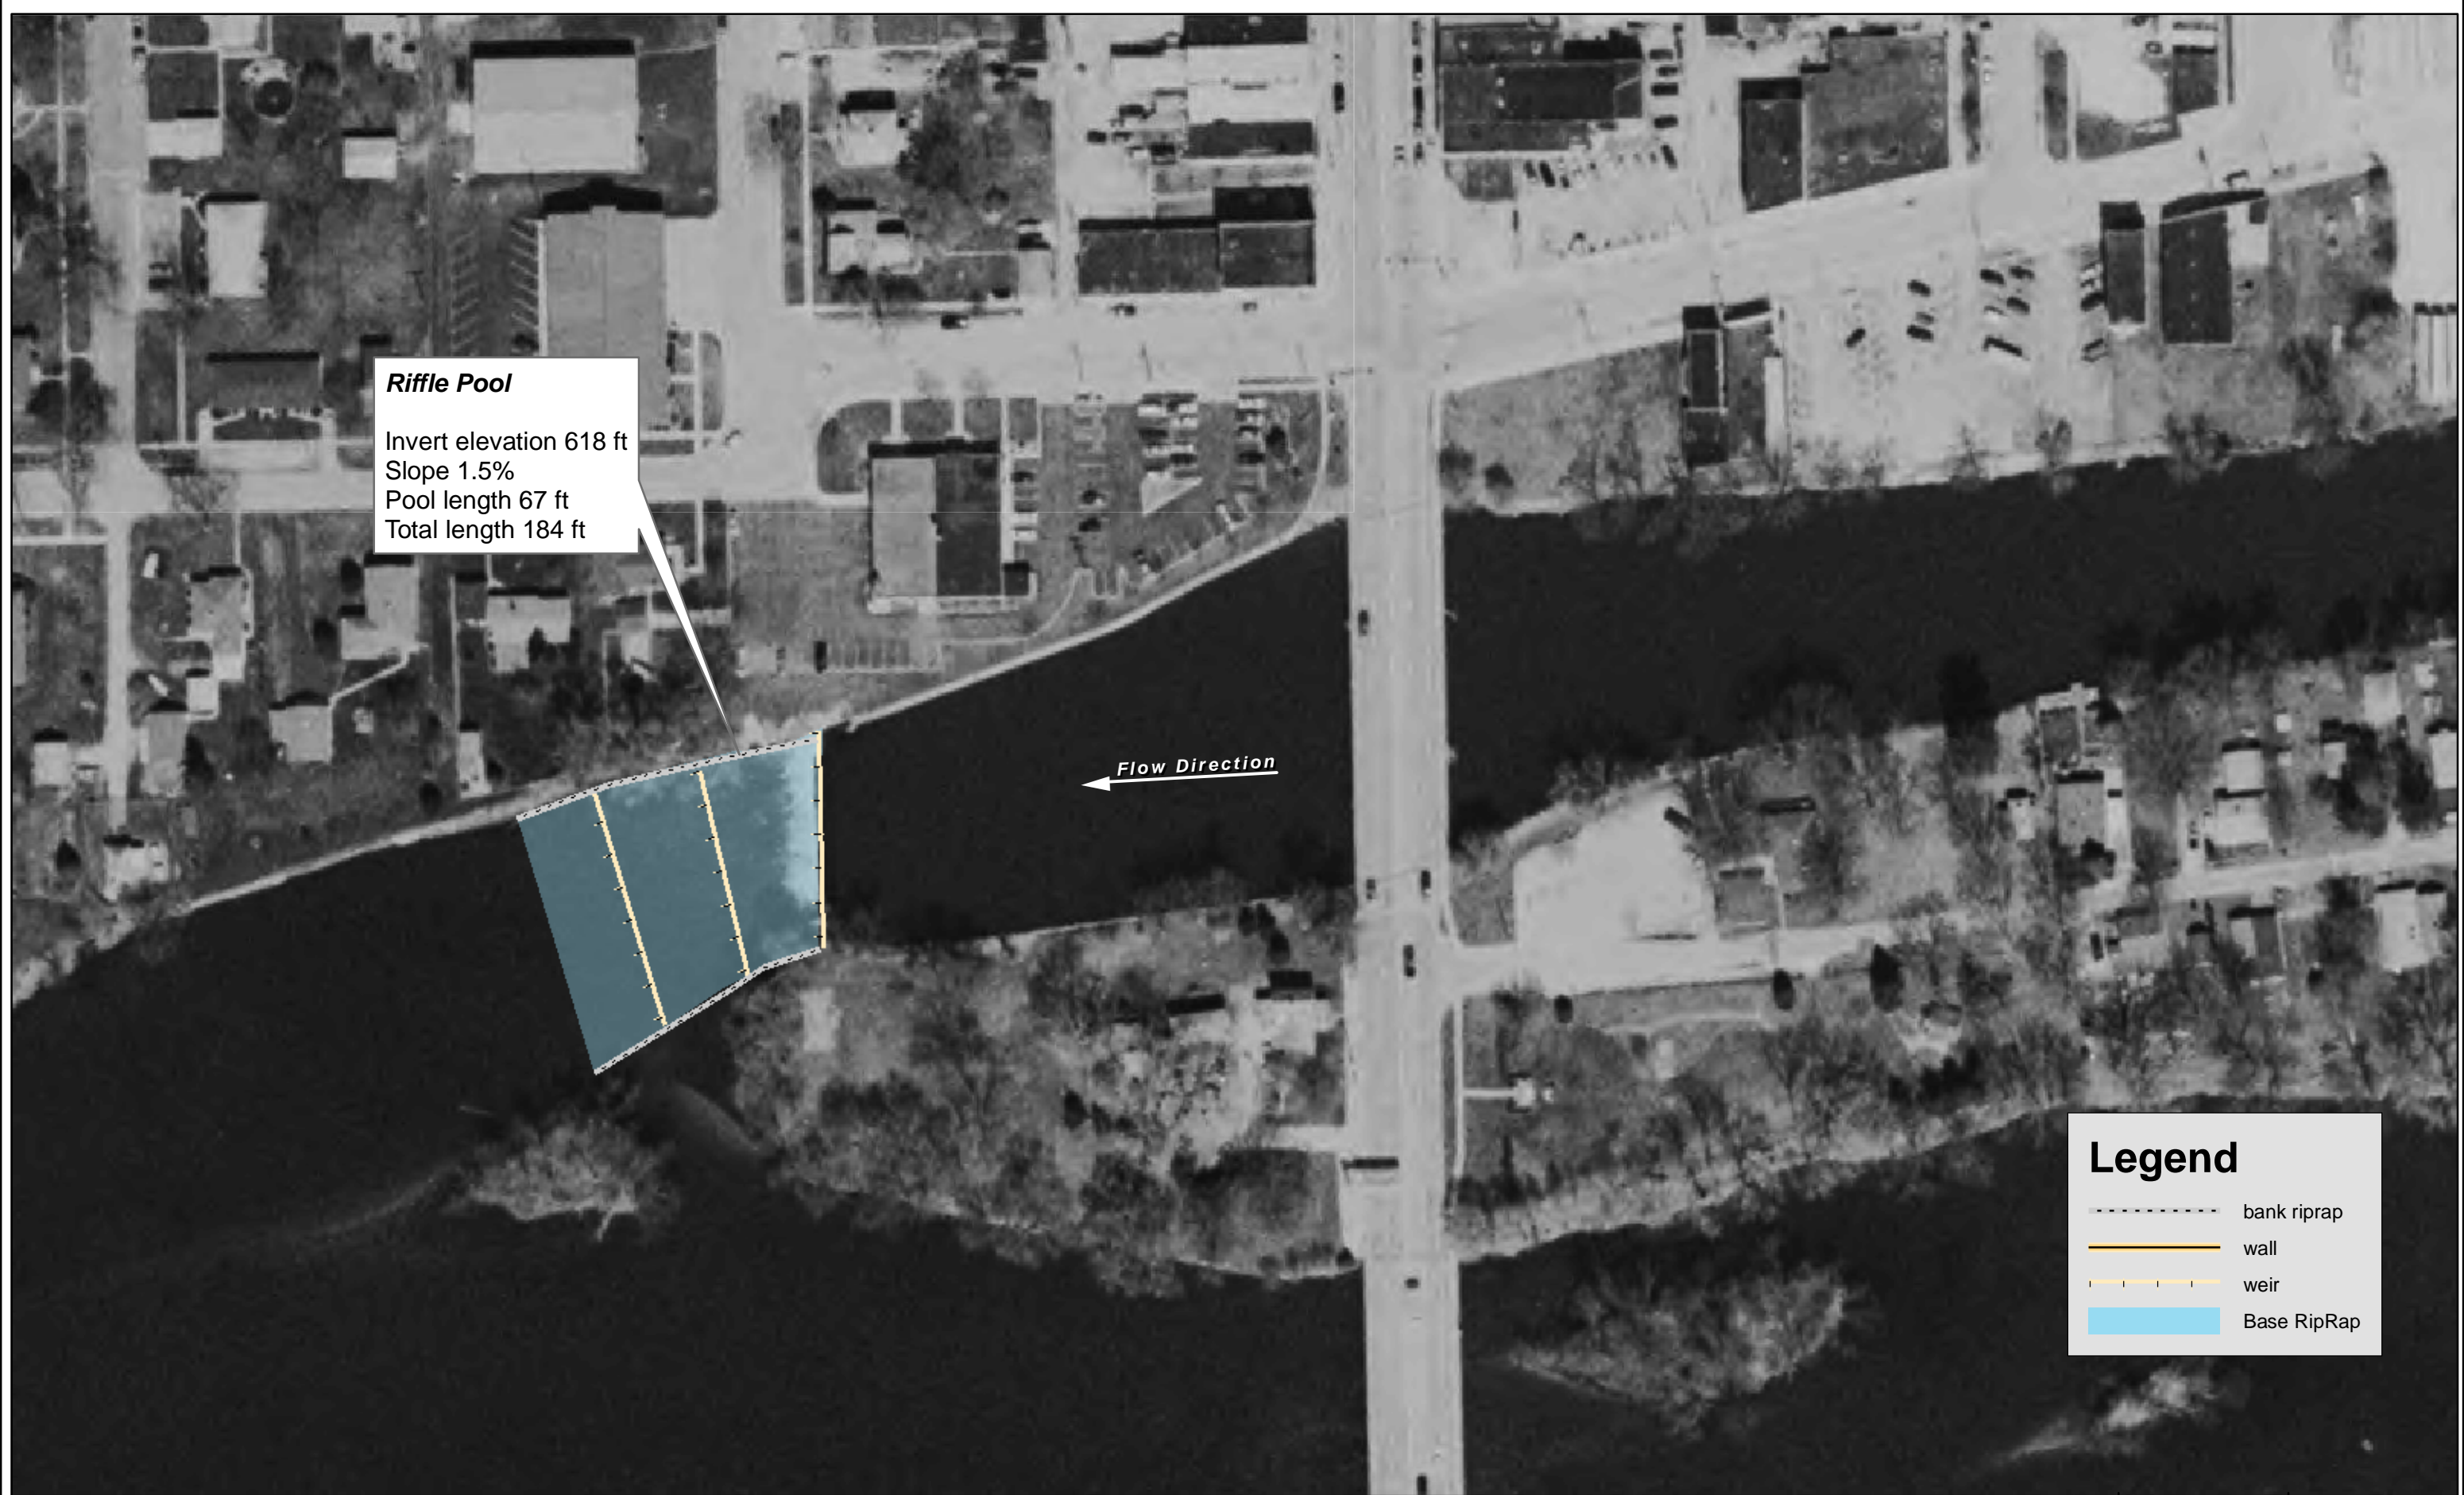
**RIFFLE POOL
 ROCK RAMP**

Riffle Pool
 Invert elevation 618 ft
 Slope 1.5%
 Pool length 67 ft
 Total length 184 ft

Momence Dam - Kankakee River
Momence, Illinois
