Identification of degraded stream sections is used to support restoration of the Illinois River.

Watershed Assessment

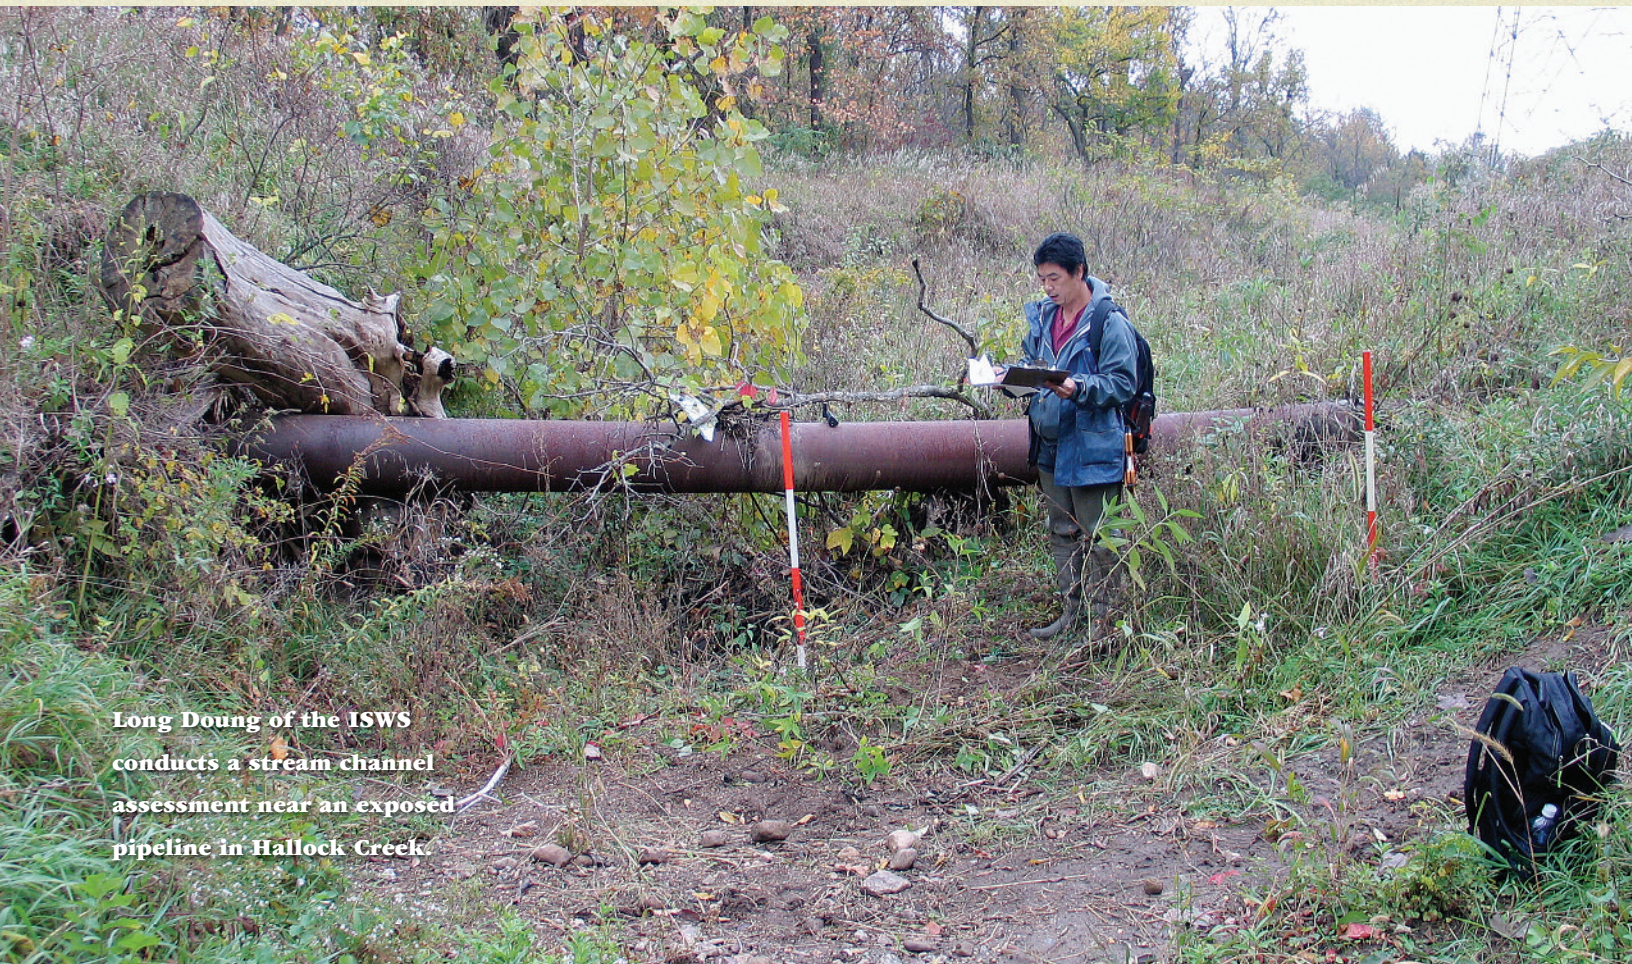
Long Doung of the ISWS conducts a stream channel assessment near an exposed pipeline in Hallock Creek.

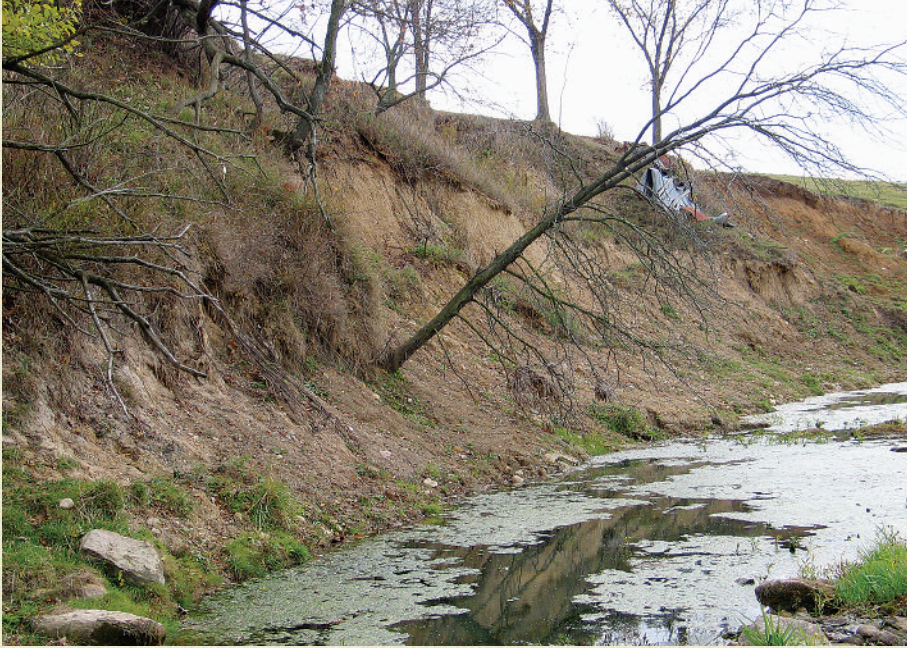
Erosion of the channel bed (channel incision) causes streambanks to fail and undermines the vegetation in Senachwine Creek. Excessive algae in the stream also may indicate water quality problems.

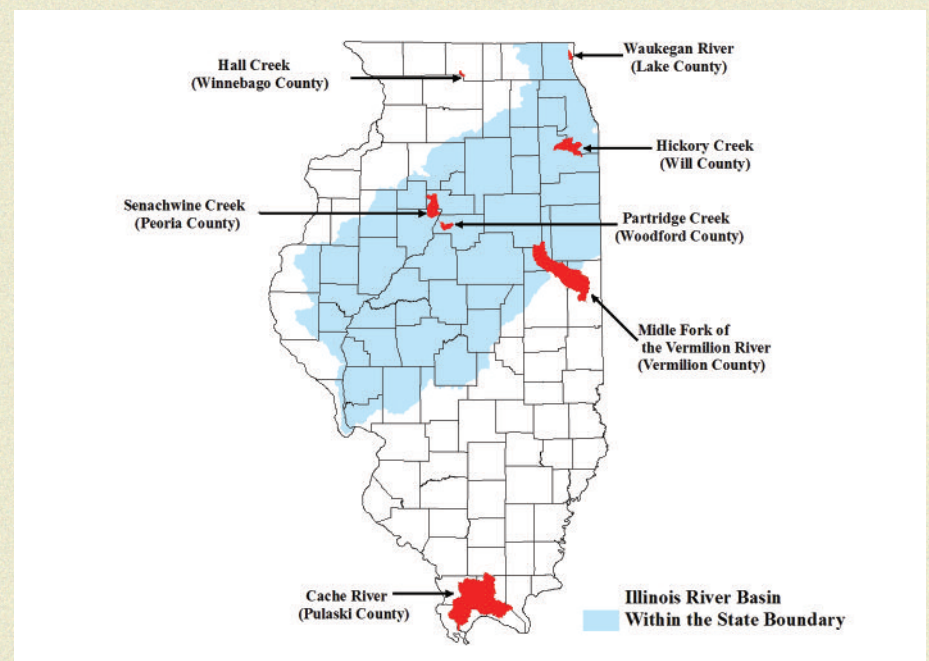
Map showing locations of select assessment areas and stream restoration and naturalization demonstration projects across Illinois.

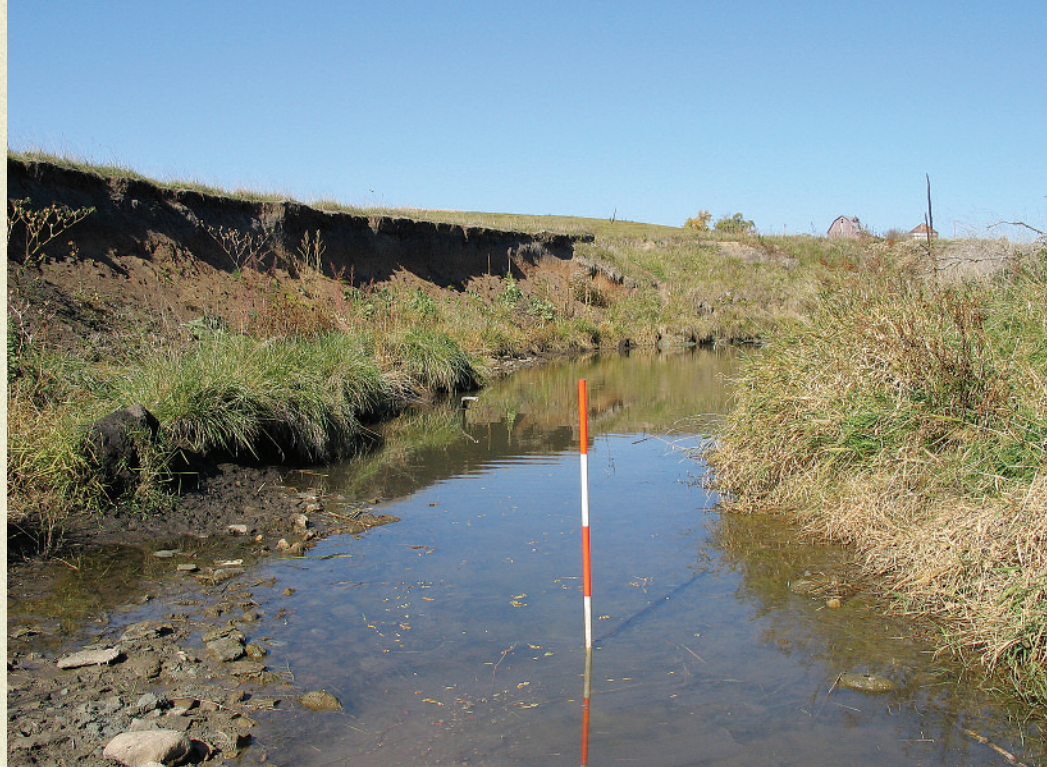
Erosion scours at the toe of a stream bank in Senachwine Creek until the upper bank collapses leaving tons of loose bank material ready to be transported by the next flood.

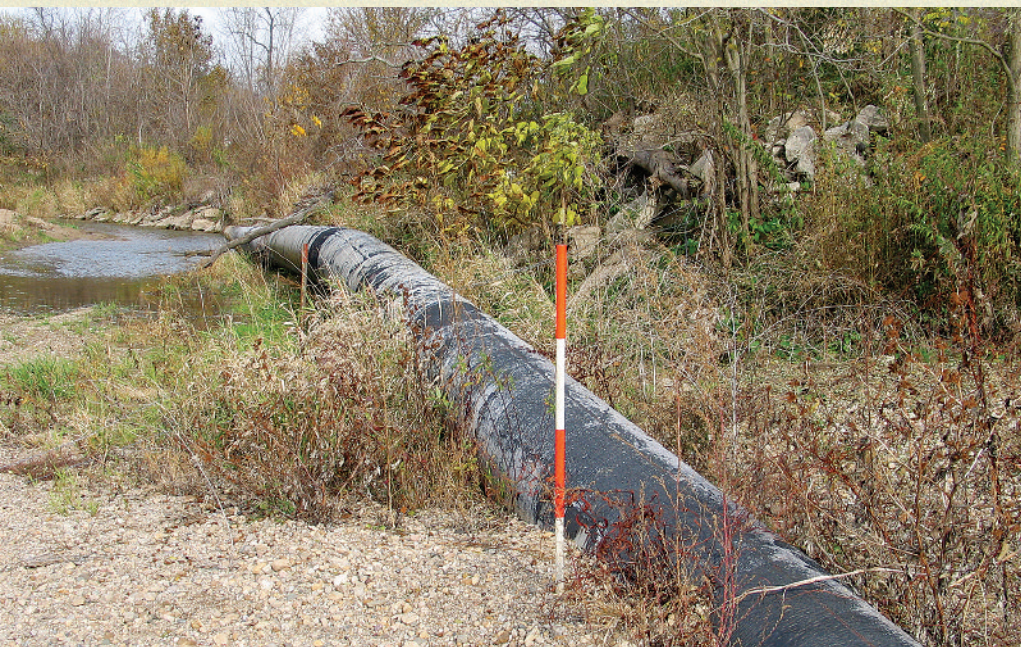
Channel incision occurs when the stream adjusts to modifications made throughout the watershed putting at risk infrastructure like this exposed pipeline in the main channel of Senachwine Creek.

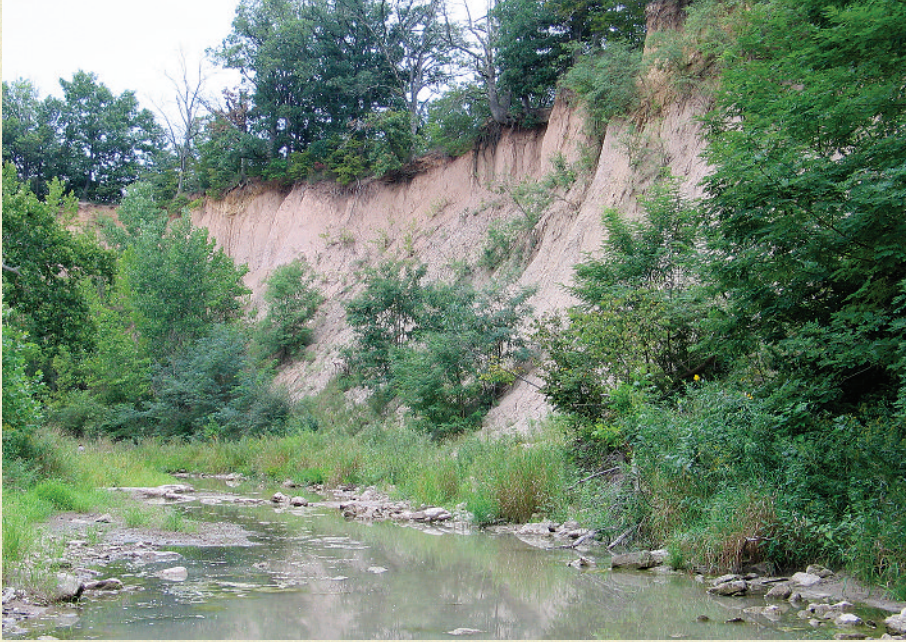
Mass-wasting of the valley walls delivers large amounts of sediment directly to the channel.

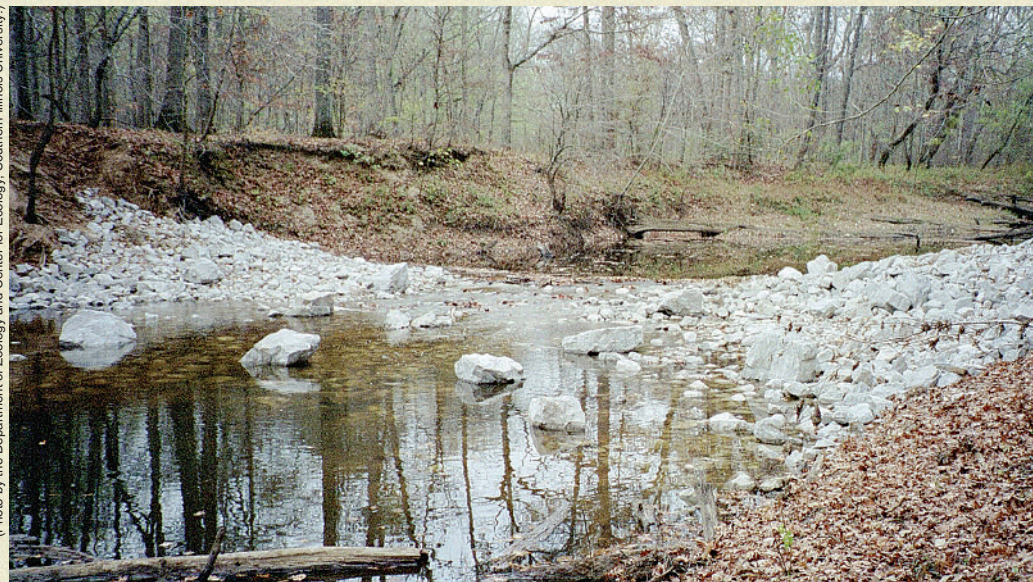
Constructed pool and riffles act as a grade control in the Cache River while enhancing habitat by increasing the pool size, supplying cover and water aeration.
