# Danville Dam and Ellsworth Park Dam Modifications Vermilion River and North Fork Vermilion River Strategic Planning Study

Danville, Illinois  
Vermilion County  
February 2013

# Sediment and Hydraulic Modeling of Danville Dam on the Vermilion River and Ellsworth Park Dam on the North Fork Vermilion River at Danville, Illinois

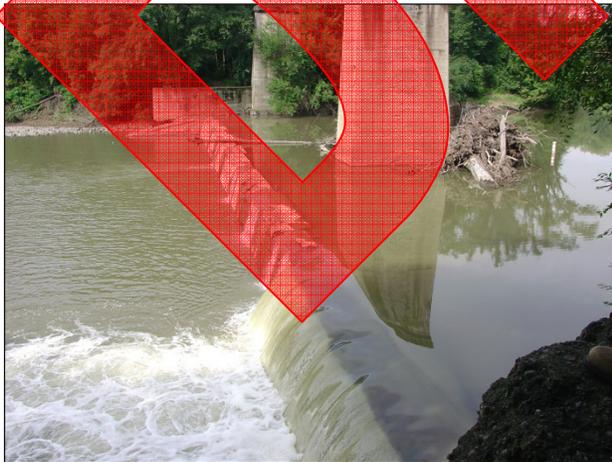
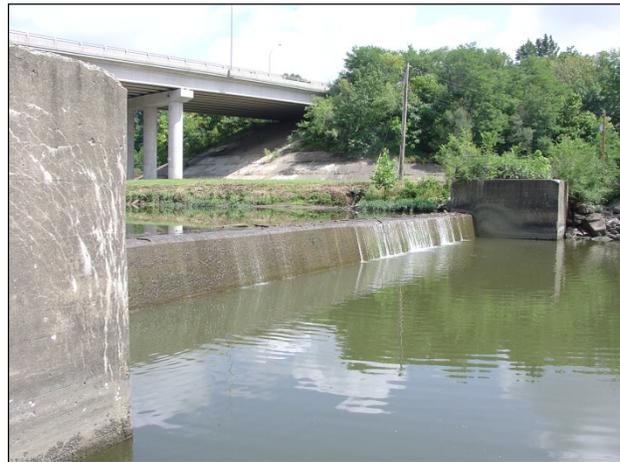
Photos Above: Danville Dam (left) and Ellsworth Park Dam (right)

The ogee shaped Danville Dam has a spillway length of 220 feet at an elevation of 519.36 feet and a height of 11 feet. The sharp crested Ellsworth Park Dam has a spillway length of 90 feet at an elevation of 523.43 feet and a height of 6 feet. Figure 2 illustrates the drainage areas to the Danville and Ellsworth Park Dams, which are 1,286 and 304 square miles respectively.

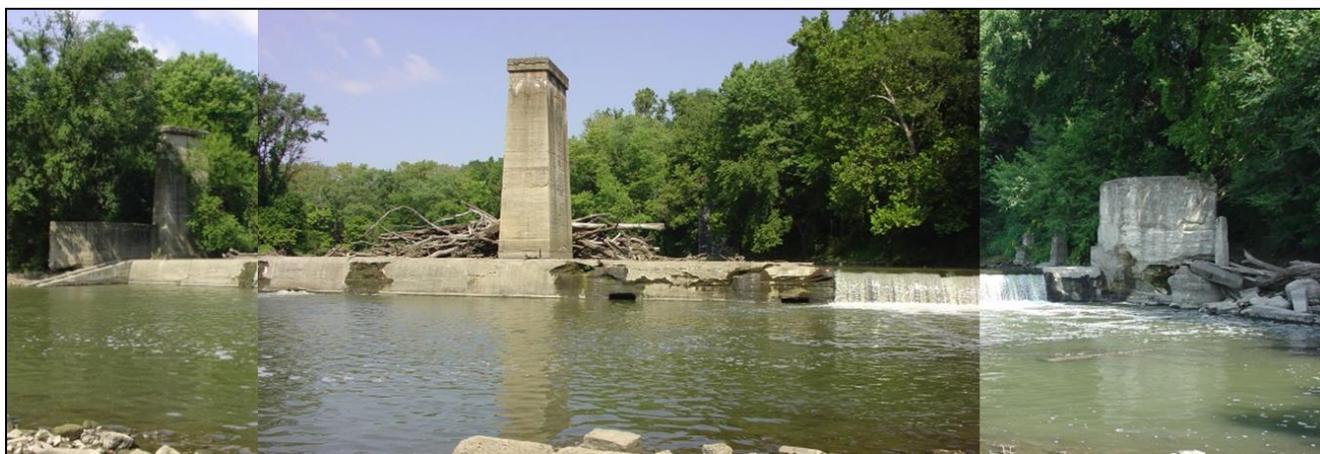
**Figure 3: Danville Dam Photograph**

The original purpose of the dam appears to have been for public steam water supply, but was later identified in 1970 as necessary for industrial operations by the General Motors Corporation. Ownership of the dam was conveyed from Illinois Power Company to the City of Danville on March 20, 1972. The Danville Dam currently serves no utilitarian purpose other than to form a recreational pool above the dam. Both east and west abutments are being undermined by heavy erosion. A portion of the dam crest has eroded approximately 1-foot down and the dam face is deteriorating allowing seepage to occur through the dam as shown in Figure 3.

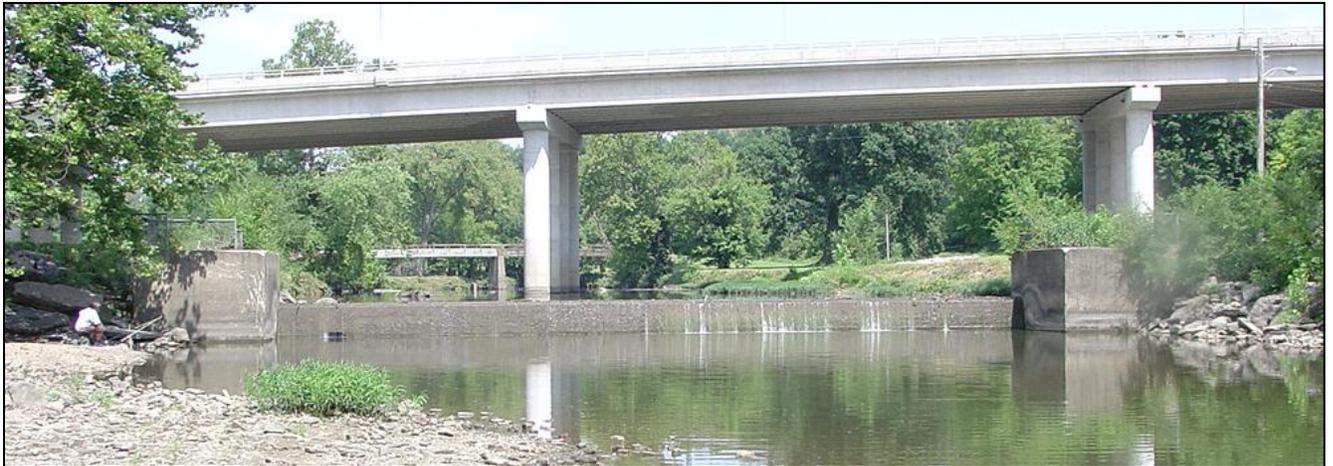
**Figure 4: Ellsworth Park Dam Photograph**

The Ellsworth Park Dam is a replacement of a dam that was previously located 100 feet downstream from its current location. The previous dam was removed in the 1920's and the new dam was constructed upstream after the removal. The Ellsworth Park Dam is provisionally classified as a Class III (low hazard) dam by the Department of Natural Resources based on the determination that failure of the dam would have little potential for causing loss of life or significant property damage. The dam is in good condition except for some minor erosion occurring around the west abutment, as shown in Figure 4.

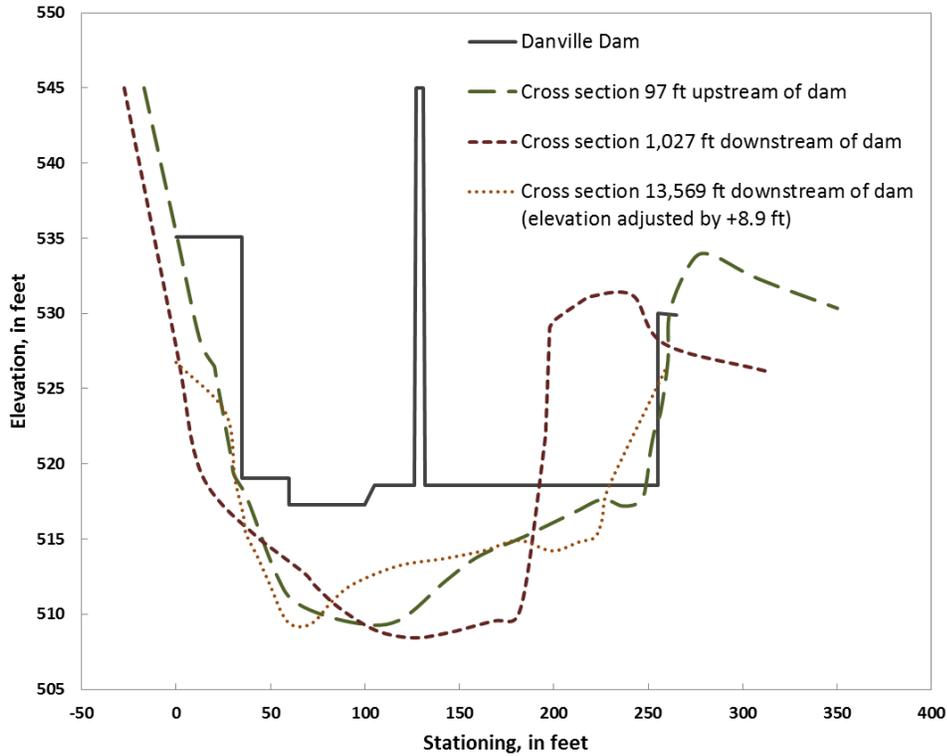
**Figure 3.** Surveyed cross section data upstream and downstream of Danville Dam near Danville, Illinois

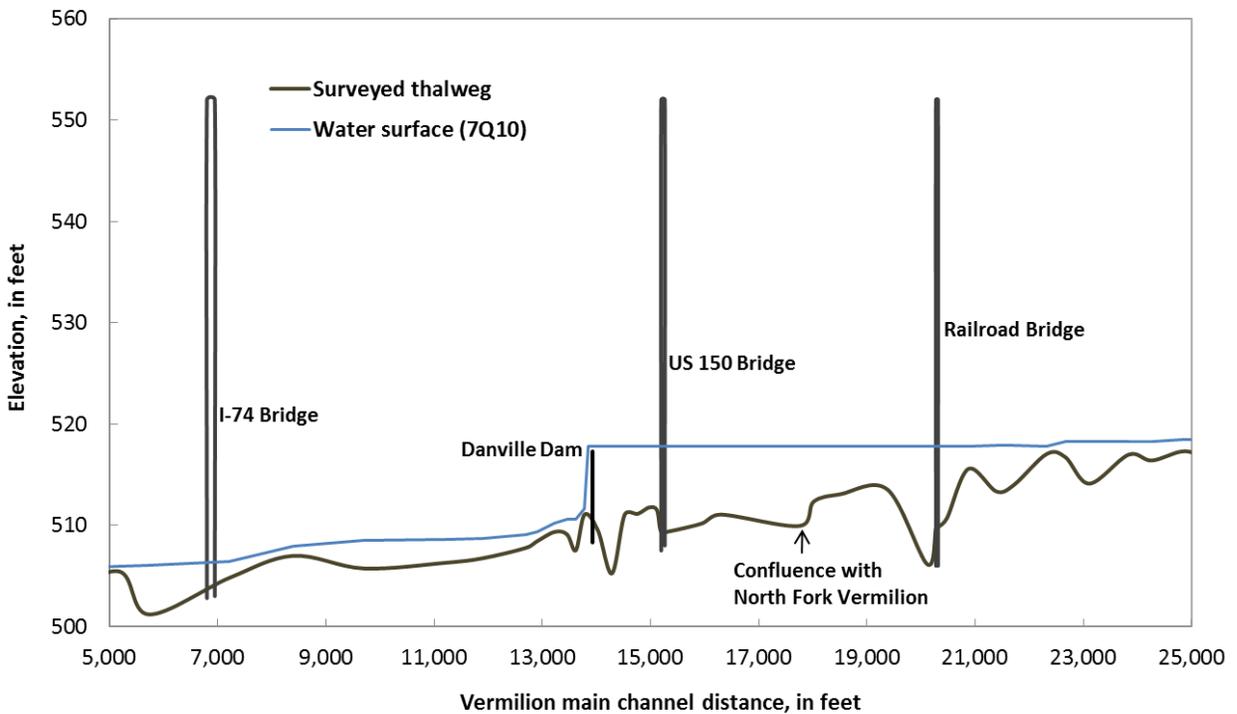
The surveyed longitudinal thalweg profile is shown in Figure 4 and adds to the knowledge gained from the cross sectional comparison about the Vermilion River system upstream and downstream of Danville Dam. There are no discontinuities or apparent deposition caused by the dam. Instead of deposition, a scour hole can be observed upstream of the dam in the meander bend.

**Figure 4.** Longitudinal thalweg profile and 7Q10 water surface of existing conditions on the Vermilion River upstream and downstream of Danville Dam

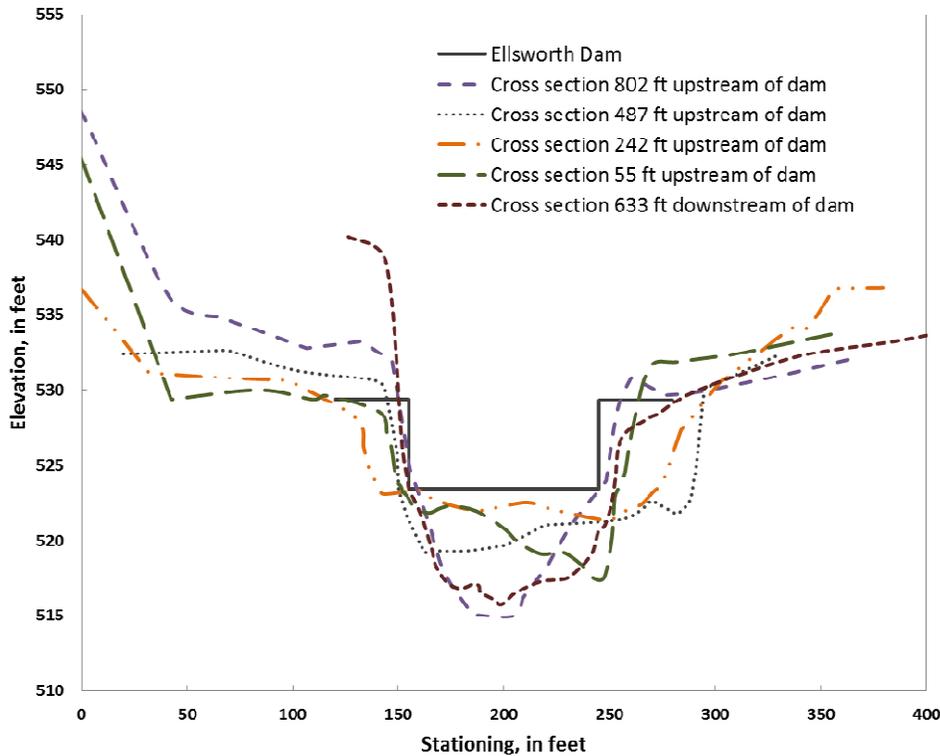
In contrast, comparing the upstream and downstream cross sections for the Ellsworth Park Dam shows that sediment has been trapped behind the dam (Figure 5). To obtain an approximate amount of sediment trapped, the cross section 633 ft downstream of the dam was used as reference to compare the cross sections 55, 242, and 487 ft upstream of the dam. Using a simple cross section area and representative reach length approach shows that approximately 6,000 yd<sup>3</sup> is trapped behind the dam.

**Figure 5.** Surveyed cross section data upstream and downstream of Ellsworth Dam near Danville, Illinois

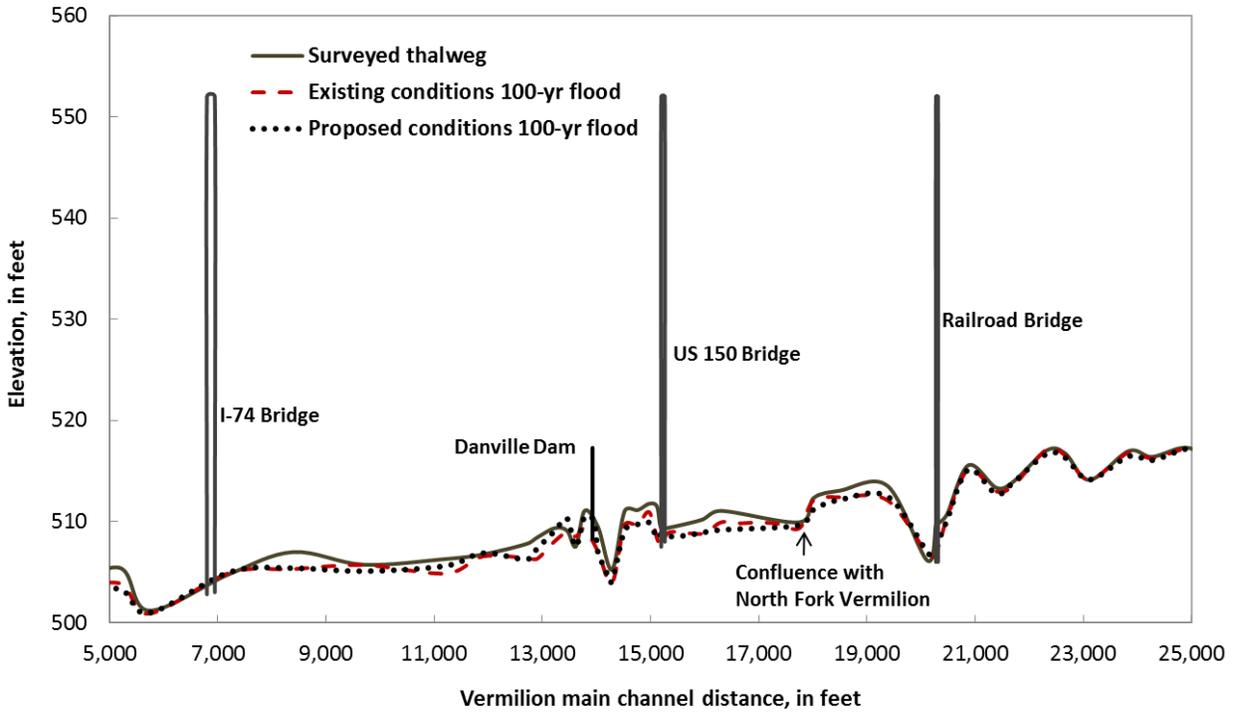
To model possible changes between existing and proposed conditions on the Vermilion River, the 2-, 10-, and 100-year flood hydrographs were modeled with sediment transport. The longitudinal thalweg profile for each flow and condition are shown in Figure 6-8, and show minimal difference between the proposed and existing conditions. The maximum difference in bed elevation changes occurs between the Danville Dam and the confluence of the North Fork Vermilion River. For the 100-yr flood event the maximum modeled difference in this reach between existing and proposed is approximately 1 ft.

**Figure 6.** Longitudinal thalweg profile of surveyed conditions, and after simulating sediment transport of a 100-yr flood on existing and proposed conditions on the Vermilion River upstream and downstream of Danville Dam

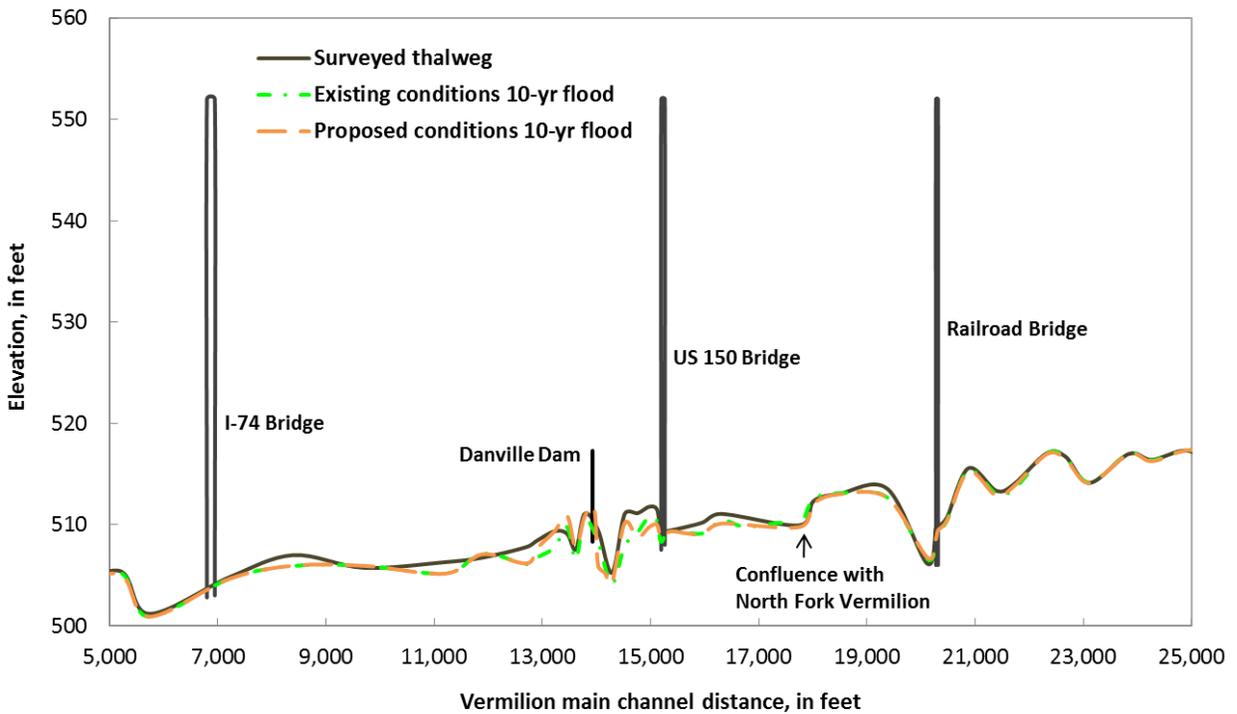
**Figure 7.** Longitudinal thalweg profile of surveyed conditions, and after simulating sediment transport of a 10-yr flood on existing and proposed conditions on the Vermilion River upstream and downstream of Danville Dam

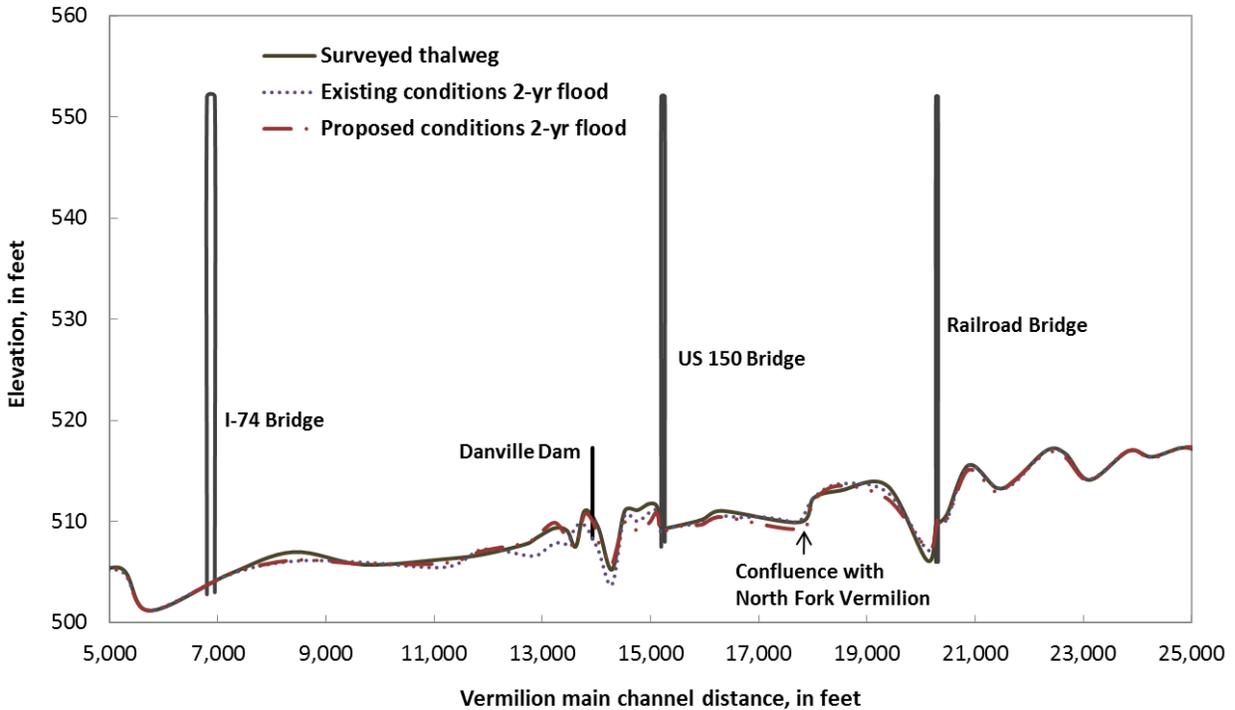
**Figure 8.** Longitudinal thalweg profile of surveyed conditions, and after simulating sediment transport of a 2-yr flood on existing and proposed conditions on the Vermilion River upstream and downstream of Danville Dam

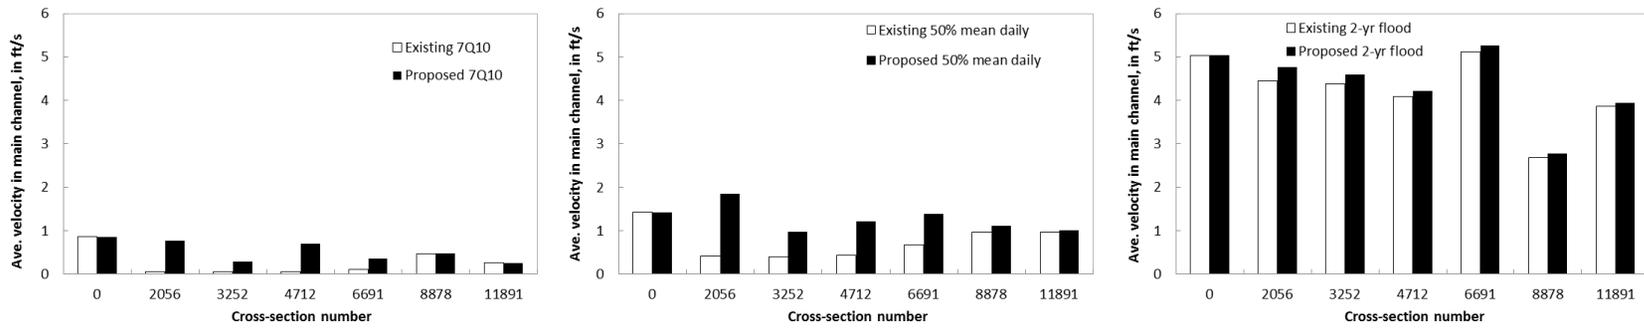
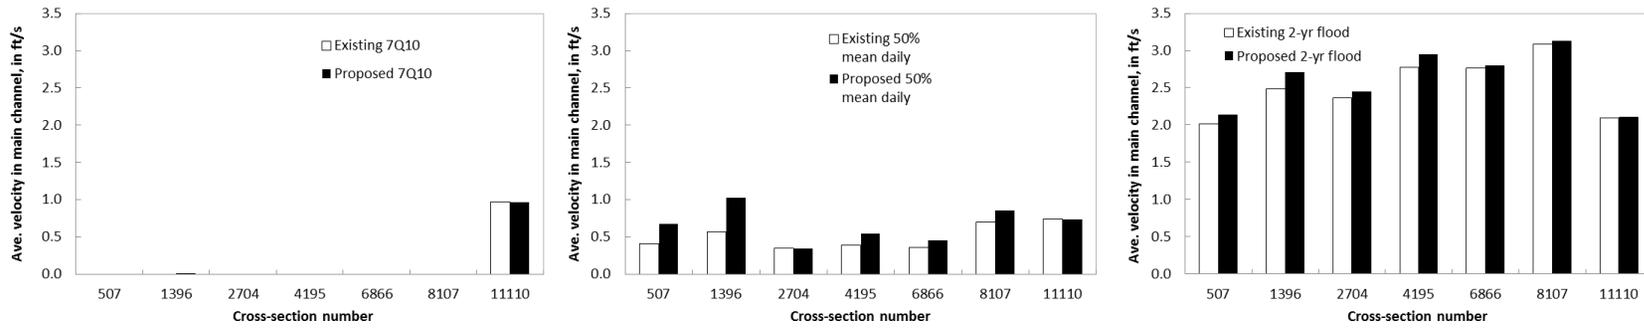
**Figure 10.** Existing and proposed condition average velocity of flow in the main channel for the 7Q10 flow, 50 percent of the mean daily flow, and 2-yr flood on the Vermilion and North Fork Vermilion Rivers

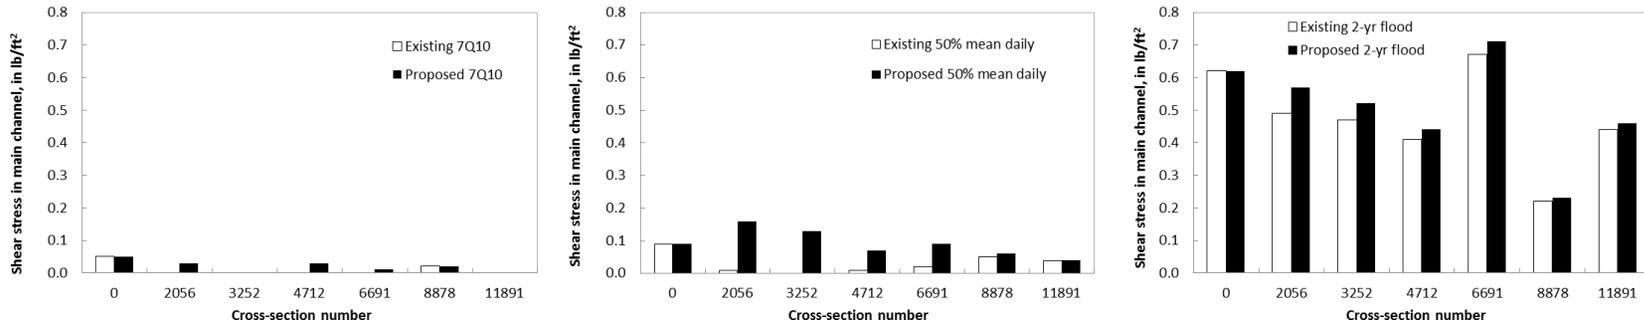
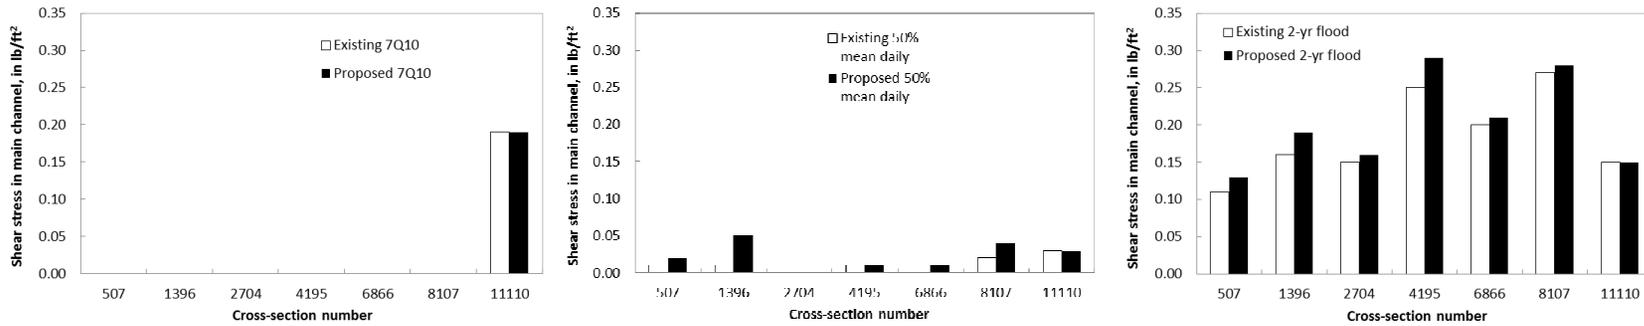
**Figure 11.** Existing and proposed condition shear stress in the main channel for the 7Q10 flow, 50 percent of the mean daily flow, and 2-yr flood on the Vermilion and North Fork Vermilion Rivers

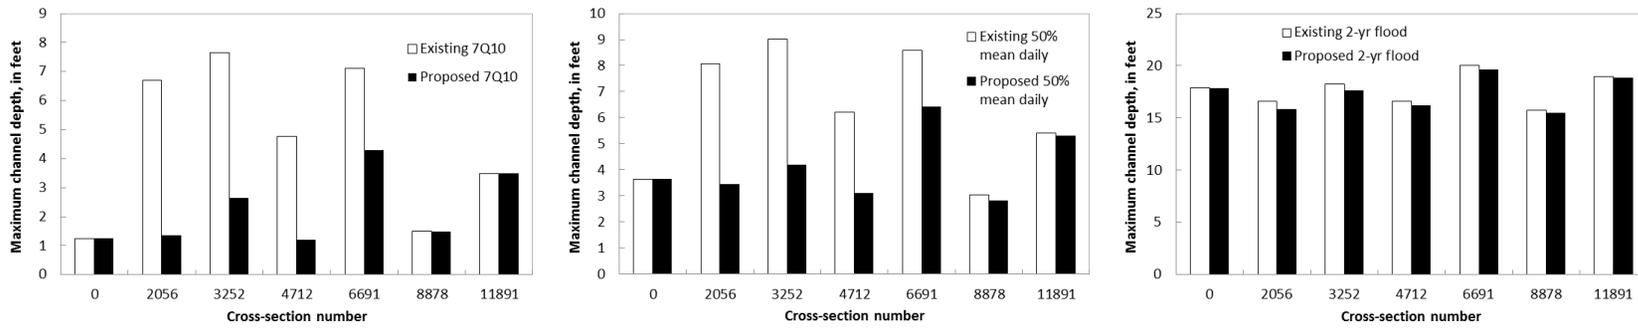
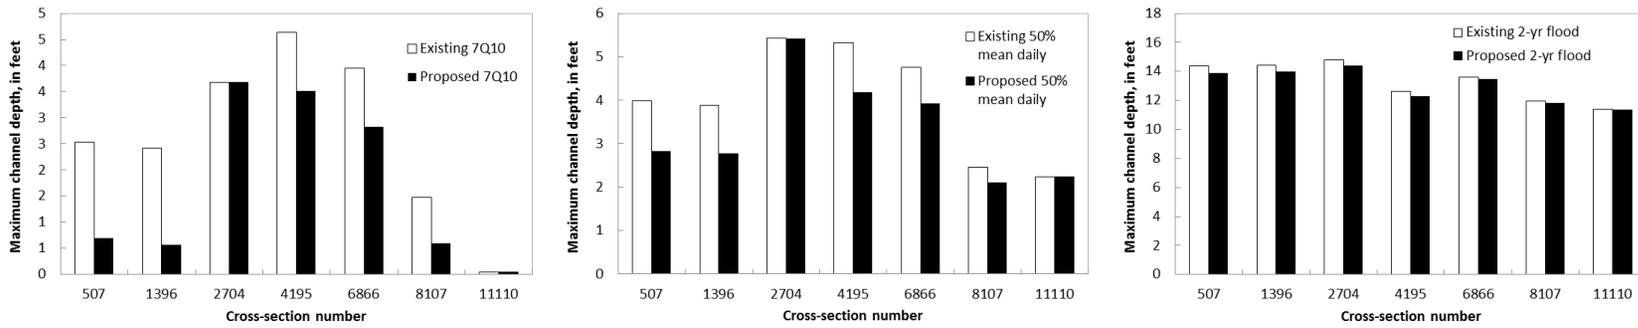
**Figure 12.** Existing and proposed condition maximum channel depth for the 7Q10 flow, 50 percent of the mean daily flow, and 2-yr flood on the Vermilion and North Fork Vermilion Rivers

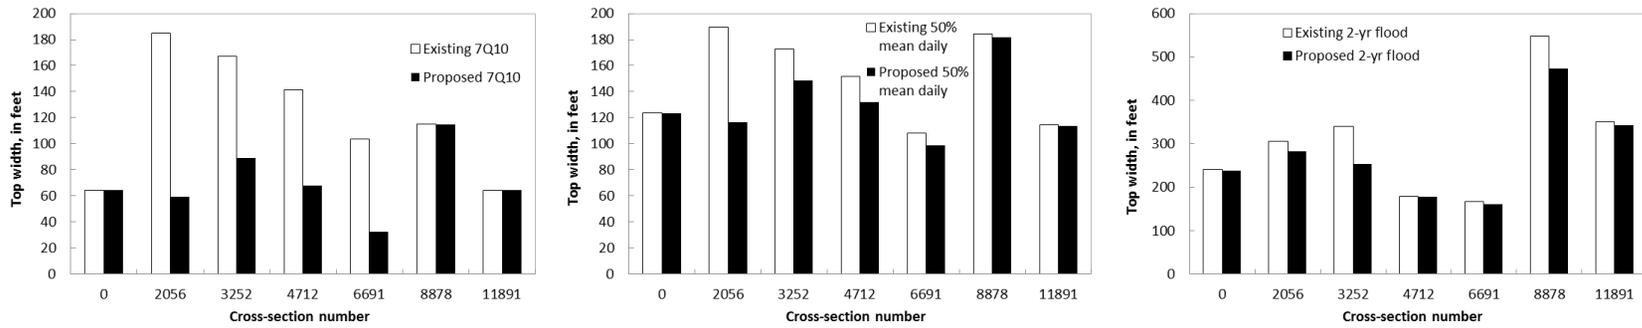
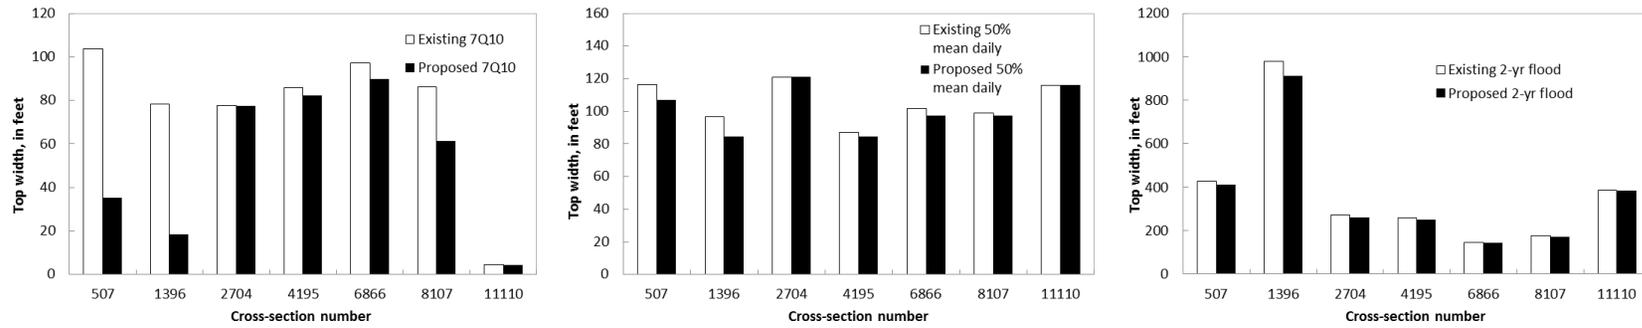
**Figure 13.** Existing and proposed condition top width for the 7Q10 flow, 50 percent of the mean daily flow, and 2-yr flood on the Vermilion and North Fork Vermilion Rivers

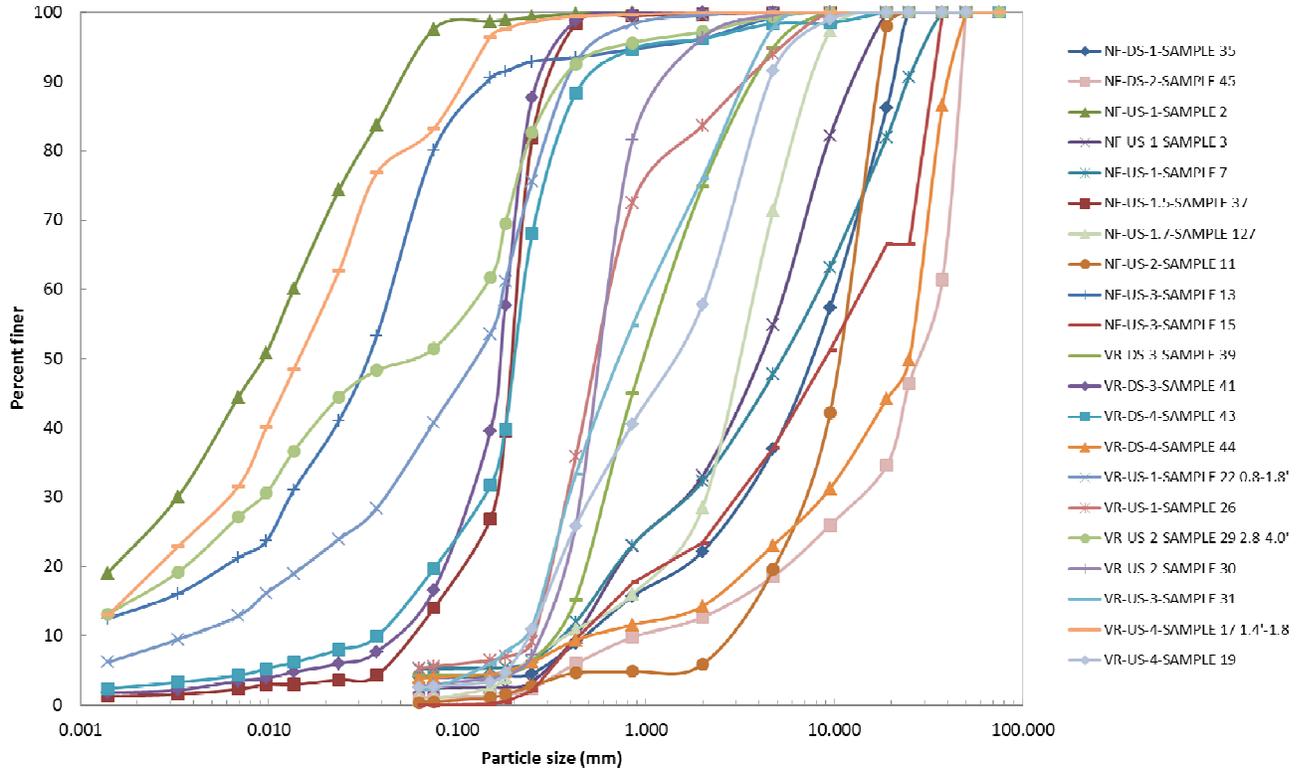
**Figure C1.** Sediment bed material or core particle-size analysis data on the Vermilion and North Fork Vermilion Rivers near Danville, Illinois
