# Copperas Creek Lock

Story By Michael Wiant  
Photos By Kelvin Sampson

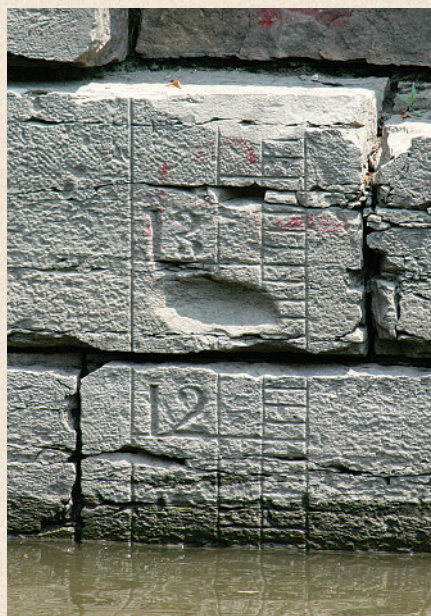
**Inset for the upstream, riverward lock door at Copperas Creek lock.**

Located on the west bank of the Illinois River, the Copperas Creek lock chamber is 350 feet long, 75 feet wide and faced with dressed limestone. Although the wooden doors used to regulate the amount of water in the lock chamber are long gone, insets in the chamber wall mark their location. Engraved in the chamber walls at the upstream and downstream entries to the lock are elevations that measure water depth.
